Artikel: Maintenance of steel structures

Autor: Palmer, M.F.

Maintenance of steel structures

Repairs to Tower Bridge

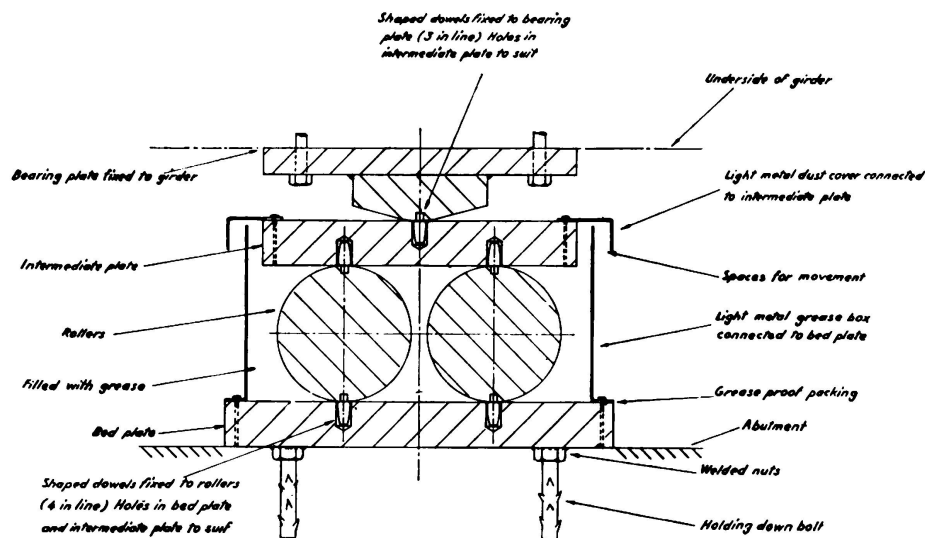
FIG. 3. Expansion bearings

In some cases, roller expansion bearings have not been easily accessible and have become completely corroded, and, in effect, fixed. It is now common practice to encase such bearings in grease boxes having dust covers, which ensures that no further attention is required for a number of years. This is exemplified by Rochester Bridge, which was reconstructed in 1912. The expansion bearings were left exposed, but

in 1930, owing to the troubles from dust and dirt, they were completely encased and packed with grease. No further attention has been necessary, and the bearings are working well. Fig. 3 gives an example of a simple enclosed bearing.
