Artikel: The development of asphalt surfacings for steel bridge decking

The Development of Asphalt Surfacing for Steel Bridge Decking

Road Research Laboratory, Department of Scientific and Industrial Research,
United Kingdom

At the request of the Joint Consulting Engineers for the proposed new bridges over the rivers Forth and Severn, the British Ministry of Transport and Civil Aviation asked the Road Research Laboratory to make tests to help to decide on the choice of a surfacing that would be sufficiently impervious to protect the steel decking from rust and corrosion, and that would be durable, non-skid and of a thickness not exceeding 2 in. It was desirable to test the possible surfacings on the full-scale and steel panels 9 ft. long by 7 ft. wide of a construction similar to that of the then proposed decking were placed in the carriageway of the Colnbrook By-pass on Trunk Road A. 4. This road carries more than 40,000 tons of traffic per day and some of the test panels were subjected to this traffic for periods of up to six years.

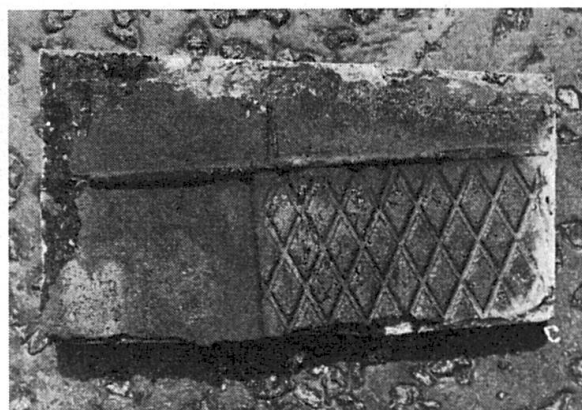
Fig. 3. The Underside of the $1\frac{1}{2}$ -in. Surfacing Removed From the Junction of the Smooth and Chequered Plate Panels.

By January, 1950, three weeks after opening to traffic, cracks began to appear at the junction of the panels and the side plates, and, by April, 1950, the side plates on all the sections, except that with a 2-in. surfacing, were outlined by cracks. A crack also appeared between the 1-in. and $1\frac{1}{2}$ -in. sections, no cracks were detected in the surfacing proper, although on that with a 1-in. surfacing, cracks appeared to be working in from the edges. In June, 1950, patches were cut from all sections and showed that rusting was occurring at the edges of the plates near the cracks. This spread under the bituminous

paint and caused failure of the bond between the surfacing and the deck plate (see figs. 3 and 4). Where the bond had failed, traffic caused "pushing" of the asphalt (see fig. 5); the general appearance of the surfacing is shown in fig. 6.

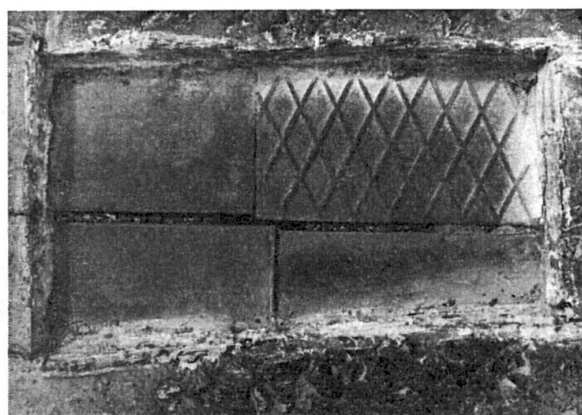
Fig. 4. Deck Plate on the Smooth and Chequered Plate Panels After Removing the $1\frac{1}{2}$ -in. Surfacing. Rusting Can Be Seen Round the Edge of the Plates.

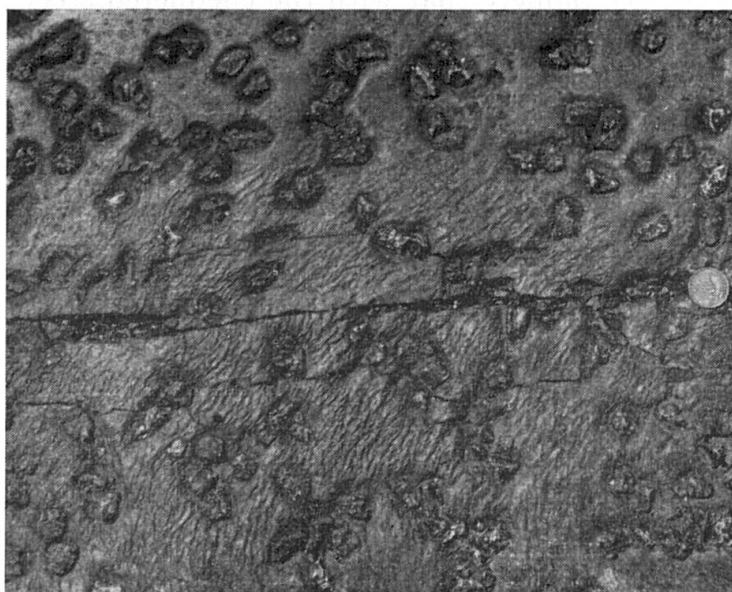
Fig. 5. Pushing of the 1-in. Mastic Asphalt Surfacing on the Side Plate Due to the Bond Being Broken Between the Surface and the Steel.

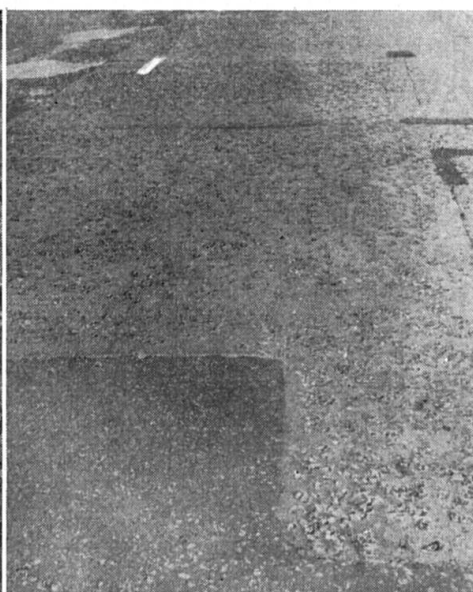
Fig. 6. View of the Surface on the Panels, Showing the Cracking Round the Side Plates.

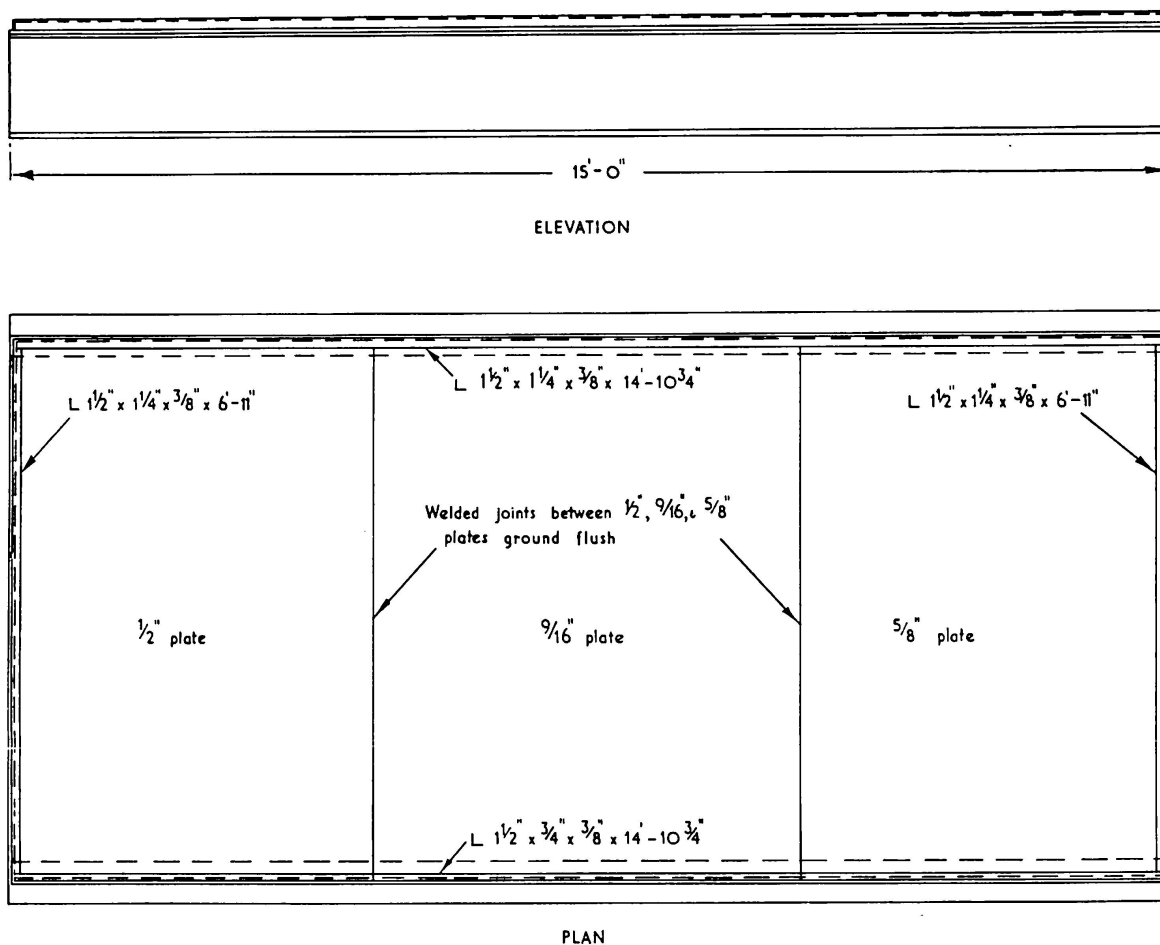
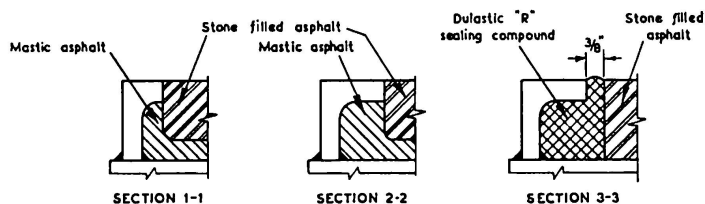
Fig. 7. Panel Used for Second Experiment.

The large panel was similar in construction to those described earlier. Angle-iron was welded along its edges as shown in fig. 7 in order to contain the asphalt. Two of the existing panels, namely that with the chequered steel plate and that carrying the 2-in. mastic asphalt surfacing, were taken out of service and replaced by the 15 ft. by 7 ft. plate in November 1950. Two methods of laying the surfacing were employed and the methods used to seal the edges are shown in fig. 7. The panel was subjected to traffic and weathering for $5\frac{1}{2}$ years and was removed for inspection in July, 1956. The surfacing was removed near to the corners to inspect the sealing and the results were as follows:

Corner A. The edge here was formed by $1\frac{1}{2}$ in. by $1\frac{1}{4}$ in. angle and was filled with a proprietary rubber/bitumen sealing compound. The joint was found to be perfect.

Corner B. The edge here was formed from either $1\frac{1}{2}$ in. by $1\frac{1}{4}$ in. or $1\frac{1}{2}$ in. by $\frac{3}{4}$ in. angles and filled with damp-proof mastic. There was an obvious construction joint between the two courses of mastic and this was filled with dust and dirt. Little adhesion occurred between the damp-proof mastic and the angle-iron: the latter showed signs of rusting.

Corner C. The construction was as for *B*. The joint between the two mastic layers was more pronounced and showed evidence of pushing. The adhesion

to the angle-iron was poor and water had entered, causing some corrosion of the angle. The steel deck plate was undamaged.

Corner D. The construction was as for *A*. The joint appeared perfect but droplets of water were found in three small pockets (1 to 2 sq.in.) under the mastic. They caused some discoloration but the zinc film was intact and the deck plate undamaged. There was no evidence to indicate how the water had reached the small pockets.

No rusting of the deck plate occurred at any of these points.

3. Special construction is necessary to keep water out of the edge joints. Angle-iron at the edges of the deck plates, filled with rubber/bitumen sealing compound together with a surfacing of $1\frac{1}{2}$ in. of stone-filled mastic asphalt gave a joint that withstood heavy traffic for at least 6 years.

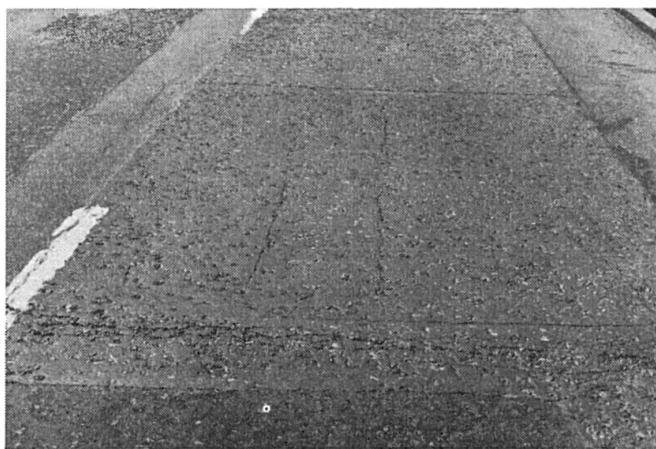
The cracks formed over the stiffeners are shown in fig. 8. On stripping the surfacing it was found to be cracked right through over the three central stiffeners for nearly the whole distance between the transverse supports. The

Fig. 8. General View of Bridge Panels After 2 $\frac{1}{2}$ yr. with 1-in. Surfacing in Foreground. Note the Pronounced Cracks Over the Three Central Stiffeners and Incipient Cracks Over the Outer Stiffeners.

cracks over the outer stiffeners were found to be in the form of a "vee", the point of the "vee" just touching the steel over a short distance. Where the cracks penetrated to the steel, and all around the edges of the panel, water had entered and caused considerable rusting. Fig. 9 shows the extent of this corrosion and also shows that, over the main area of the panel where the adhesion to the mastic had remained good, no penetration of water had occurred and hence no rusting. The considerable crack over the central transverse support did not extend through the surfacing and no water had penetrated to the steel.

1. A 1-in. thickness of stone-filled mastic asphalt would be too thin for use on the deck of the proposed bridge. Cracks would probably form over the longitudinal stiffeners and permit water to penetrate through to the steel plate.

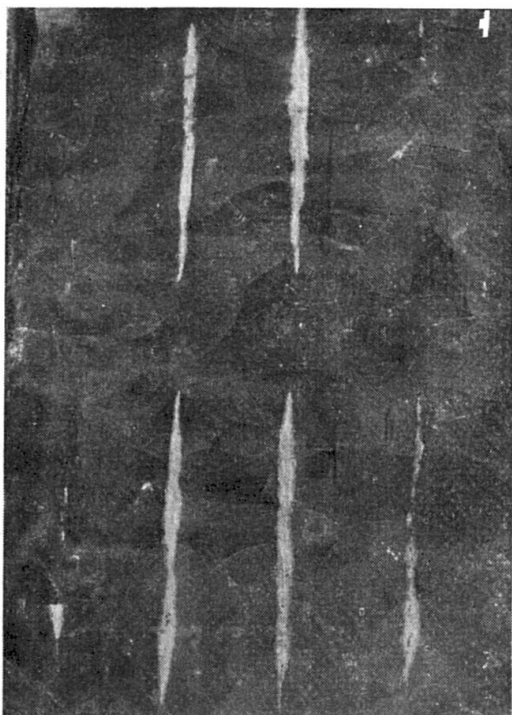
Fig. 9. The Steel Deck-Plate After Removal of 1-in. Surfacing. Note the Corrosion After $4\frac{1}{2}$ yr. Owing to Water Penetrating Through the Cracks Shown Above.

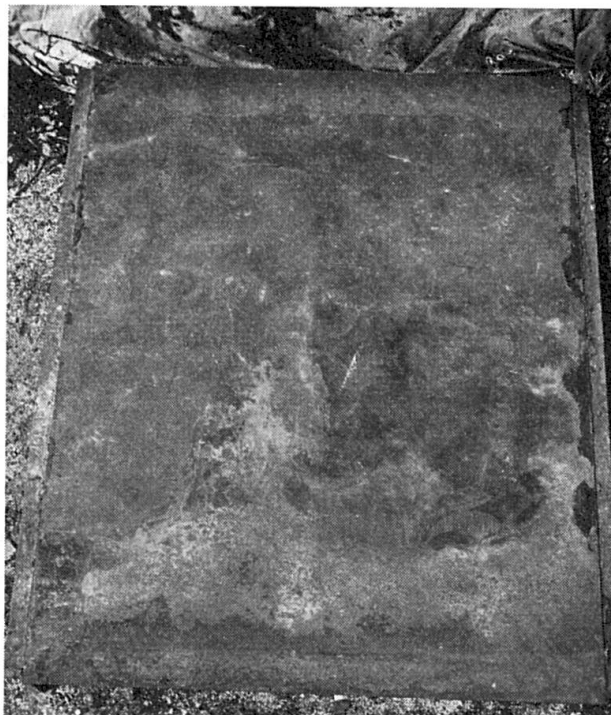
Fig. 10. The 9 ft. By 7 ft. Deck Plate After Removal of the $1\frac{1}{2}$ -in. Surfacing. Note Absence of Any Corrosion After $4\frac{1}{2}$ yr., Due to Cracking; and Also the Very Considerable Corrosion Where the Mastic Asphalt Had Not Adhered Properly Over the Front and Centre Portions of the Plate.

There was a fairly well defined crack about $\frac{1}{16}$ in. wide over the central stiffener and a very short, faint crack over each of the two adjoining stiffeners. None of these cracks penetrated to the steel plate. As with the 1-in. surfacing, water entered all around the edges of the plate and caused considerable corrosion, particularly at the west end of the panel (on which traffic first runs). Approximately a quarter of the whole area had no adhesion between the

mastic asphalt and the steel. Here the plate was extensively rusted and the mastic asphalt was widely cracked over its underside. The cracks were filled with rust and slime, but did not penetrate to within $\frac{1}{2}$ in. of the top surface. No cracks were detected in the region where the adhesion to the steel was good. Fig. 10 shows a photograph of the steel plate after the $1\frac{1}{2}$ -in. surfacing had been removed.

5. It was found advantageous to sand-blast the steel plate, spray it with metallic zinc, and to prime it with bituminous paint to minimise rusting and corrosion and to improve the bond between the surfacing and the plate.

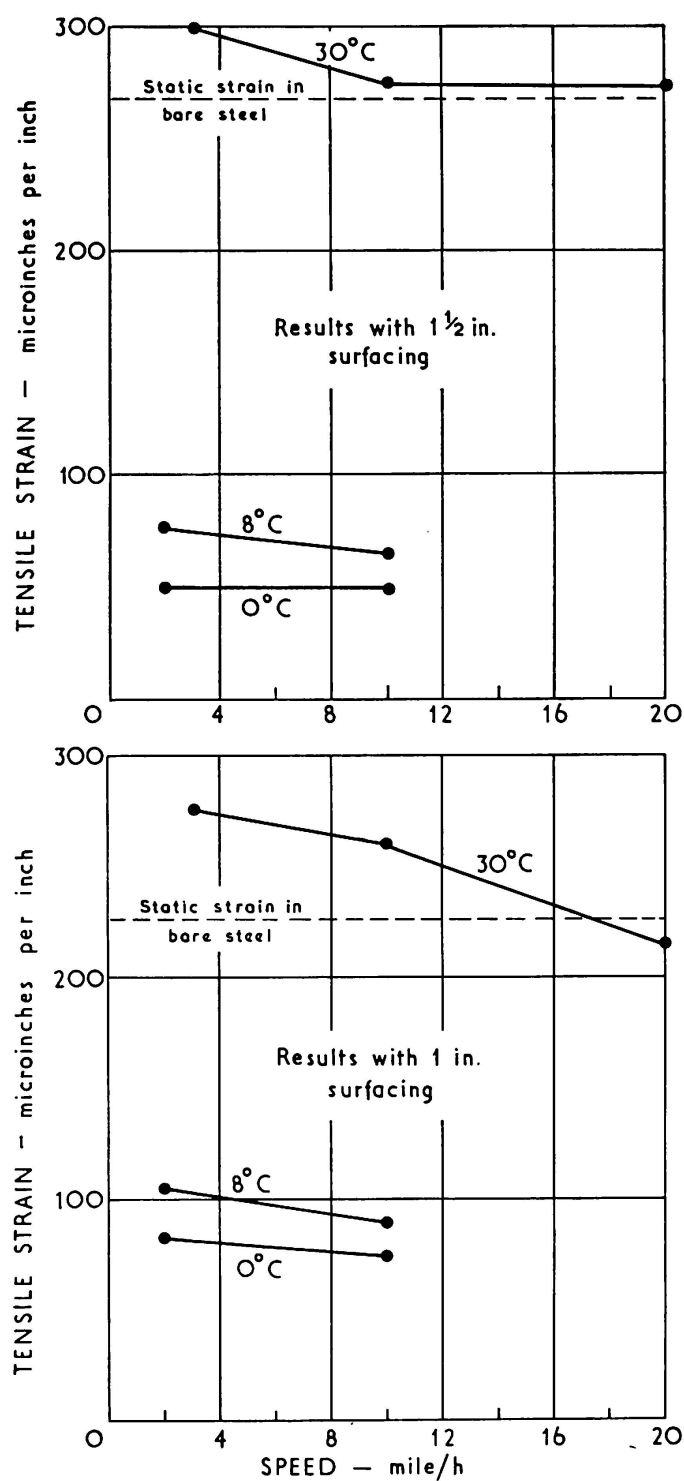
Fig. 15. Effect of Vehicle Speed and Temperature on the Dynamic Strains in Bridge Panels Caused By a Wheel Load of 11 000 LB.

Values of the peak tensile strain recorded by gauge No. 6 in each test run are shown in fig. 15 plotted against the vehicle speed, separate curves being shown for the three surfacing temperatures studied. Separate sets of curves are shown for each panel, and each diagram shows the tensile strain deduced from the static tests at a load equal to that applied by the rear wheel of the moving lorry, i.e. 11,000 lb. The distribution of strain occurring under the load applied by the jack to a rubber disc 11 in. in diameter and that applied by the vehicle tyre having an elliptical contact area about 12 in. by 8 in. will not be identical. The static strains have been included in fig. 15 merely as a yardstick by which to judge the strains recorded under the moving vehicle. The fact that, at 30°C, the dynamic strain recorded with, say, a surfacing 1½ in. thick, was actually greater than that recorded statically, with the load applied to the bare steel, therefore, has no significance.

Both sets of diagrams on fig. 15 show much larger strains in the steel when the surfacings were at a temperature of 30°C than at 0 and 8°C. The diagrams indicate that at 30°C, the surfacings made only minor contributions to the rigidity of the steel plate, whereas at the lower temperatures, their contributions were appreciable. If it is assumed that the strains measured in the static test were directly comparable with the dynamic values, it would appear that, at 0°C, the 1½-in. surfacing contributed about 80 per cent as much as the steel plate to the overall rigidity, while the contribution of the 1-in. surfacing was 60 per cent. If the mastic asphalt behaved elastically under the stresses and rates of loading applied by the moving vehicle, it would be expected that the elastic modulus would be higher at the low temperature than at 30°C. Tests on bituminous materials have indicated that the change of modulus corresponding with this temperature change may be of the order of three to four times greater and this would largely explain the recorded differences in strain at summer and winter temperatures.
