# Fracture and retrofit of Dan Ryan Rapid Transit Structure

Autor(en): **Fisher, J.W. / Hanson, J.M. / Hausammann, H.**

Zeitschrift: **IABSE congress report = Rapport du congrès AIPC = IVBH  
Kongressbericht**

Band (Jahr): **11 (1980)**

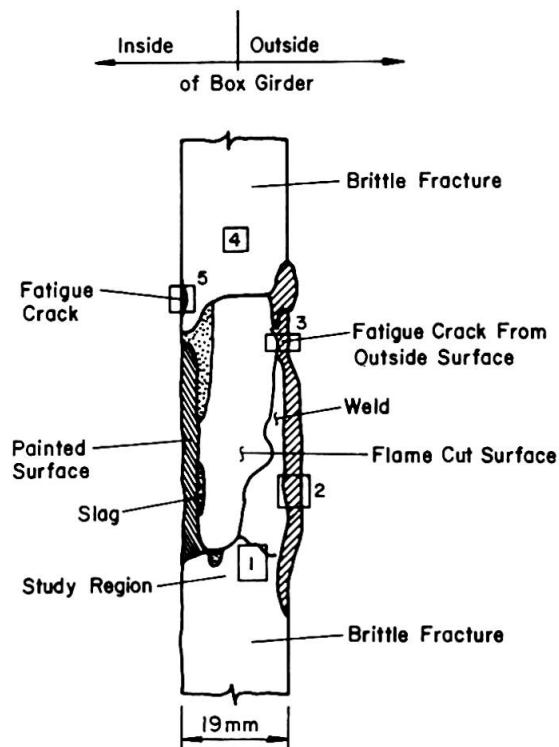
Fig. 3b Schematic of Fracture Surface

Surface replicas were prepared from different locations of the crack surface indicated in Fig. 3b and investigated with the transmission electron microscope. Fatigue striations (see Fig. 4) were found on all three fracture surfaces. These striations represent the extension of the crack front during one load cycle and confirmed the development of fatigue crack growth. Striation markings were found in regions 2 and 3 in Fig. 3b; the measured growth rate was  $2.10^{-5}$  mm/cycle near the exterior surface and  $5.10^{-5}$  mm/cycle near the lack of fusion area. The examination of region 4 near the upper end of the discontinuity showed mainly cleavage fracture with river patterns. The examination of each fracture surface confirmed that fatigue crack growth originated at the lack of fusion area and at the exterior weld surface at the weld toe on the box side plate. It was estimated that about 6 mm of fatigue crack growth was experienced before the cracks became unstable.
