Reconstruction of a Railway Station in Budapest

TIBOR SIGRAI

UVATERV

The track-hall of the Nyugati Western Railway Station of Budapest, built 1875–1877, is a steel structure with a span of 42 m, and a length of 153 m consisting of Polonceau trussing. The hall was to be reconstructed because of the damages caused by corrosion. The reconstruction was carried out during 1978–79, by taking into consideration the aspects of the protection of historical buildings. The less damaged but valuable structural parts were preserved and the newly manufactured parts were fitted to them.

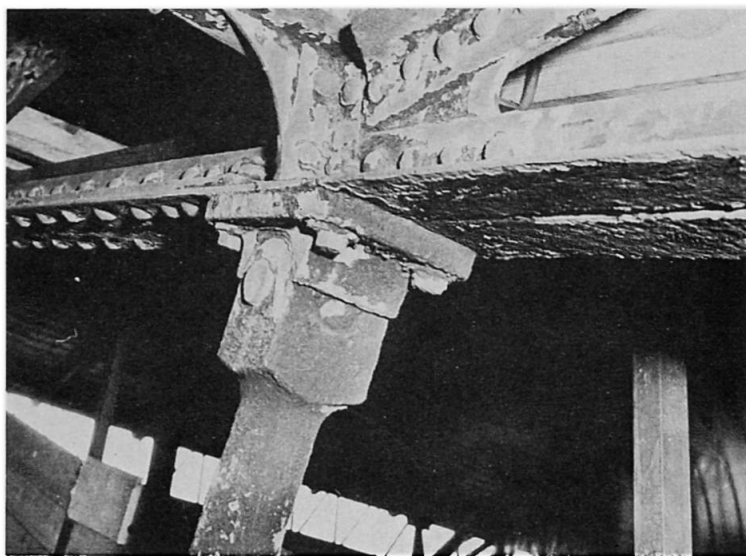
The extent of the corrosion at the middle part of the trussings, that are the most exposed to the fumes reached or surpassed the 50% limit. The corrosion of the bearing columns was caused by the faults in the rainwater drains. At the same time in the case of the decorative frame corners and the tension bars, the extent of the corrosion was negligible. The corrosion was also negligible at the two frame trusses to be found near the Great Boulevard, where the locomotives did not pull in.

5. Detail of a corroded trussing

Therefore the basic principle of the reconstruction was on the one hand the saving of the less damaged but historically most important part of the structure, on the other hand the replacing of the practically destroyed and non-renewable ones.

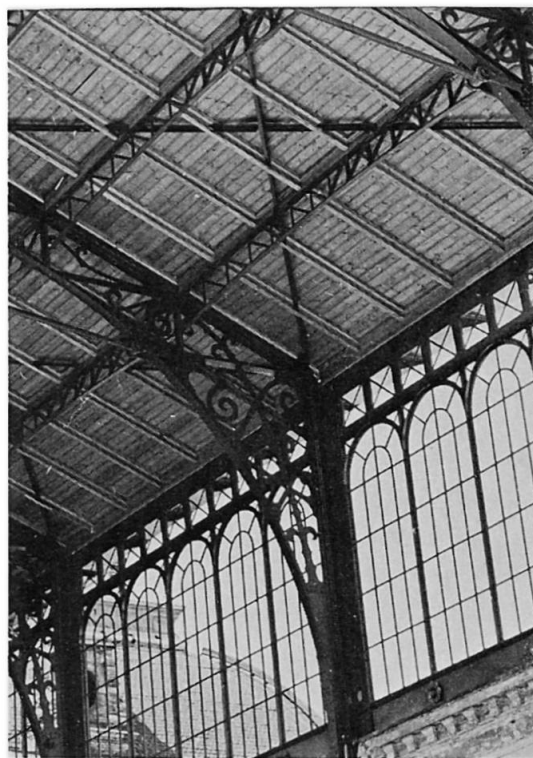
6. A renewed frame corner

The reconstruction took into consideration the point of view of the historical interest. It was based on saving of the less corroded structural parts, on the construction of a horizontal support system, on the load relief of the frame corners, and finally — taking into account that the problem was the mixed construction of the remaining and new parts — based on a conception that needs a very thorough manufacturing and assembly technology. The new track-hall, regarding its appearance, is almost the same as the old one, apart from minor details. The curtain wall, facing the Great Boulevard of Budapest, remained as it was and also remained the first two frames attached to it. These were cleaned by metal-spraying and were stiffened at the necessary places. The same principle applies to the decorative corners of the other frame structures. The latticed frame trusses between the frame corners are made anew by welding. The shape, the dimension and arrangement of the sections follows the original very closely.

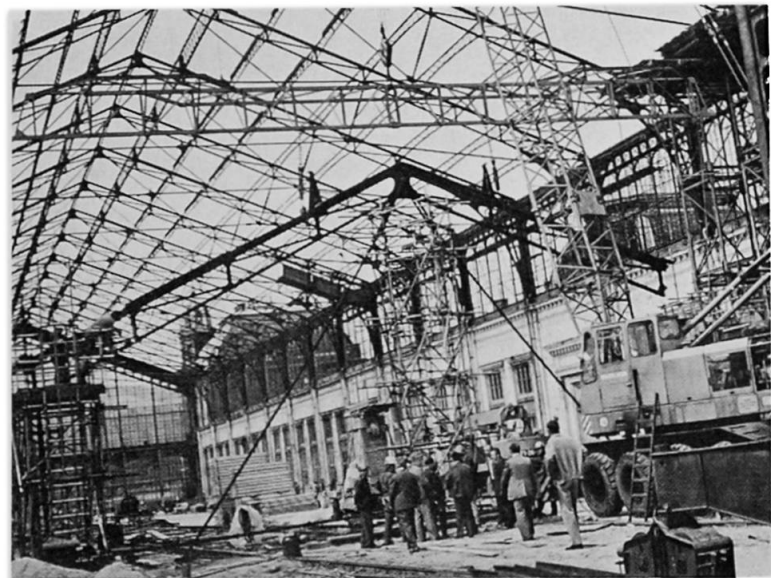
8. The demolition of a trussing

The demolition started at the exit side with the curtain wall, for this scaffolding was built on which the demolished structure was cut into transportable pieces. The demolition of the trussing was carried-out with the help of a rocker device that was fixed to the structure, and after the trusses were cut at the boundary line of the remaining frame corners they were lowered by an autocrane to the floor. The construction was started by strengthening of the remaining two trussings and this was done with a full scaffolding. The repaired corner elements were replaced on the reinforced columns, then the connecting longitudinal walls were lifted-in and the junctions were made.

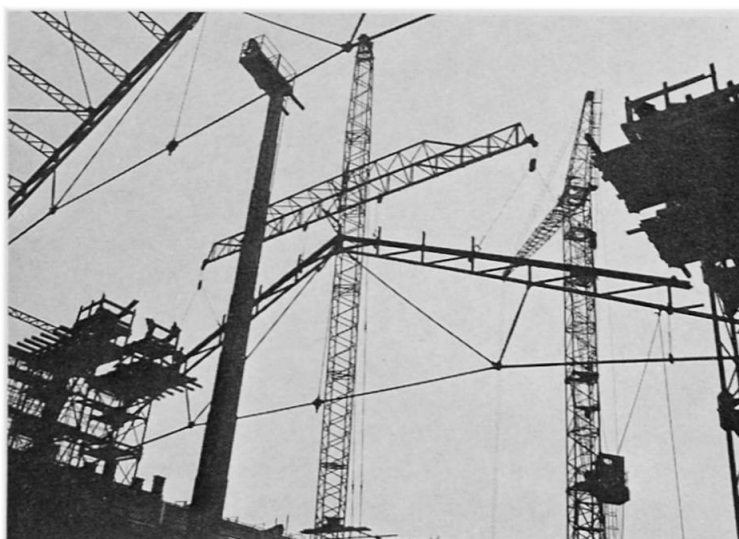
9. The lifting in of a new trussing

The new trussing part was assembled on the ground in the vertical position and the tension bars were adjusted in this position. With the help of the rocker device, the trussing

was lifted-in between the two corners. The tension bar was connected and the trussing was placed into its final position by further lifting to allow the connection of the trussing onto the corner parts with the plates. Afterwards the purlins and the windbraces were lifted-in. During the erection of the steel structure of the end wall for the exit side the 42 m long bridge, manufactured in three pieces was lifted in by three cranes simultaneously. The connections were made in the air, then the bridge was lowered onto its supports. The reconstruction of the roof boarding was made according to its original shape and over the boarding one layer of roof-plate water-proofing was placed finally on its top a zinc sheet covering was laid.

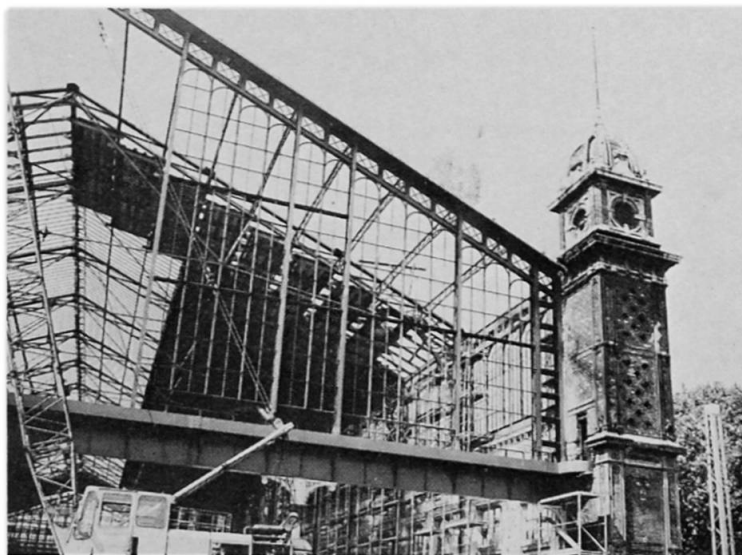
10. Erection of the new curtain wall

The new curtain wall was constructed as a closed frame-structure by building into a new vertical Vierendel-truss on each edge.
