# Timber bridge replacement to resist deicing agents

### Timber Bridge Replacement to Resist Deicing Agents

#### J.R. VERNA

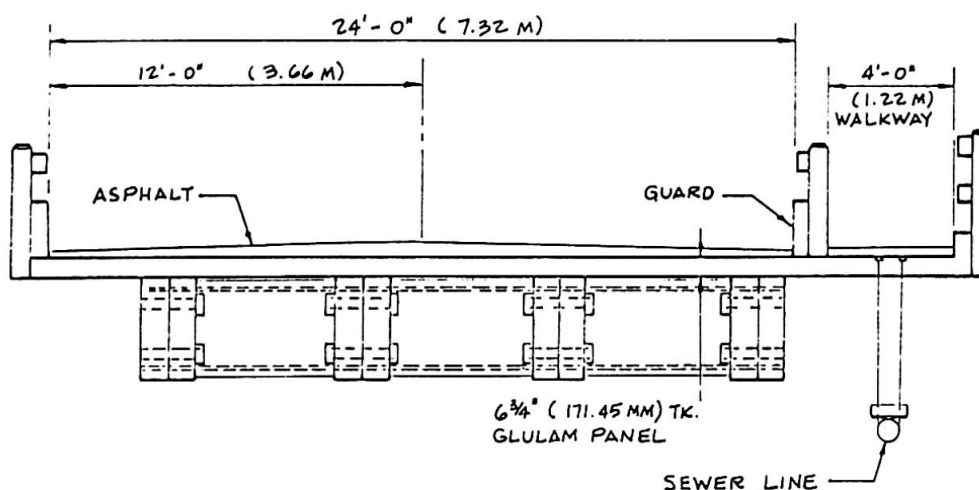
Figure 1: Case Study 2 - Cross section of glue-laminated timber replacement bridge.

The structure was widened from two 8-ft (2.4 m) lanes to two 12-ft (3.7 m) lanes and a four ft (1.2 m) sidewalk was added to the structure, as shown on Figure 1. The abutments, originally constructed from blocks of sandstone, which is also not affected by deicing agents, were in excellent condition and, therefore, reused.

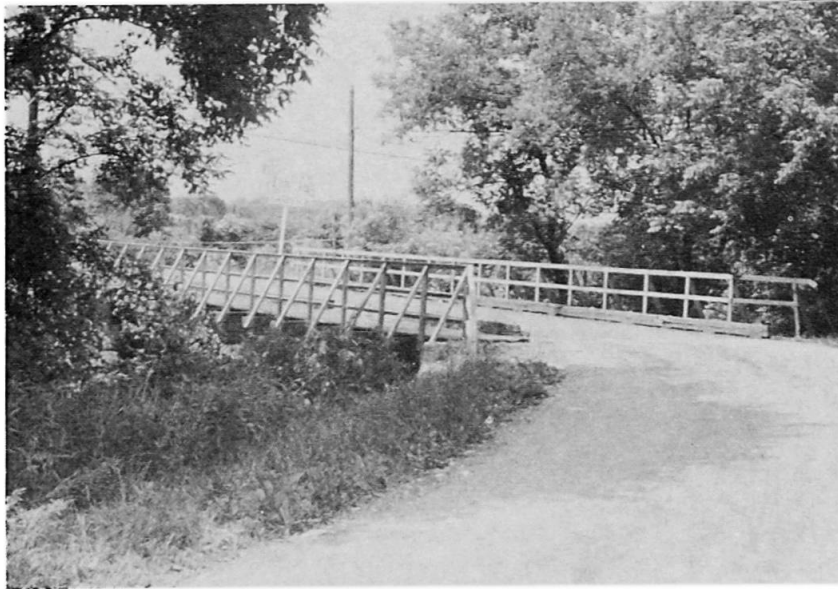
Two case studies are presented. The first deals with a deck replacement and the second with the replacement of the entire bridge structure. In 1947, a steel beam bridge structure with a mechanically laminated wood deck was constructed in Allegheny County, Pennsylvania, U.S.A. Thirty years later the deck had become weakened from use without a protective wearing surface. Where the wood had been worn from traffic and damaged with snow plows, decay by natural organisms had done the damage that water, temperature, and deicing agents had not been able to do, as shown on Photograph 1.

Photograph 1: Case Study 1 - Bridge prior to renovation.

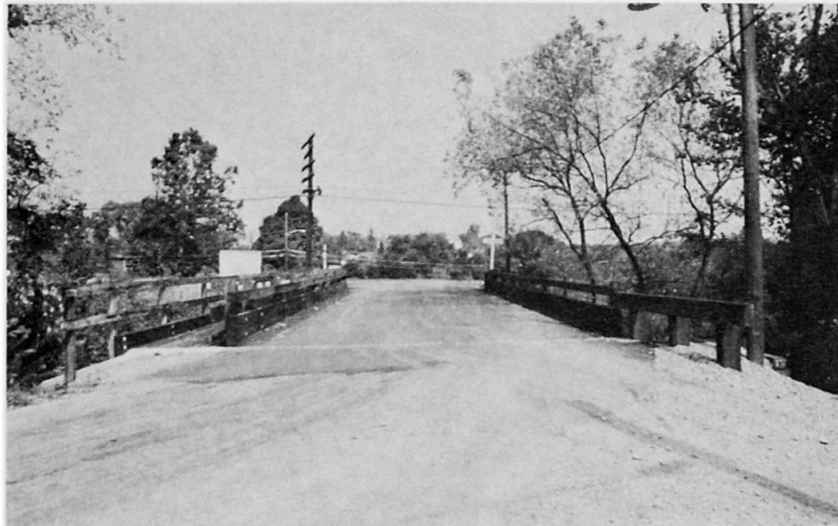
Photograph 2: Case Study 2 - Bridge with glue-laminated timber deck.

The 61 ft (18.6 m) span with two nine-ft (2.7 m) lanes and a four ft (1.2 m) sidewalk was designed to carry coal trucks weighing 60,000 lb (27,215 kg) to a mining site. The rehabilitated structure was to be able to carry 73,280 lb (33,239 kg) trucks in an AASHTO (American Association of State Highway and Transportation Officials) HS-20-44 configuration in two 11-ft (3.3 m) lanes while continuing to support the cantilevered sidewalk, as shown on Photograph 2.
