Artikel: Wood truss repair by epoxy injection

Autor: Sanders, Paul H. / Avent, R. Richard

**IX****Wood Truss Repair by Epoxy Injection**

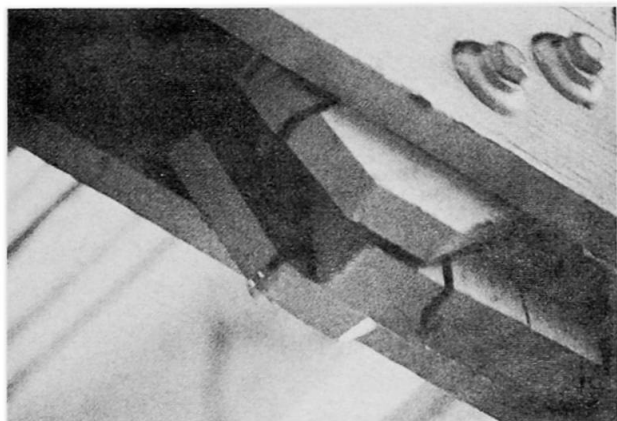
Fig. 1 - End Splits of Members

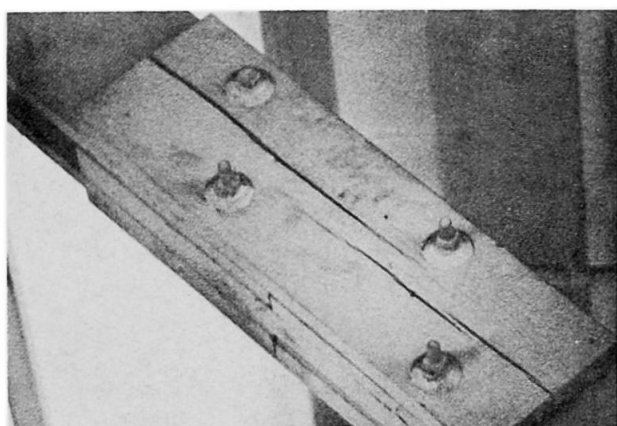
Fig. 2 - End Splits of Bolted Splice Plates

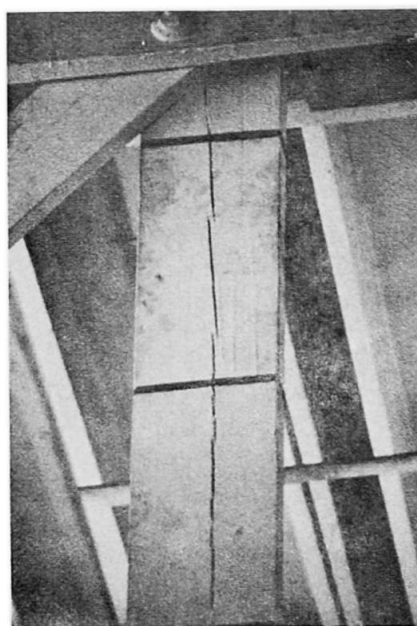
Fig. 3 - Longitudinal Split, Interior of Member
