Rehabilitation of post-tensioned bridge deck

Autor(en): **Ostenfeld, Klaus H. / Jonsen, Leif**

Zeitschrift: **IABSE congress report = Rapport du congrès AIPC = IVBH
Kongressbericht**

Band (Jahr): **12 (1984)**

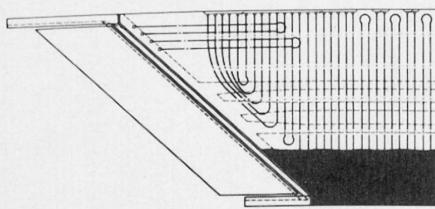
Plan section

Existing transverse and longitudinal prestressing. The 12×5 mm transverse prestressing wires were re-used, but cut off at the edge of the bridge deck.

After cut-off, the
 12×5 mm bars
 were stripped for
 coupling with simple bar
 anchorages. The 5
 mm bars were pro-
 vided with button
 heads on site.
