AMERICAN EXPERIENCES WITH THICK PAVEMENTS ON ORTHOTROPIC STEEL DECK BRIDGES

F.F. FONDRIEST

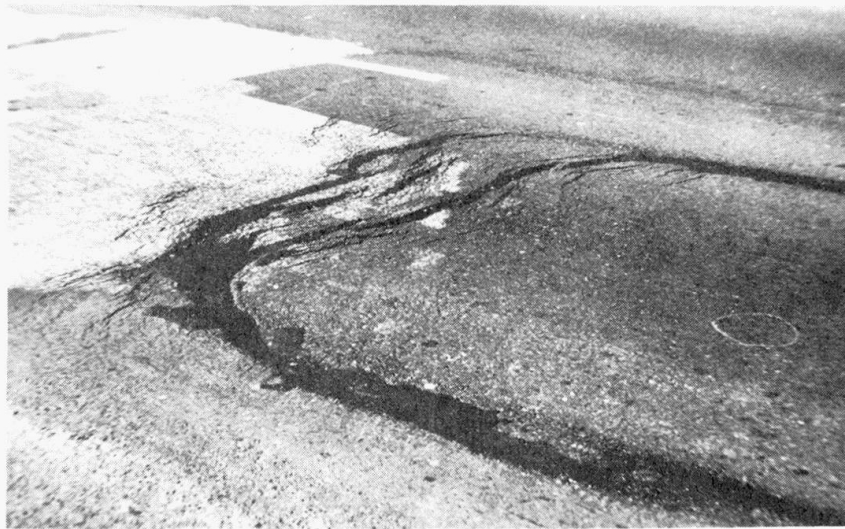
Within a few weeks after being opened to traffic, random cracks appeared in the AC surfacing. Shortly thereafter the pavement began debonding and within three months was literally shoved off the bridge. The mode of failure can be seen in Figure 3. The AC was replaced again using only an emulsion tack coat to bond the pavement to the deck plate. Within nine months the new AC pavement had again failed in the same manner as before. The pavement was replaced a second time in the same manner. This third pavement has remained in place and is performing reasonably well after almost two more years of service.

FIGURE 3. MODE OF FAILURE DUE TO DEBONDING OF THE AC PAVEMENT ON THE ULATIS CREEK BRIDGE AFTER ONLY A FEW MONTHS IN SERVICE

As was shown in Table 2 there is a wide variation in the amount and gradation of aggregate chips used. The importance of an effective bond can be determined from the experience of the AC surfacing placed on a portion of the Ulati Creek Bridge. In this installation, only an emulsion tack coat was used to provide bond between the deck and the pavement. This lack of bond resulted in a complete failure of the pavement. Another instance of a lack of good bond was noted on the Troy Test Bridge where a heavy loading of fine stone chips was used in conjunction with an AC leveling course. After about 2 years in service, moderate cracking had occurred in the surfacing and upon removal of the pavement, little or no bond was found between the seal coat and the asphalt pavement. There was, however, sufficient shear resistance to prevent the pavement from shoving. The only other instance where the bond between the bond coat and the pavement was qualitatively checked was on the Humphreys Creek Bridge. In this instance the bond was found to be excellent.
