BEHAVIOUR OF LARGE PANEL BUILDING DURING
THE ROMANIA EARTHQUAKE OF MARCH 4,1977

Miodrag Velkov *

Summary

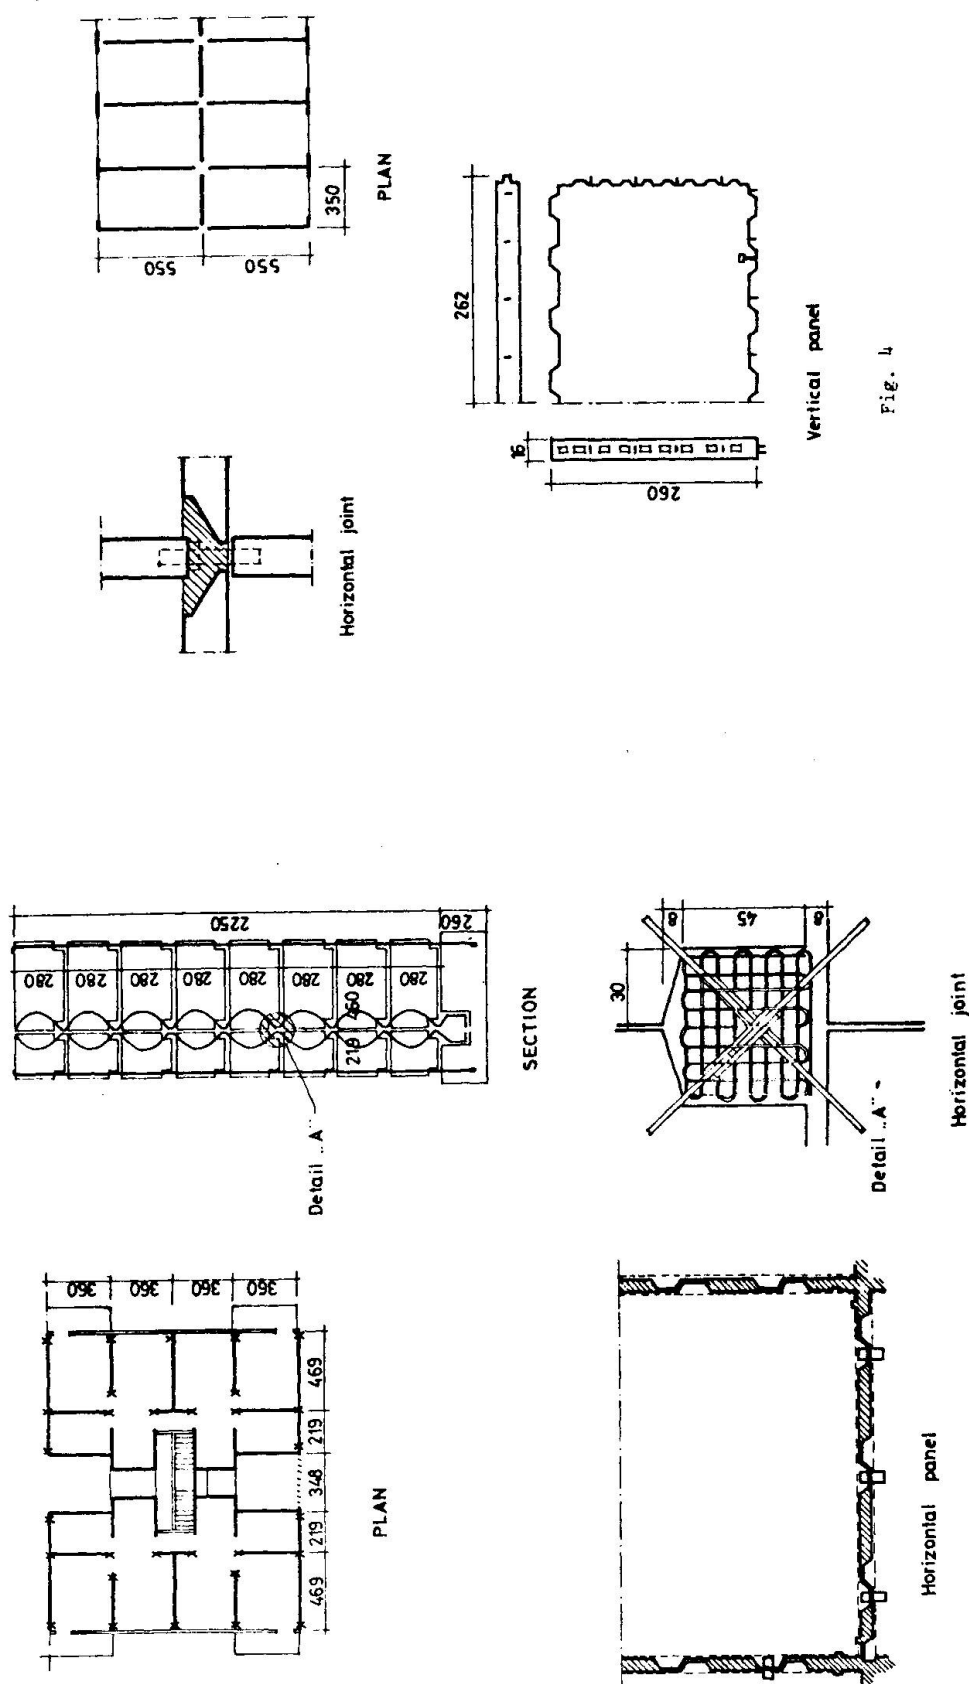
2. Two way system of ten storeys with basement. It is a precast basement structure on monolythic foundations. The system is constructed in series in Bucharest and its use will continue in future, no matter of the recent earthquake event. Fig. 4
