Short communications

Zeitschrift: **IABSE reports of the working commissions = Rapports des commissions de travail AIPC = IVBH Berichte der Arbeitskommissionen**

BEHAVIOUR OF AN ASEISMIC STRUCTURE
DURING CAUCETE EARTHQUAKE
OF NOVEMBER 23, 1977

DAMAGE TO BRIDGES DURING THE NORTH CAUCASUS EARTHQUAKES

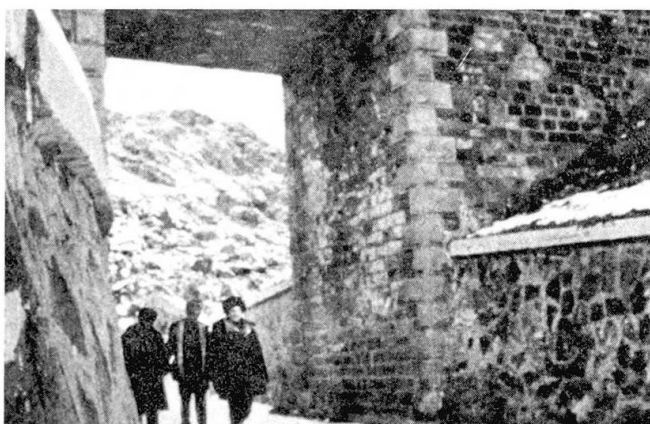
In 1970 most of girder and arch railway bridges, constructed in 1914 (fig. 3), suffered moderate damages such as deep cracks in wing walls of abutments (fig. 4), ice-breakers (fig. 5), bridge seats and concrete arches. Among massive structures the least damages were received by simple-span bridges with reinforced concrete slab superstructures, anchored in the abutment masonry.

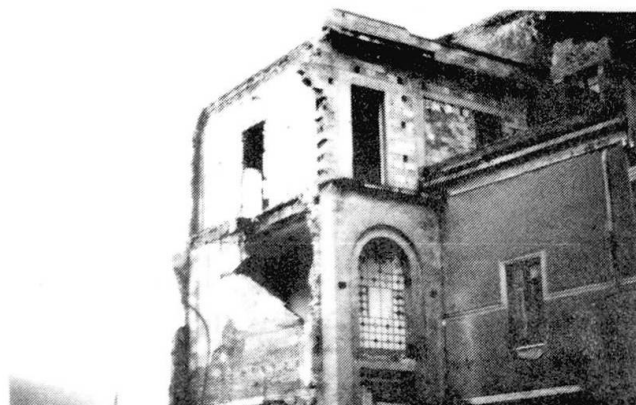
The worst damaged houses in Patti were those founded on sandstone, built of masonry and rarely cemented, in the old centre of the town.

On that site the sandstone formation assumes a hill configuration, which could produce an amplification on maximum ground acceleration (Maugeri, 1976), which can explain, together with the poor construction quality, the severe destruction of some houses.

In fig. 6 the damage suffered by one wing of Patti Cathedral is visible and in fig. 7, the damage at the corner of the main nave is evident.

Fig. 6: Patti Cathedral: the left wing.
