BEHAVIOUR OF AN ASEISMIC STRUCTURE
DURING CAUCETE EARTHQUAKE
OF NOVEMBER 23, 1977

SILVESTRO BRUSCHI

TECHINT Engineering Company

S U M M A R Y

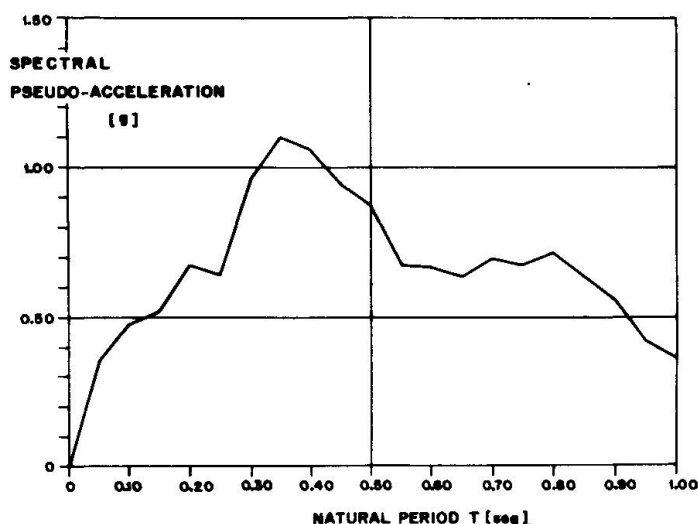
Fig. 3 - Pseudo-accelerations spectrum of Caucete 23.11.77 earthquake

To investigate this behaviour we used the spectrum shown on fig. 3, which was obtained from the spectrum calculated by IDIA, by multiplying its ordinates by the ratio between the records of two seismoscopes, one located in Caucete town, about 200 m distant from the structure, and the other beside the IDIA accelerograph in the city of San Juan,

These spectra are calculated for a damping ratio of 5% of critical damping. This figure is assumed to occur in reinforced concrete structures reaching yield, according to records from San Fernando earthquake of 1971.

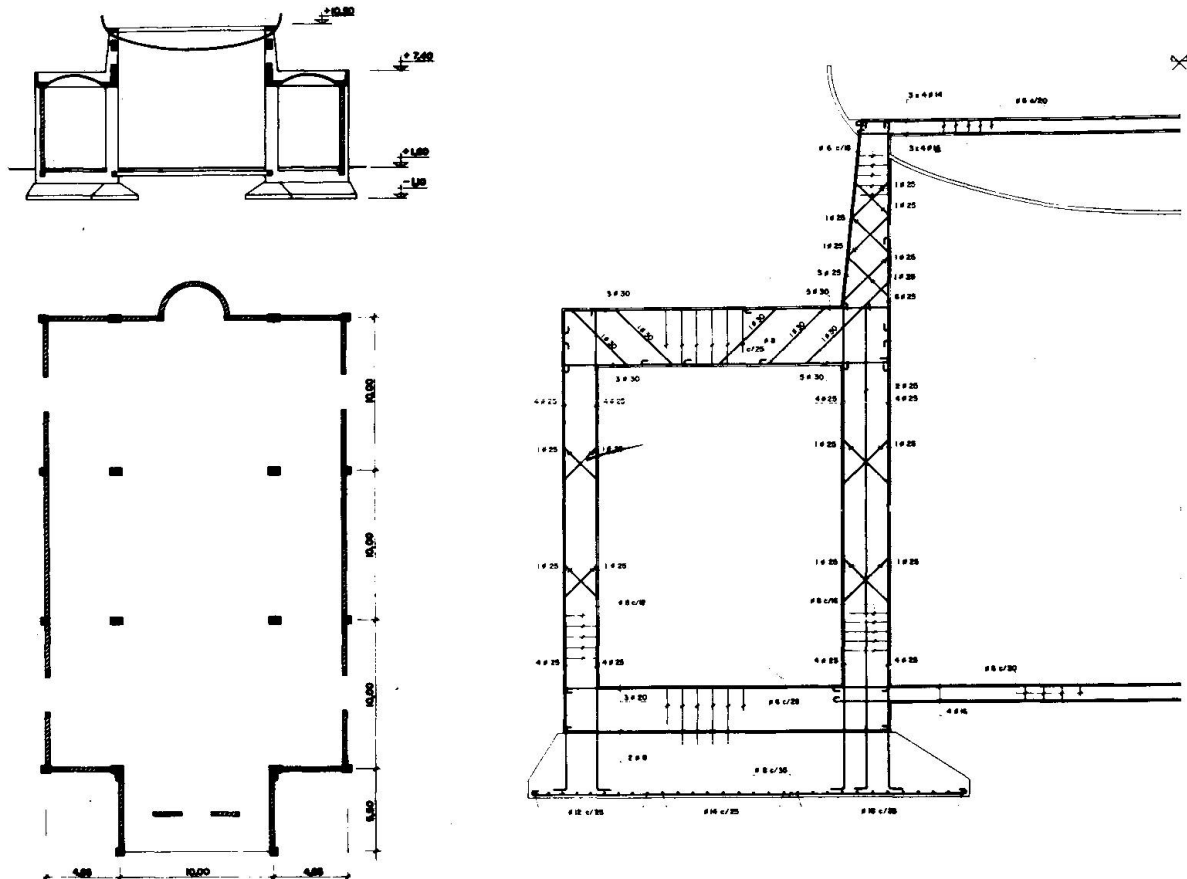
Fig. 4 - Plan and elevation of the building

The main structure is formed by four transverse and four longitudinal frames. Perimetral frames are stiffened by brick masonry walls, while the inner ones are free of elements which could affect their structural behaviour.

The two columns of each frame have a common footing, designed for a maximum pressure on soil of 1.1 kg/cm^2 . The large stiffness of this foundation ensures a practically perfect fixed end for both columns. Due to the change of roof design these frames were joined by an element of certain stiffness, formed by the shell plus the top compression beams.
