Autor(en): **Suarez, Mario G. / McCarthy, Daniel J.**

Zeitschrift: **IABSE reports = Rapports AIPC = IVBH Berichte**

## Correcting Design Deficiencies in a New Five-Story Building

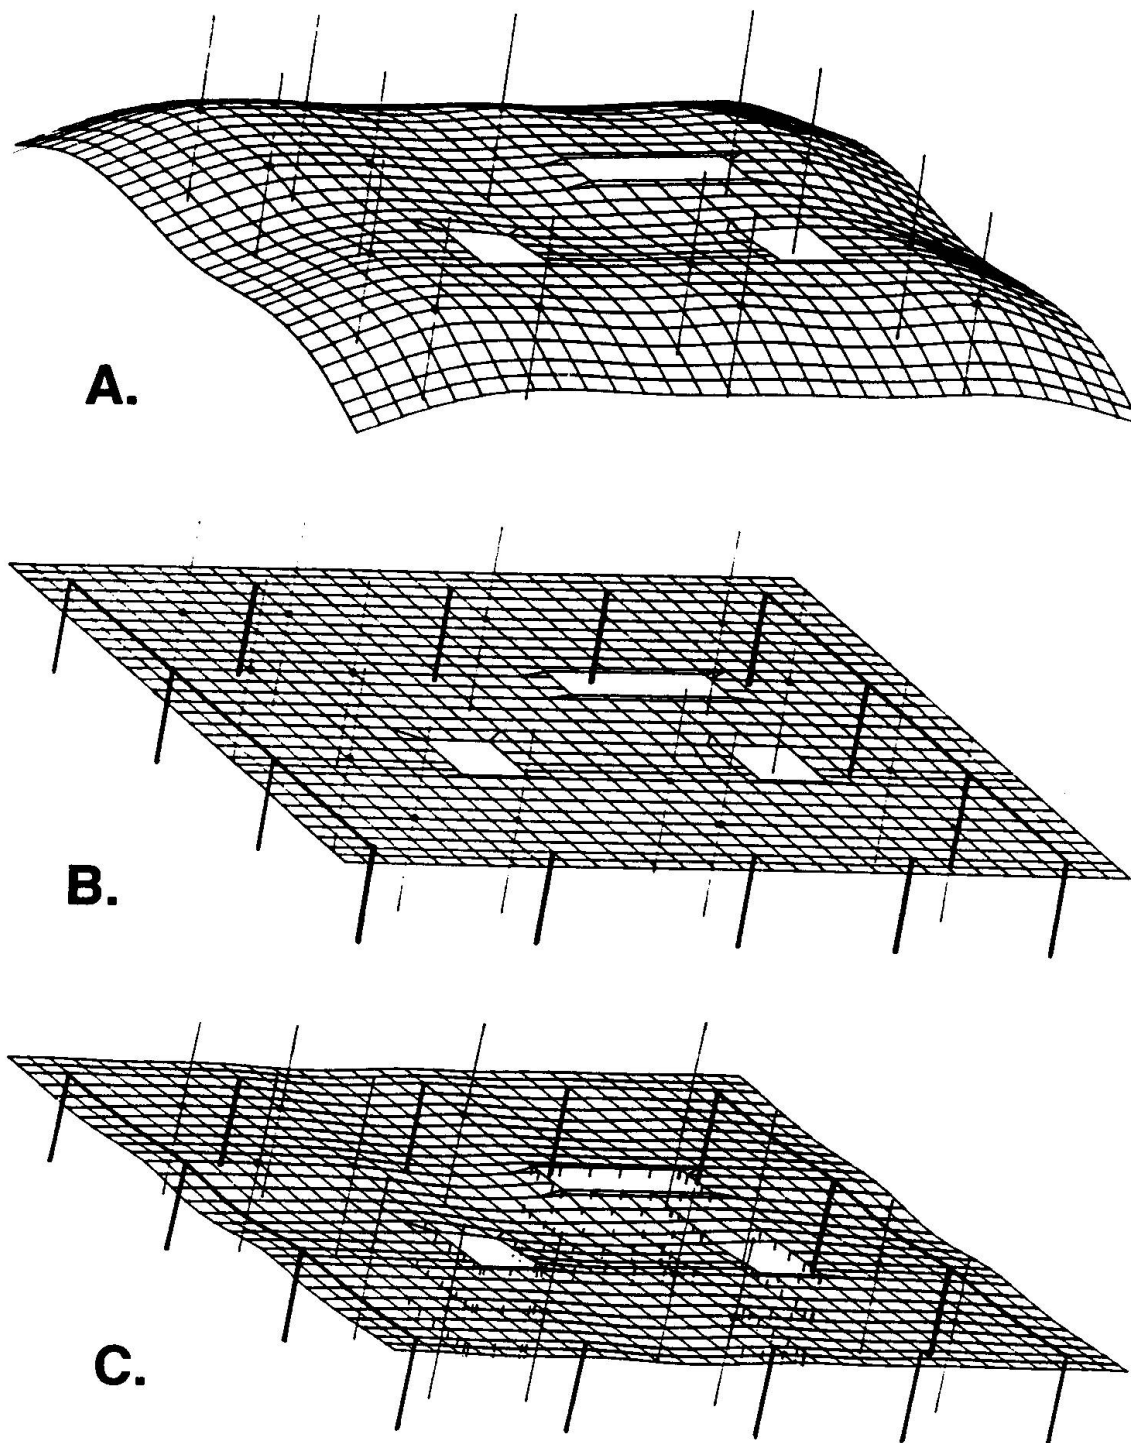
**Fig. 2** Finite element models of fifth floor two way posttensioned slab system:

The principal deficiencies determined by analysis were: the cantilevered slab/beam assemblies were under-designed and had excessive deflections; most of the supporting columns, especially the perimeter ones supporting the overhangs, were also found to be significantly under-designed.

Fig. 2A shows the deflected shape, as determined by analysis, of the fifth floor slab system, as originally designed, under full service load. It is quite apparent that the slab deflections, especially those of the cantilever overhangs, are excessive, possibly implying that the slab is overstressed. There was some visual evidence of this overstress in the form of slab top and column cracking. Fortunately, the fact that the cantilevered slabs had remained shored all along must have limited the amount and size of cracking observed.

- A. Deflected shape under full service loads as originally designed (scale factor = 50).
- B. Location of added steel beams and perimeter columns (shown bold on undeflected model).
- C. Deflected shape under full service load with added steel beams and perimeter columns (scale factor = 50).

Fig. 2C represents the deflected shape of the strengthened fifth floor under full service loads. Comparing this figure with Fig. 2A, it is readily evident that the cantilever slab deflection and, thus, tensile stresses, have been substantially reduced. The latter, as shown by analysis, appear to be within allowable code levels.

The major strengthening was accomplished by adding a new line of steel columns (in effect, "permanent" shores) around the periphery of the floor to reduce the slab cantilever (see Fig. 2B). A steel beam was placed on top of the columns parallel to the north and south slab edges in order to control the cantilever deflections in the uniform spaced tendons direction. The new steel beams were preloaded by shimming to predetermined beam deflections, in order to pick up, at least, part of the dead load. The steel columns on the east and west sides were shimmed directly under the short cantilever beams. All the new steel columns sit directly on top of the periphery concrete columns supporting the fourth floor. Consequently, the loads picked up by them is directly transferred down the structure to the footings. This strengthening scheme was chosen because of its relative ease and speed of implementation, and its relatively minor disruption of lease space.

Where analysis indicated several local regions of slab bottom overstress, these areas were locally strengthened by adding supplemental reinforcing steel bonded to the slab soffit with latex modified shotcrete. A slab top area near the elevator core which analysis indicated was overstressed, since no top steel was called for in the original design, was strengthened by placing reinforcing bars in slots cut into the slab and bonding the bar to the slab with latex modified mortar.

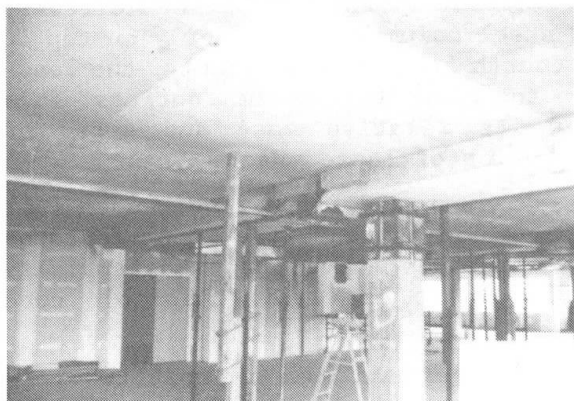
The principal design-related deficiencies found were: the shallow, reinforced concrete transfer girders, as well as a number of their supporting columns were significantly under-designed; some local slab areas were found to be overstressed (in tension). It is not known why the fourth floor slab was designed in conventional reinforced concrete, when post-tensioning could have been particularly beneficial.

Evidence of the probable distress which could be anticipated in the transfer girders, under full service loads, was the observed extensive flexural cracking

under dead load only, principally under the columns supported by the girders. The magnitude of the cracking of the transfer girders, under partial dead load and relatively light construction loads, clearly indicated a lack of structural strength.

The columns below, supporting the transfer girders, also had evidence of distress under reduced dead load conditions in the form of flexural cracking. Because of the heavy concentrated column load coming down at about midspan of the transfer girders, the top of the supporting columns would bend in towards the center of the building, with cracking thus expected on the outside faces of the columns. This cracking was clearly evident under partial dead load conditions only. Excessive deflections and failure of some structural elements might have occurred had full service loads ever been achieved.

**Fig. 3** External post-tensioning of transfer girders and steel collars confining column tops

The most practical solution to retrofit the transfer girders was determined to be the use of external post-tensioning (see Fig. 3). To fully resolve all structural deficiencies resulting from the analysis would have been impractical. Therefore, a re-analysis of the fourth floor allowing for plastic deformation of the concrete (the creation of hinges) at factored load conditions was carried out. In this way, moments were redistributed to girder and slab regions which would be more convenient to reinforce. Yet, up to factored load conditions, no structural integrity would be compromised.

Based on this re-analysis, using plasticity principles, the external post-tensioning was designed to ensure that the transfer girders achieve ultimate strength at factored load conditions. The deficient top and bottom slab regions were strengthened with additional reinforcement bonded to the slab (as was done on the fifth floor level). The re-analysis revealed that the strengthened slab system would perform adequately if the tops of the 7 deficient columns were allowed to develop a plastic hinge as a

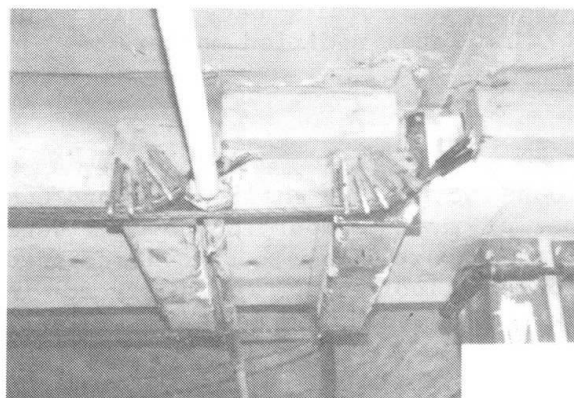
**Fig. 4** Close-up of external post-tensioning tendon deviation saddles at transfer girder

connection to the concrete beams above. To ensure the safe plastic deformation of the concrete column tops, confinement was provided using steel angle collars tightened together by high-strength bolts to achieve about 3.4 MPa of lateral pressure (see Fig. 4).
