Correcting Design Deficiencies in a New Five-Story Building

Mario G. SUAREZ

Daniel J. McCARTHY

SUMMARY

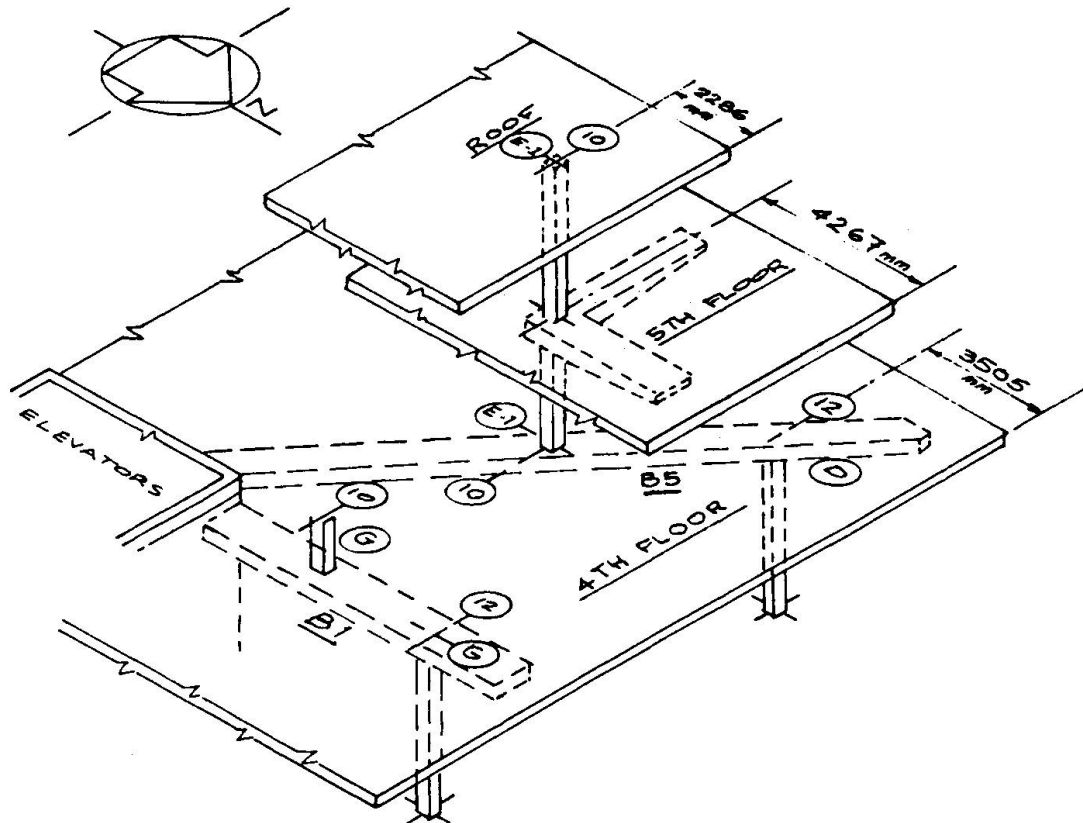
Fig. 1 represents the general structural framing of a quadrant of the original as-designed building. The roof, fifth and fourth floor slabs stepped back for architectural purposes. The third, second and first structural levels (not shown) have supporting columns around the perimeter of the building.

Fig. 1 Schematic view at corner of structure showing upper floors.

The fourth level was constructed as a conventionally reinforced concrete slab and beam frame. As is seen in Fig. 1, the exterior perimeter columns supporting the roof and fifth levels did not extend below the fourth level but, instead, were supported on and transferred their loads to shallow, reinforced concrete transfer girders.

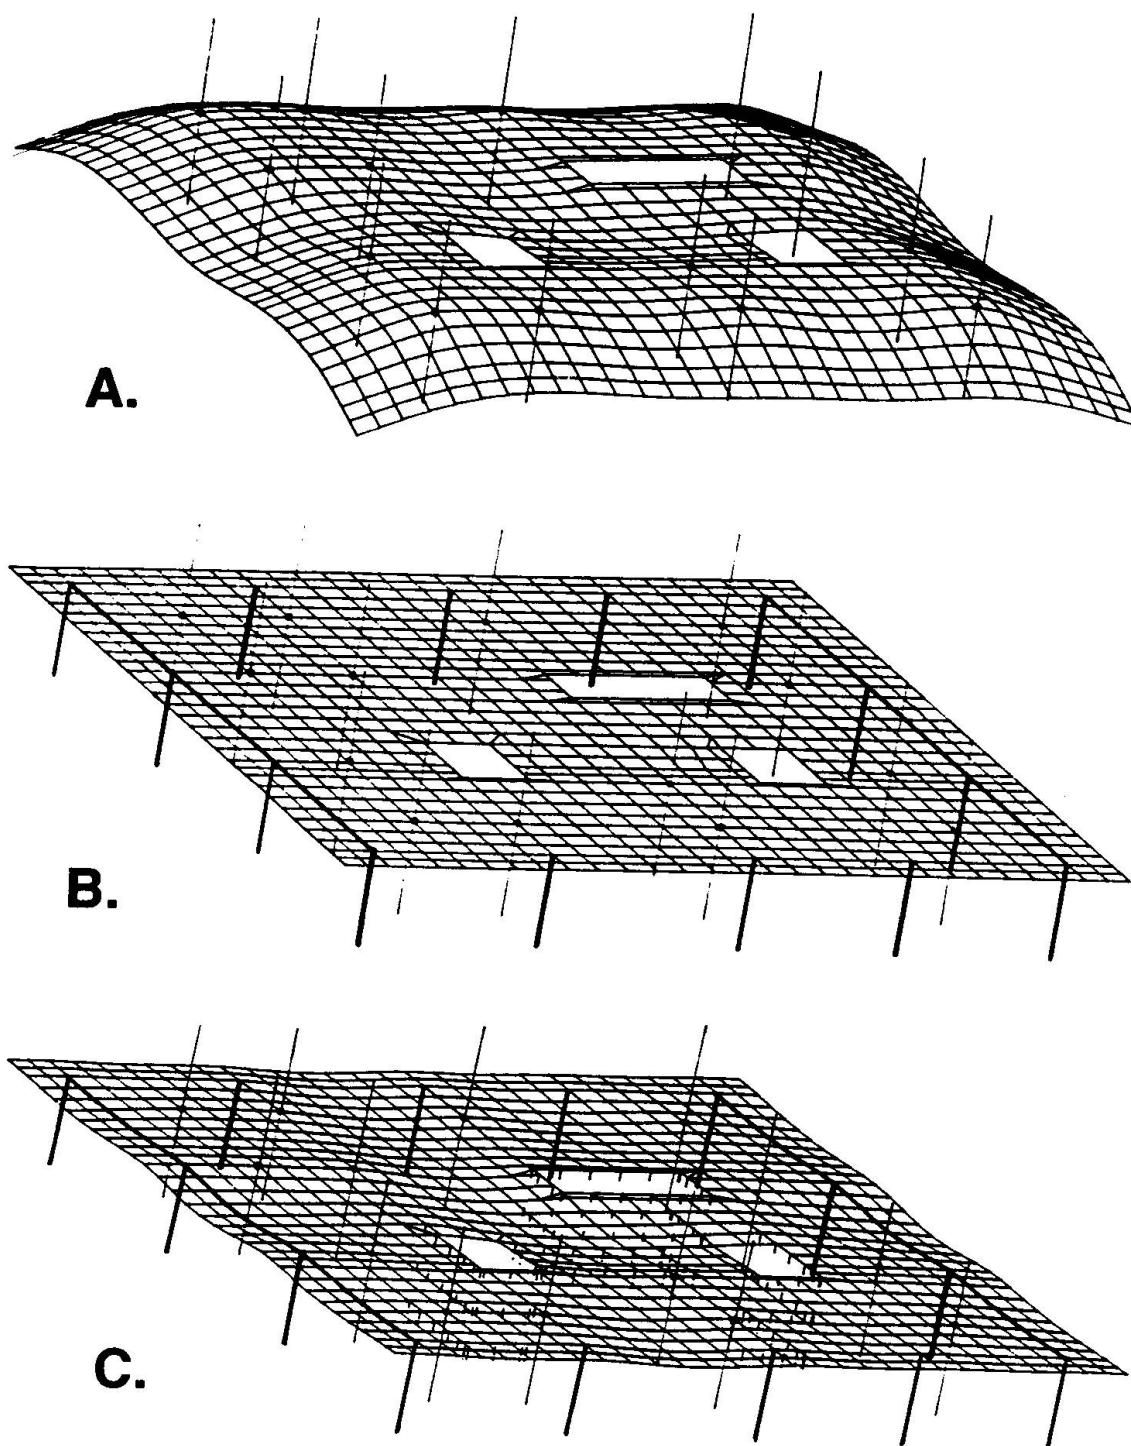
The principal deficiencies determined by analysis were: the cantilevered slab/beam assemblies were under-designed and had excessive deflections; most of the supporting columns, especially the perimeter ones supporting the overhangs, were also found to be significantly under-designed.

Fig. 2A shows the deflected shape, as determined by analysis, of the fifth floor slab system, as originally designed, under full service load. It is quite apparent that the slab deflections, especially those of the cantilever overhangs, are excessive, possibly implying that the slab is overstressed. There was some visual evidence of this overstress in the form of slab top and column cracking. Fortunately, the fact that the cantilevered slabs had remained shored all along must have limited the amount and size of cracking observed.

Fig. 2 Finite element models of fifth floor two way posttensioned slab system:

- A. Deflected shape under full service loads as originally designed (scale factor = 50).
- B. Location of added steel beams and perimeter columns (shown bold on undeflected model).
- C. Deflected shape under full service load with added steel beams and perimeter columns (scale factor = 50).

columns would possibly have failed had full service loads ever been achieved. Therefore, a code load test, as requested by the Engineer, was judged to be inappropriate as it would have likely resulted in permanent damage to or partial failure of the structure.

The major strengthening was accomplished by adding a new line of steel columns (in effect, "permanent" shores) around the periphery of the floor to reduce the slab cantilever (see Fig. 2B). A steel beam was placed on top of the columns parallel to the north and south slab edges in order to control the cantilever deflections in the uniform spaced tendons direction. The new steel beams were preloaded by shimming to predetermined beam deflections, in order to pick up, at least, part of the dead load. The steel columns on the east and west sides were shimmed directly under the short cantilever beams. All the new steel columns sit directly on top of the periphery concrete columns supporting the fourth floor. Consequently, the loads picked up by them is directly transferred down the structure to the footings. This strengthening scheme was chosen because of its relative ease and speed of implementation, and its relatively minor disruption of lease space.

Fig. 2C represents the deflected shape of the strengthened fifth floor under full service loads. Comparing this figure with Fig. 2A, it is readily evident that the cantilever slab deflection and, thus, tensile stresses, have been substantially reduced. The latter, as shown by analysis, appear to be within allowable code levels.
