**Artikel:** Strengthening of an unreinforced masonry building  
**Autor:** Heintz, Jon A. / Wosser, Thomas D.  
**DOI:** <https://doi.org/10.5169/seals-55176>

## **Strengthening of an Unreinforced Masonry Building**

50 Green Street is a two-story brick structure located north of Market Street in San Francisco's warehouse district. It occupies the entire city block between Green, Commerce, Battery, and Front Streets. The exterior facade consists of an arcade of slender piers and graceful semicircular arches along all four elevations. Ornate brick relief patterns around the arches, raised detailing in the four corners, and corbelled courses of brick at the parapet give the building a distinctive appearance.

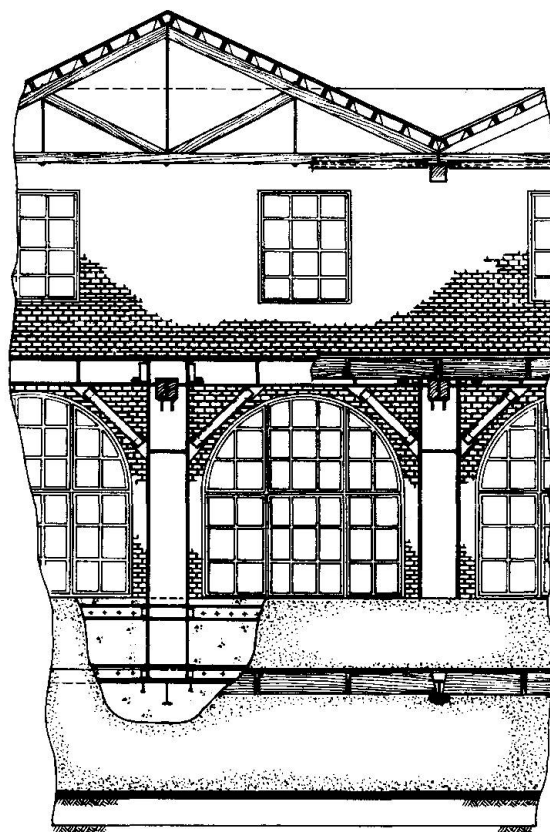
A steel knee-braced frame was selected to supplement the longitudinal walls. A relative rigidity analysis was performed using the structural analysis program, RISA-2D, to verify that the knee-braced system would draw load from the existing brick walls. The resulting W36x150 column members are stiffness controlled. They are embedded in a concrete foundation wall that extends up to the sill of the arched windows, providing a fixed base and shortened effective story height. Centered on the arched piers, the new columns must support the existing floor girders that frame into the wall at the same location. The girders were shored, cut back from the wall to erect the columns, and then seated on a bracket welded to the column web.

**Fig. 2** Drawing of Knee-Braced Frame System

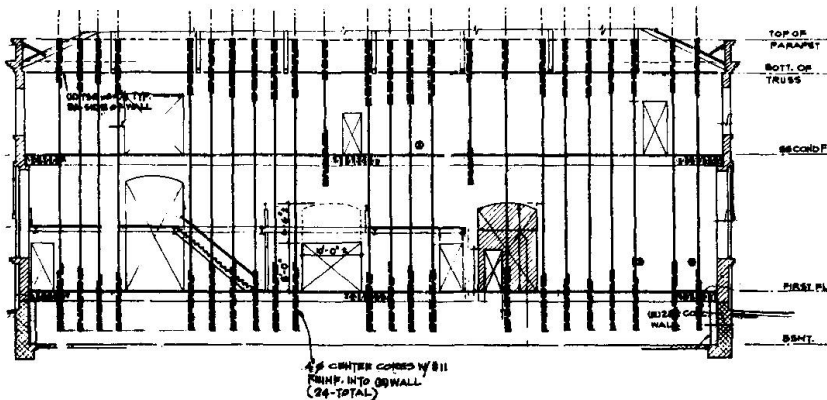
In the transverse direction, a more favorable pier configuration existed, allowing the use of the existing brick walls for transverse lateral force resistance. To strengthen the walls, deformed reinforcing bars were installed using the CenterCore technique. Cores were added at wall locations that were highly stressed for in-plane shear, and at window and door jambs to provide trim reinforcement wherever possible. CenterCores provided reinforcement to stabilize the slender interior walls for out-of-plane forces, and were designed using standard reinforced masonry principles.

**Fig. 3** Interior Elevation of CenterCore Locations

The CenterCore technique involves core drilling vertically through the wall from parapet to foundation, and installing grouted reinforcing bars. Coring specifications allowed a tolerance of two inches out of plumb at the base of the wall, 15 meters below the top of the parapet. Occasional repairs to wall surfaces were required when the bit broke through the side of the wall after being forced off line by unexpected iron embedded in the wall. A dry coring method was selected to avoid the disruption of water associated with wet coring operations. This resulted in dust migrating through micro-cracks in the walls during coring operations. Dust became so severe that the entire length of each wall within the building was wrapped in plastic and ventilated with negative air machines to prevent infiltration throughout the tenant spaces. Based on lower unit cost and superior performance noted in the Breiholz report, polyester based resins were specified for grouting the cores. The resin

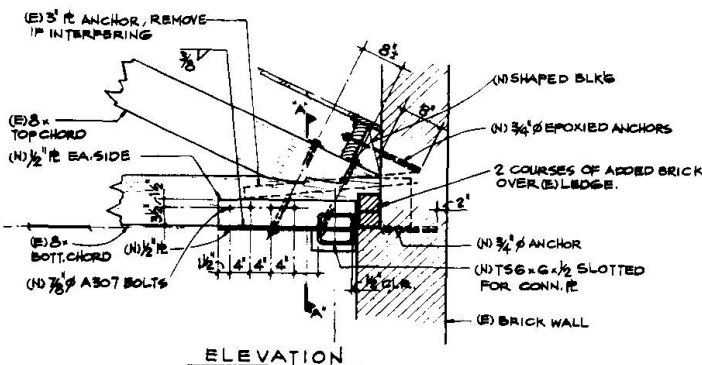
**Fig. 4** Roof Diaphragm Connection at Truss

To avoid the new roof membrane, a steel tension rod diaphragm was installed at the bottom chord of the roof trusses. Slotted tube connections, clevises, and turnbuckles allowed fit up tolerance and angular adjustments during erection. In anticipation of inevitable variations in field conditions, a liberal safety factor was incorporated into the design. This came in handy when existing conditions were not "square" and eccentricities had to be built into the system. Particularly challenging, were connections between the new steel elements and the integral wood trusses. Connection brackets were prefabricated, and consisted of vertical tabs for bolting into the side of the truss, welded to horizontal gusset plates. Extra bolt holes were provided in the tabs in case non-typical truss connections interfered with a prefabricated bolt location.

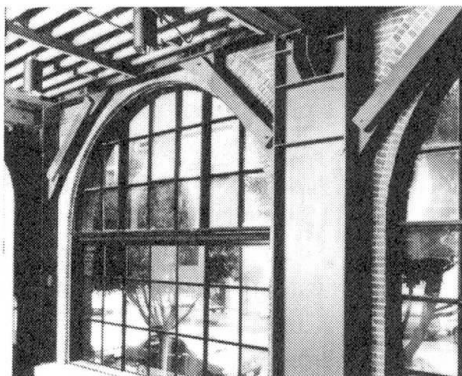
**Fig. 5 Completed Knee-Braced Frame**
