Strengthening of an unreinforced masonry building

Autor(en): **Heintz, Jon A. / Wosser, Thomas D.**

Zeitschrift: **IABSE reports = Rapports AIPC = IVBH Berichte**

Strengthening of an Unreinforced Masonry Building

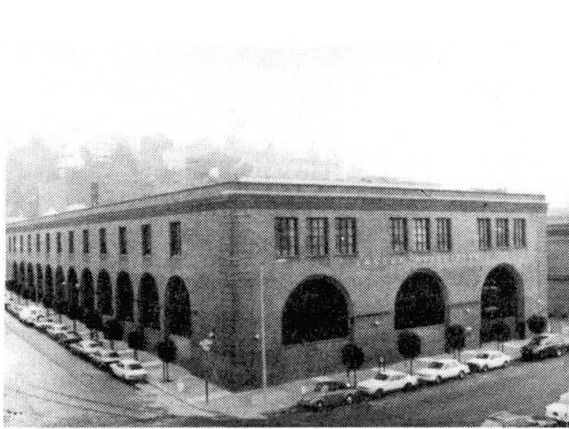
50 Green Street is a two-story brick structure located north of Market Street in San Francisco's warehouse district. It occupies the entire city block between Green, Commerce, Battery, and Front Streets. The exterior facade consists of an arcade of slender piers and graceful semicircular arches along all four elevations. Ornate brick relief patterns around the arches, raised detailing in the four corners, and corbelled courses of brick at the parapet give the building a distinctive appearance.

Fig. 1 Building Exterior

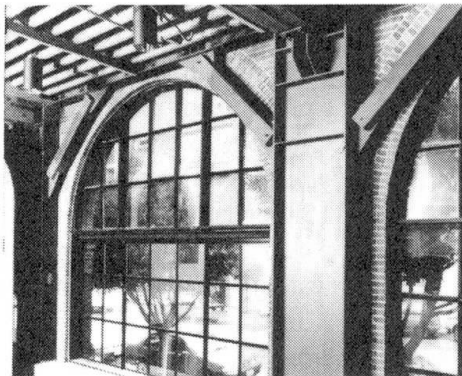
Fig. 5 Completed Knee-Braced Frame
