Diagnosis, maintenance, retrofitting, repair

Zeitschrift: IABSE reports = Rapports AIPC = IVBH Berichte

Collapse and Rehabilitation of Composite Trussed Structures

Major Repairs to Frank Lloyd Wright's Largest House: Wingspread, Racine, WI, USA

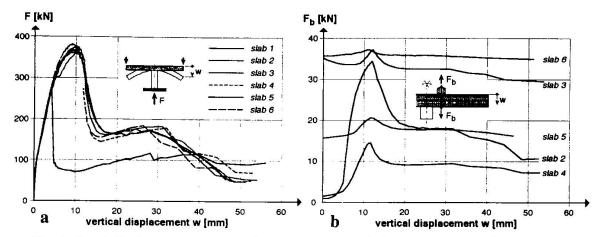
The test results are presented with the load-displacement curve (Fig. 1a) and the mean force in the bolts versus the vertical displacement of the slab (Fig. 1b). It follows that the punching load is increased from 280 kN up to 380 kN or 37% due to the strengthening. The vertical displacement at maximum load is significantly increased by the strengthening as it has more than doubled. It is observed that slab 1 is characterized by a punching cone inclined at an angle of approximately 30°. For all strengthened slabs, the punching cone is formed between the column diameter and the perimeter defined by the bolts. The inclination of the punching cone is approximately 70° (Fig. 2). This means that all the strengthened slabs exhibit a punching failure which is characterized by a punching crack that did not cross the strengthening bolts.

Fig. 1: Load-displacement curves and mean force in the bolts versus vertical displacement

The post-peak descending branch of the load-displacement curve is characterized by a strong reduction of the load carrying capacity with increasing displacement characterizing punching failure (Fig. 1a). After peak, the first drop of the load carrying capacity is about 200 kN for all the slabs (strengthened or not) which indicates that this decrease is due to a similar failure mechanism, that is, the concrete failure.

Injection modifies the slab mode of resistance so that it resists globally resulting in reduction of the stress level in the bolts (compare slab 2 and 4 in Fig. 1b). The injection also improves the serviceability of the slab and provides a protection against corrosion of the bolts.
