Artikel: Rehabilitation of two existing tunnels in West Malaysia: a case study
Autor: Singh, Parnam
DOI: <https://doi.org/10.5169/seals-59073>

Rehabilitation of Two Existing Tunnels In West Malaysia: A Case Study

Parnam Singh
Manager
L&M Structures Sdn
Bhd, West Malaysia

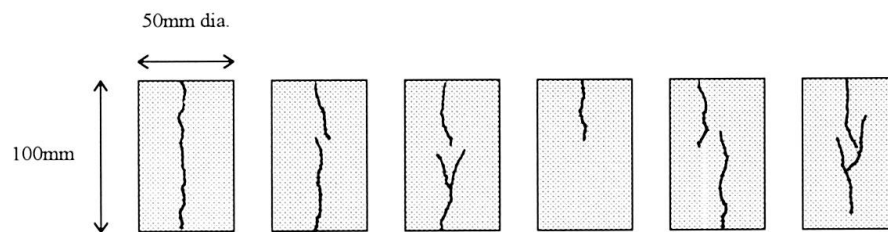
Based on the findings of the preliminary investigation a series of test were conducted to determine in-situ condition of concrete in the tunnel linings. As a means to determine surface hardness, Rebound Hammer test was carried out at selected locations after installing a mobile working platform. One lane of the dual carriageway was closed to traffic during the testing works. In order to determine the extent of cracks in the concrete a number of 50mm diameter core samples were extracted at cracked locations of the concrete. In most core samples the depth of cracks were observed to be in excess of 300mm. In some core samples the cracks were observed to have a series of smaller width cracks branching from the main crackline. Most of the cracks examined under a magnifying glass showed signs of contamination by dirt. An attempt was made to determine the depth of cracks using the indirect method for Ultrasonic Pulse Velocity test in areas where core sampling could not be conducted. This test served as a complementary test to compare sound concrete with cracked concrete by non-destructive methods. A hammer test was also conducted to check for weak spots in the concrete. This test was performed as a guide to differentiate between "ring" sound (often indicative of good concrete) and a "hollow" sound for loose or cracked concrete. Carbonation test was carried out on selected locations by spraying phenolphthalein indicator on freshly exposed concrete. At most test locations the depth of carbonation was noted to be close to 5mm.

Fig.4 Section through 50mm diameter core samples
