Zeitschrift: Schweizerische Bauzeitung
Herausgeber: Verlags-AG der akademischen technischen Vereine
Band: 83 (1965)
Heft: 42: Prof. G. Schnitter zum 65. Geburtstag, 1. Heft

Artikel: Design and construction of Mänika Dam
Autor: Bjerrum, Laurits / Kjaernsli, Björn
DOI: <https://doi.org/10.5169/seals-68283>

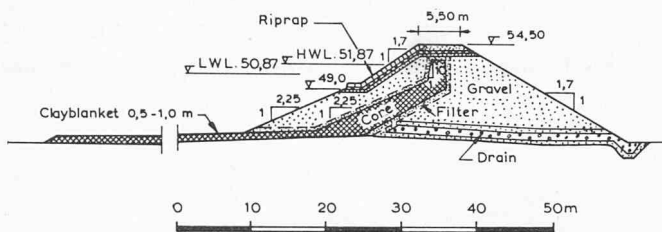
Fig. 3. Original Design of Mänika Dam, scale 1:1000

In Fig. 3 a cross section of the original design of the dam is shown. During construction, however, it became necessary to change the design.

Soon after placement of this clay in the dam had started it was evident that this material was difficult to handle and compact. What was even more important was that the clay lost most of its strength upon remoulding and after being put in place it did not possess sufficient strength to secure a stable dam as designed. Laboratory tests showed that the natural water content of the clay was 50%, the liquid and plastic limits were 50% and 24% respectively. According to

According to the original design, if the dam was to have a sufficient factor of safety against sliding the shear strength of the core material had to be approximately 4.0 t/m². Since the clay was placed with a shear strength less than ten percent of this required value and because oedometer tests on the clay had shown that the coefficient of consolidation for this material was only $5 \cdot 10^{-7}$ cm²/s, it was evident that the core material could not gain sufficient strength due to consolidation during the period of construction.

After realizing the ineffectiveness of a flatter upstream slope and of a counterweight, consideration was given to the possibility of eliminating the internal clay core and instead placing the clay as an impervious facing on the upstream slope without any surcharge as an extension of the impervious blanket. It was felt that the clay would be stable on a slope of 1 vertical to 3 horizontal and the design which was agreed upon is shown in Fig. 4. At this stage, however, the loaded area downstream of the dam in figure 4 was not included in the design. To take advantage of the gravel fill that had already been constructed the dam was moved downstream so that the fill could be incorporated into the new structure simply by flattening the upstream slope of the fill to 1 on 3. To protect the clay facing from the deteriorating effect of ice and waves the clay from the top of the dam down to 1,0 m below the lowest regulated water level was protected by a riprap of stones with a minimum weight of 50 kg placed on a layer of sand and gravel; below this level, the facing and clay blanket were left unprotected.

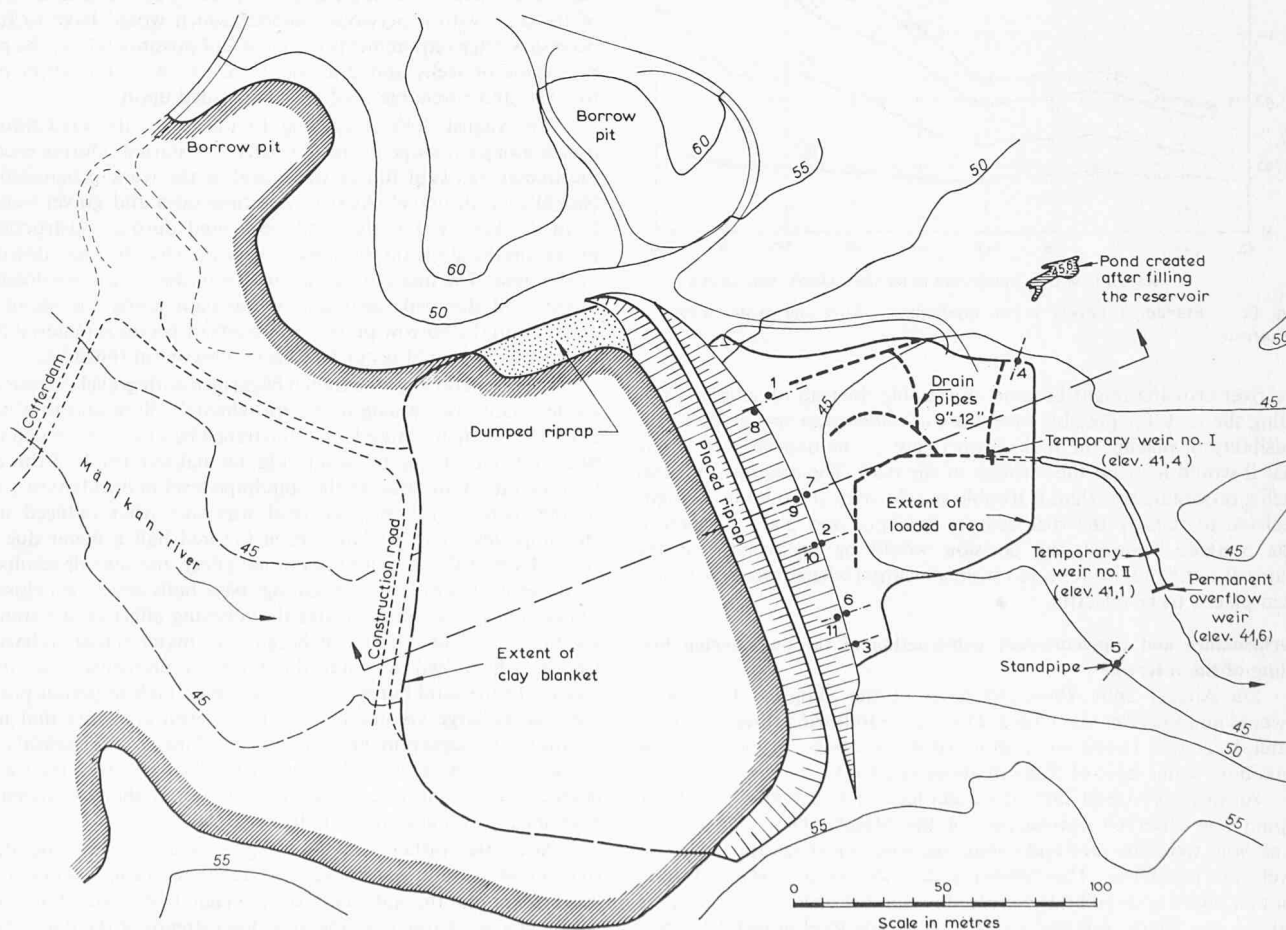
Fig. 5. Mänika Dam in Plan, scale 1:2500

Two overflow weirs were constructed downstream of the dam for seepage measurements and five standpipes, numbers 1 to 5 in Fig. 5, were installed for measuring the ground water level downstream of the dam.

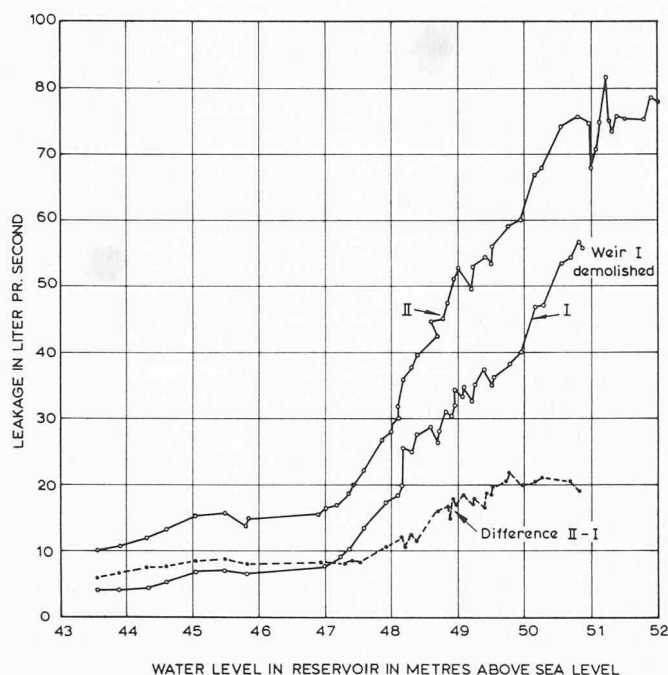
Fig. 6a. Leakage measured at temporary Weirs I and II versus Water Level in Reservoir

Before closing the main branch of the river at the Skogfoss Dam and raising the water level in the reservoir, the seepage and standpipe levels were measured for a water level upstream of the Mänika Dam which very nearly corresponded to the normal river level that existed prior to construction of the dam. For example, at the end of May 1964 the water level in the Pasvik river upstream of the cofferdam was 44,12 m above sea level and the water level in the pond between the cofferdam and the Mänika Dam was 43,55 m above sea level. Under these conditions, the seepage at the two overflow weirs was found to be 4,2 l/s and 10,3 l/s respectively, see Fig. 6a. The standpipe levels at the five measuring points for the same situation is shown in Fig. 6b.

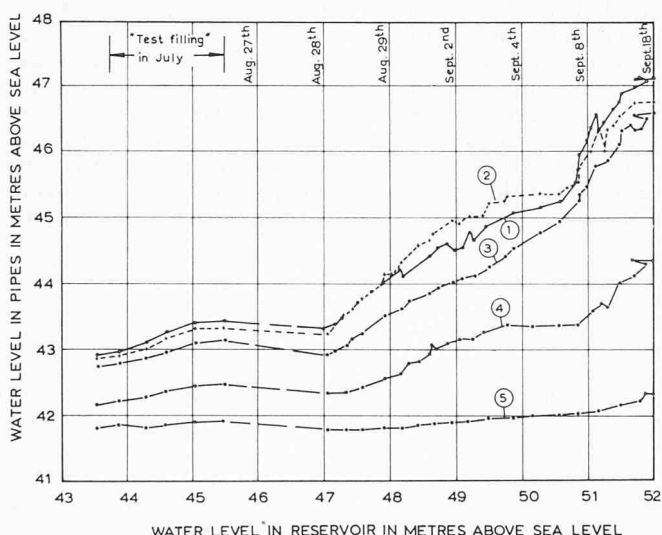
Fig. 6b. Standpipe Levels in Installations 1-5 versus Water Level in Reservoir

As early as August 28th, at a water level of 47.0 m above sea level, piping was observed downstream of the Mänika Dam. On the left bank boils were observed and a slight increase in leakage and standpipe level was registered. The following day the water level had risen another metre and the boils increased in number as well as in size; the leakage was almost doubled and the standpipe level in installations 1 and 2 had risen as much as the reservoir level, Fig. 6b. Downstream of

After several days the trench backfilled with gravel extended along the left bank over a length of approximately 30 m and to a depth of 2 to 3 m. Along its entire length the trench had been excavated into the fine sand layer. It can be seen in Fig. 6b that as a result of this excavation the rate of increase of the standpipe level in installation 1 relative to the increase in reservoir level was somewhat reduced and the standpipe level had probably been lowered half a meter due to this work. Even if this was an intentional effect, the overall results of the work were somewhat disappointing. New boils developed close to the trench and it was obvious that the relieving effect of the trench was less than anticipated primarily because the material used to backfill the trench, which had to fulfil the filter requirements, was pervious relative to the sand but was not pervious enough to permit passage of the relative large volume of seepage. It even appeared that in some locations an excess pore pressure was developed in the backfill material in the trench. As a means of improving drainage from the trench the decision was made to excavate a narrow and shallow trench in the backfilled gravel and install a drainage pipe.

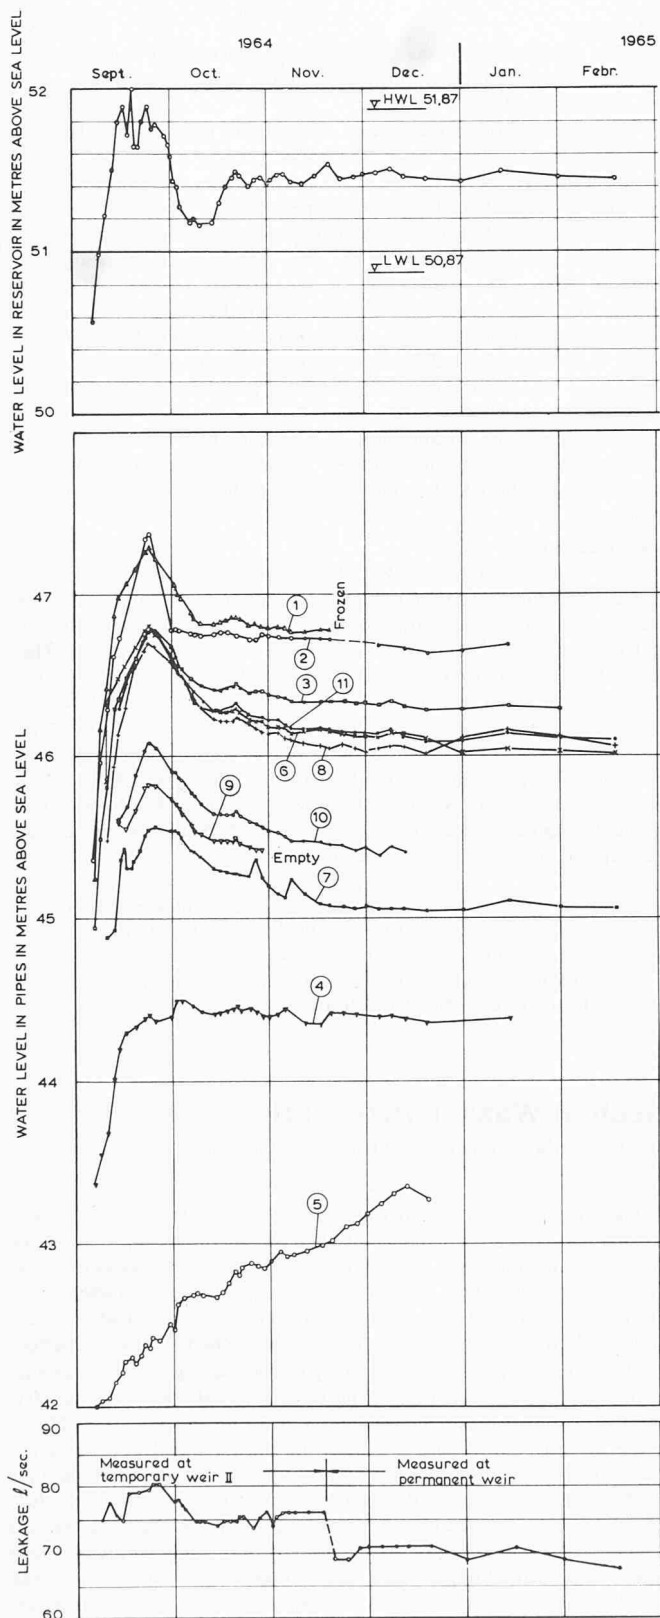
Fig. 7. Water Level in Reservoir, Standpipe Level and Leakage versus Time

The task of loading and draining the area downstream of the dam was completed as the water level in the reservoir reached its maximum at 52,0 m above sea level on September 18th. The leakage under full reservoir head increased to 78 l/s which is, of course, fairly large but of no economical importance for this hydroelectric development. Since then the water level in the reservoir has fluctuated between 51 and 52 m above sea level. The measured leakage as well as the standpipe levels for all installations are shown in Fig. 7.

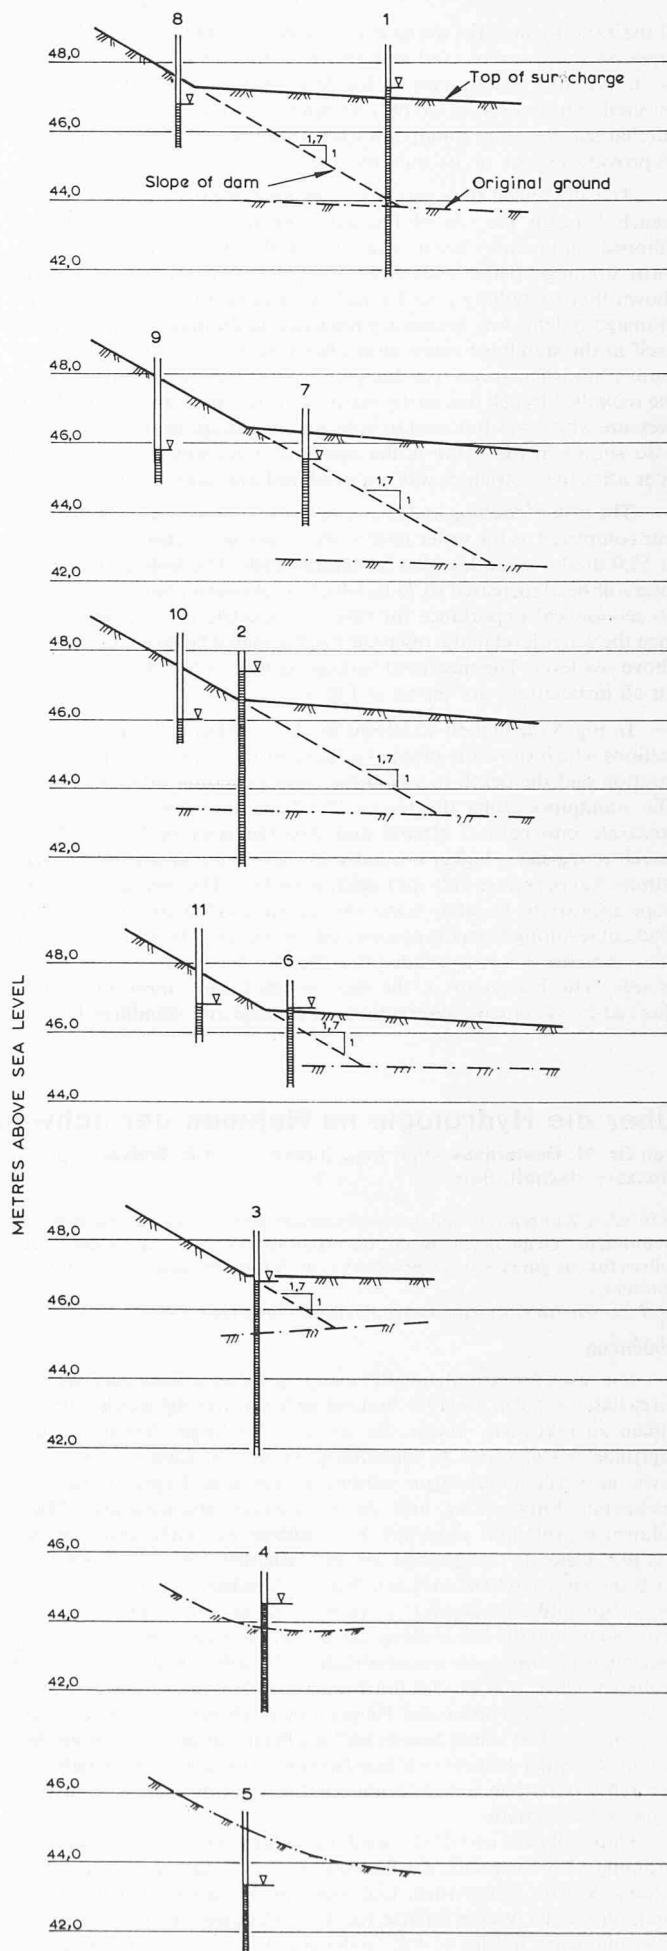
Fig. 8. Highest Standpipe Levels recorded

In Fig. 8 the highest standpipe levels are indicated in several cross sections which show the original ground surface, the surcharge at that location and the depth to which the pipes penetrate into the ground. The standpipes along the toe of the dam, numbers 1, 2, 3 and 6, penetrate into natural ground and into the layer of fine sand and therefore register a higher ground-water level than at the other installations that penetrate only into sandy gravel fill. The seepage line in the slope appears to be safely below the surface and the upward hydraulic gradient resulting from the pressure difference is safely below 1,0. From these sketches it was concluded that the structure could be considered as safe. The behaviour of the dam in the future, however, will be checked by systematic observations of leakage and standpipe levels.
