RECORDED FAILURES OF ELECTRICALLY WELDED WROUGHT-IRON AND MILD STEEL BRIDGES.

H. J. L. BRUFF, Bridge Engineer, North Eastern Area, London and North Eastern Railway,
York.

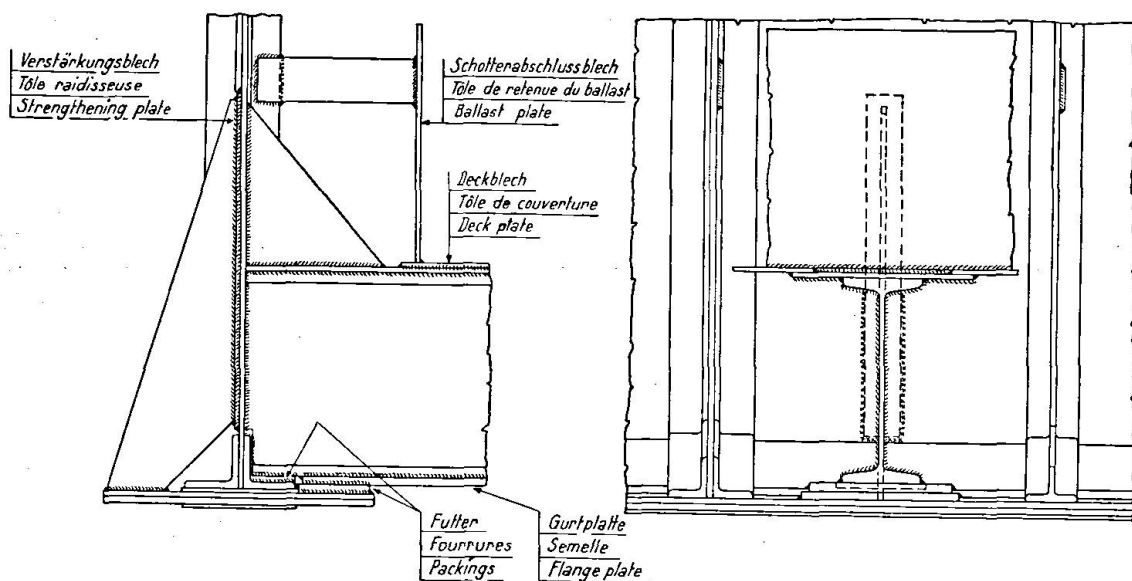
Einzelheiten von Knotenblech- und Stegblechsaussteifungen (Brücke No. 32, South shields Linie).
 Détails des goussets et raidisseurs de l'âme. (Pont n° 32, ligne South shields).
 Details of gussets and web stiffeners. (Bridge N° 32, South shields branch).

The first experience of this type of failure occurred in the case of the reconditioning of a large plate main girder of a wrought iron bridge the floor of which was entirely renewed. As it was necessary to place the new cross girders between the old cross girders, where there were no web stiffeners, provision had to be made at these points for proper distribution of end fixing moments and shear from the cross girder ends. A strengthening plate was therefore welded to the outside of the web of the main girders and a triangular gusset plate welded on to it directly opposite the new cross girder end, as shown on Fig. 1.

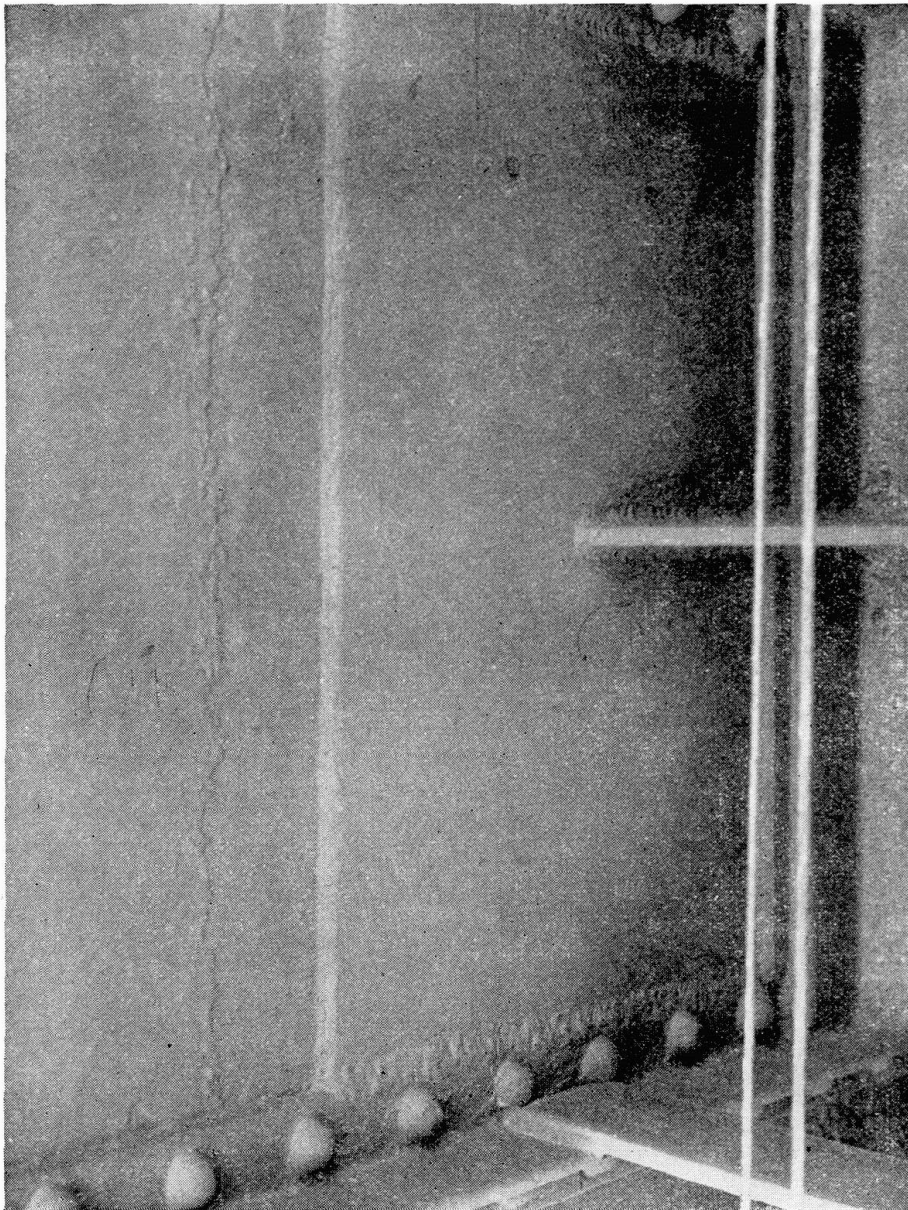
Fig. 4.

In another instance where the webs of the main girders had been holed through corrosion and the webs required to be repaired, fractures took place along the welded seams which were probably due to the contraction of the heated parts of the girder. The failures which were fairly numerous were all identical, being fractures of the vertical butt welds between the new web streng-

thening plate and the toes of the "T" and angle stiffeners. Fig. 4 shows details of construction.

As will be seen from the section it was intended that the welds should not only unite the strengthening plates and the toes of the "T" or angle stiffeners, but also the old web itself. On cutting out the fractured welds, as shown in Fig. 5, it was found, that good penetration had been obtained between the strengthening plate and the "T" but that there was no penetration in the case of the web, as will be seen from the photograph of a part of the "T", strengthening plate and web which were cut out in order that the cause of the fracturing might be ascertained.

The gap between the strengthening plate and the "T" had been prescribed to be $1/16$ ", but apparently this had not been worked to in all cases, the weld cut out was barely $1/16$ " and it appeared that the strengthening plate had not

been in full contact with the web plate. Out of 48 welds 17 were found to be fractured, these were all cut out and in not a single instance had penetration with the web been secured. The practice is now to make the gap $1/16''$ min. the face of the chamfer the same, using a No. 10 electrode with a slightly higher

Einzelheiten von Stegblechreparaturen. (Brücke No. 2, Monkwearmouth Güter-Linie).
 Détails de réparations de l'âme. (Pont n° 2, ligne Monkwearmouth — trains de marchandises).
 Details of repairs to web. (Bridge N° 2, Monkwearmouth Goods Branch).

amperage than normal, which in the case of so light a run is not likely to overheat the mild steel. Fig. 6 shows the repaired girder with removed section (Fig. 5) which was not replaced, the hole was merely fillet welded round the edges as there was ample section left for strength. The bottom flange, which the photo shows covered with gunite, was badly wasted by blast from engines,

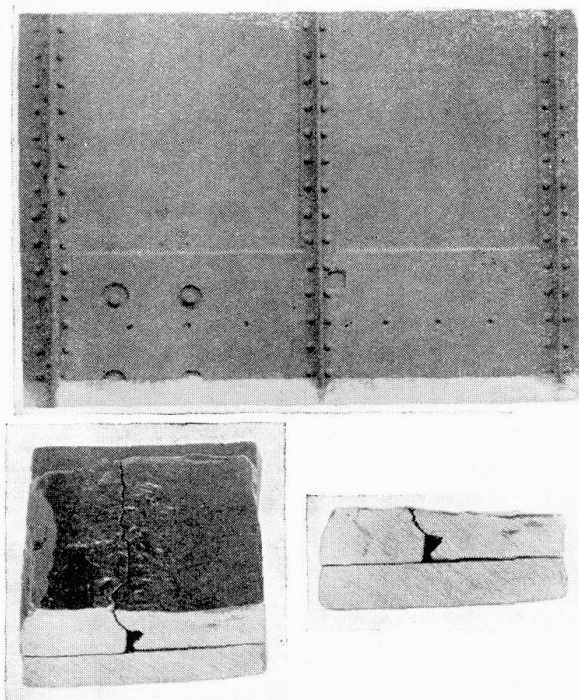
Fig. 5.

Schnitt durch die gerissene Schweißung.
Coupe à travers la soudure rompue.
Section of fractured weld.

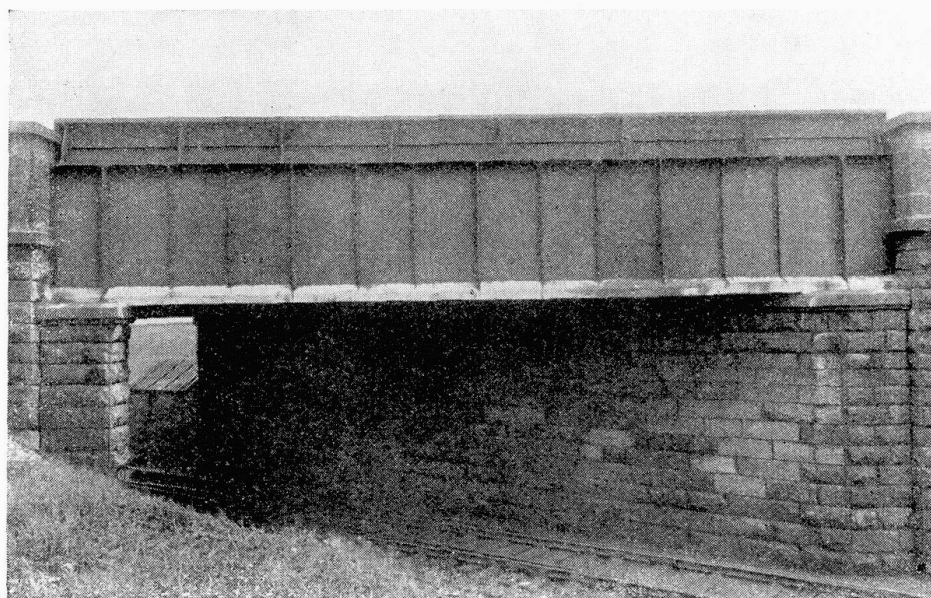
Fig. 6.

Träger mit repariertem Stegblech. — Poutres dont l'âme est réparée.
Girders showing repaired web.

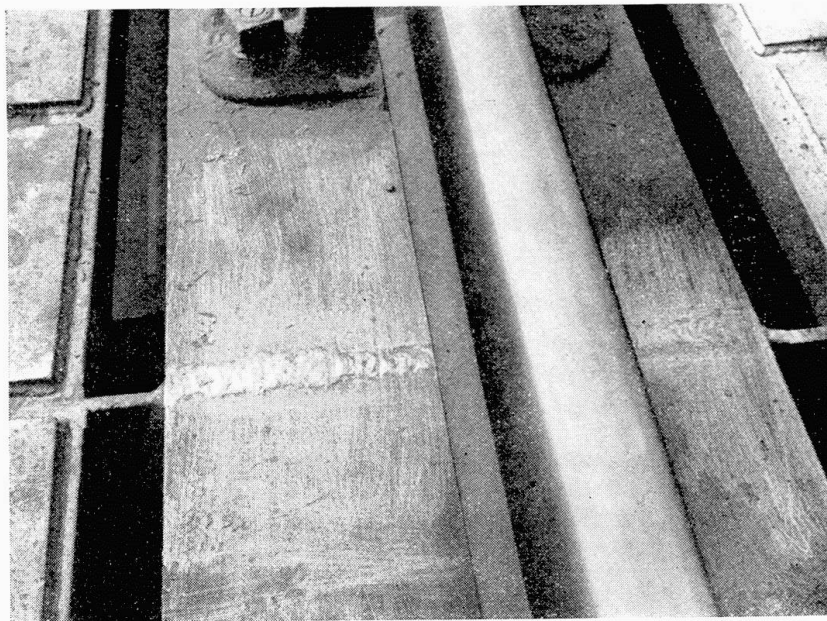
Another failure of similar nature was the fracturing of the butt weld between two channel way beams, of construction as shown in Fig. 7.

The gap intended to be 1/16" wide was somewhat wider when fitted and to expedite the work two welders were put on to make the weld. One of the

men had advanced further than the other when they left off for a meal, when shortly afterwards the weld fractured with a loud report. The weld after all the old weld metal had been removed and the butt prepared afresh was rewelded by one man commencing at the centre, working slowly without unduly heating the channels, as it was thought that the unequal and rapid cooling off of the overheated weld had been the cause of the fracture. As this, as well as all the other welds of this construction, all have remained perfect, it is clear, that butt welds of free ended sections must not be allowed to become too hot when being run.

Stumpfschweißung an Längsträger (Schienenträger). (Brücke No. 41, Denaby Linie).
Soudure bout à bout des longerons (sous les rails). (Pont n° 41 de la ligne Denaby).
Butt weld of way beam. (Bridge No. 41 Denaby Branch).

of the steel way beams (consisting of the rolled steel beam and the channel). Two of these gussets at one end of the bridge, where there is a switch, have fractured. The position of the fractures are indicated on Fig. 7 and on the photograph of the bridge end, Fig. 9.

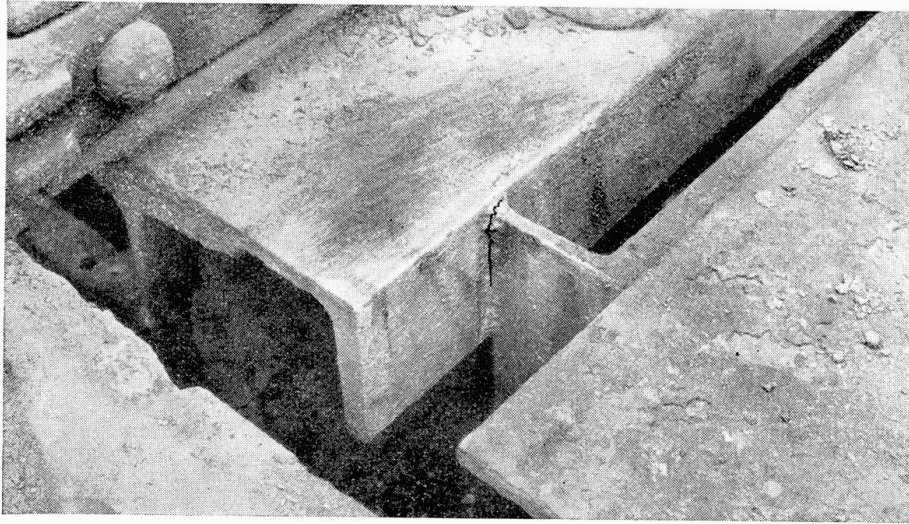
As will be noted the position of the fractured gussets occur on the convex side of the curve, where tension will be produced through the rigidity of the wheel base of engine counteracting the centrifugal action. A close up photograph of the fracture is shown in Fig. 10.

executed; unfortunately the conditions under which the work was carried out were adverse, as it was necessary to complete within limited time under traffic pressure, and during wet and cold weather. It is therefore possible, that the fractures are initially due to internal welding stresses. After more than a year no further fractures have taken place and this to a certain extent indicates that this may be the case. It is also possible that the construction is too rigid and that it is necessary to have a certain amount of flexure of the way beam to withstand the sway of the engines when travelling.

Gerissenes Knotenblech. — Tôle fissurée d'un gousset. — Fractured gusset.
