**Artikel:** Strengthening the foundations of a building in Helsinki (Finland)  
**Autor:** Varstela, I. / Roitto, P. / Haapala, M.  
**DOI:** <https://doi.org/10.5169/seals-20917>

## 8. Strengthening the Foundations of a Building in Helsinki (Finland)

**Owner:** *Säästöpankkien Keskus-Osake-Pankki SKOP*  
**Architectural planning:** *Järvinen Simo & Co.*  
**Structural planning:** *Heiskanen RJ & Co. Ky*  
**Building contractor:** *YIT-Yhtymä Oy*  
**Execution time:** *13 months*  
**Execution year:** *1986*

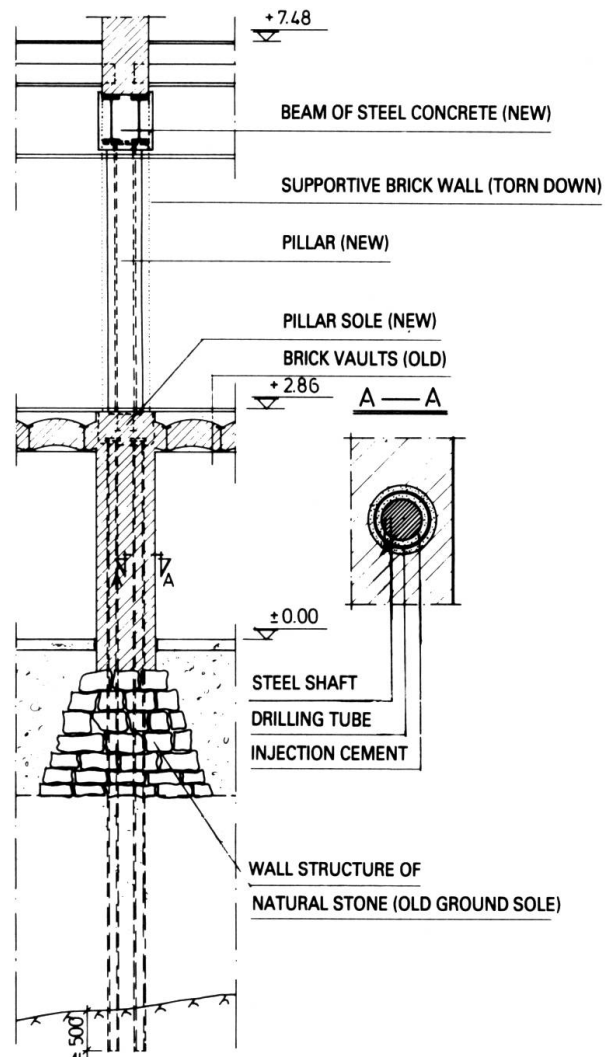
*Fig. 1 Location of piling in the basement wall*

The solution finally adopted was that the piles were driven from the ground floor level, through and within the walls of the basement restaurant level. Fig. 1 shows the applied solution. Through excavations in the supportive brick walls, later to be removed, holes were sunk vertically through the basement walls. The drilling was continued through the old foundations of natural stone, and further down, each drilling to penetrate no less than

0.5 metres into solid bedrock. The tubes used in the drilling process,  $\varnothing 140 \times 4.0$ , were left in position. The actual supportive piles, steel shafts, were then sunk into these holes, with each hole being filled with injection cement before insertion of the piles. Each steel concrete pillar is supported on a group of 3-5 such piles. The total length of piling was some 700 metres, with an average pile length of 7 metres, 2.5 metres of which was contained inside the brick walls of the basement restaurant. The piles were assembled on site from lengths of 1.5 metres, joined together by welding fig. 2.
