## **The Collapse and Reconstruction of a Prestressed Concrete Box-Section Girder**

**Hugo Bachmann**

**Werner Horisberger,**

### **SUMMARY**

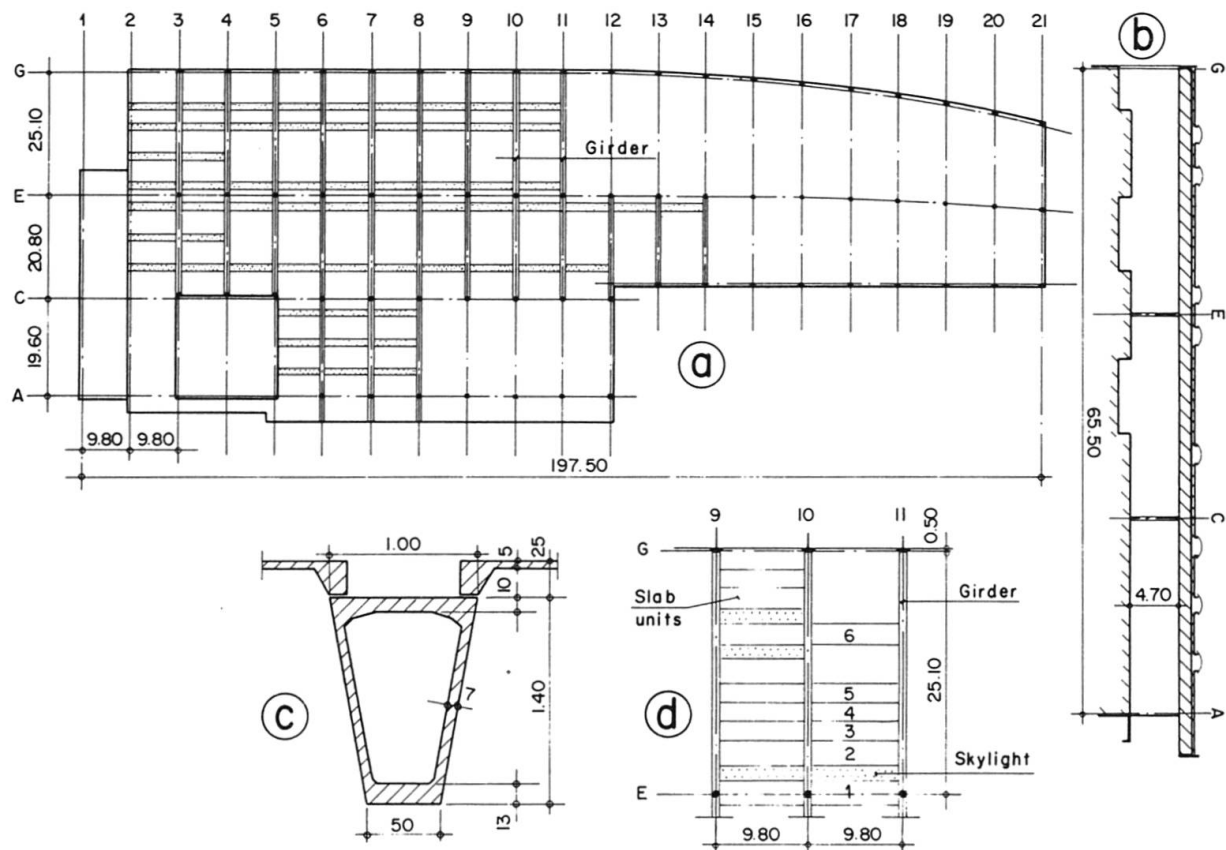
Fig. 1 Rapid goods station Berne

- a) Hall floor plan (position of construction at the time of collapse)
- b) Hall section on grid line 8
- c) Girder cross-section
- d) Plan of the collapse section

The collapse occurred after about half the hall roof was erected. The day before the collapse, the girder 10/E-G and the slabs in section 9-10/E-G had been placed. The next day the erection of the girder 11/E-G and a large part of the slabs in section 10-11/E-G was carried out. Several minutes after the placing of slab unit No. 6 the girder 10/E-G failed. This was without additional external loading (see Fig. 1).

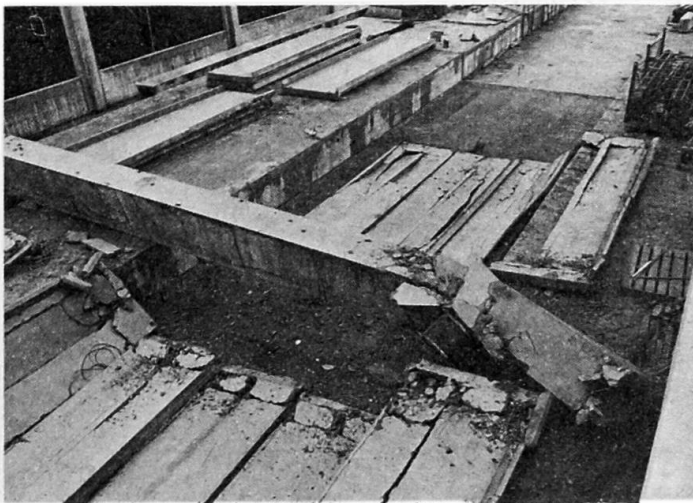
Fig. 2

The situation on the construction site immediately after the collapse is shown in Figs. 2, 3 and 4. The first examinations showed immediately that the girder 10/E-G had somehow broken through at the support at column E/10. From there it had fallen to the ground and in doing so also tore away from the support G/10.

View from E/9 towards the collapsed box-section girder. In front and behind are the collapsed roof slab units.

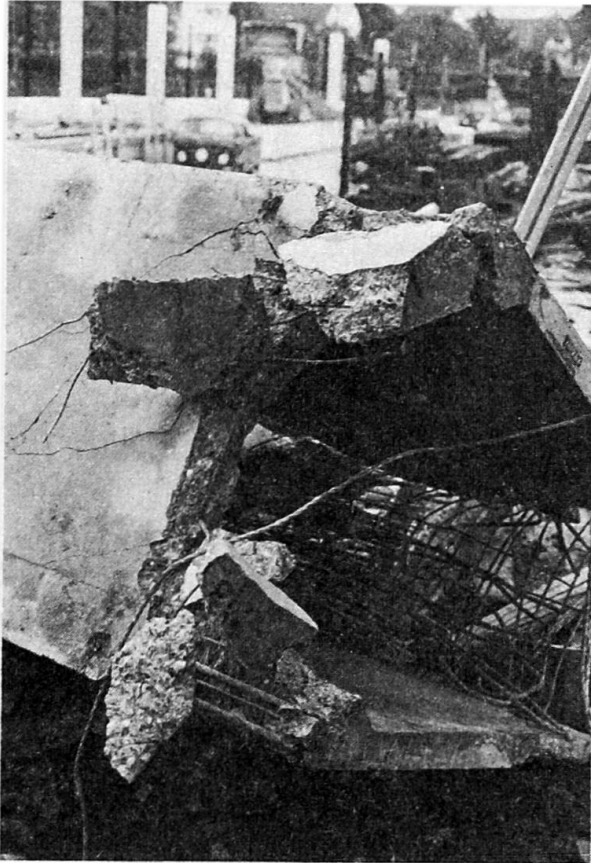
Fig. 4

View of girder end E/10. The girder has broken through the bottom and top flanges at the support.

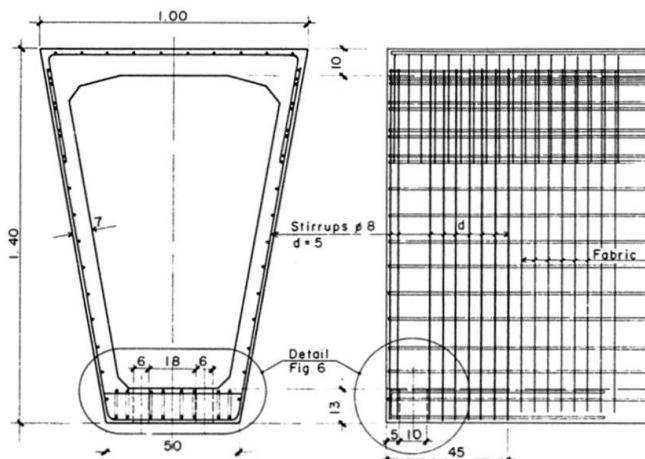
Fig. 5

The to scale dimensions and reinforcement of the support region are shown in Figs. 5 and 6. The girder had no transverse end beam. In the bottom flange were 10 cm long x 5 cm wide holes for 3 cm  $\varnothing$  bolts cast into the column. The support bearing points in the centre of these holes were to scale 10 cm from the girder

Dimensions and reinforcement of the girder support region.

end. However this value could be reduced to nearly 7 cm when measurement variations were taken into account. This was the case with the collapsed girder. The workers on site informed that the bolts had scarcely fitted through the holes in the girder. In the transverse direction the support points did not sit beneath the webs, but were about 10 cm within the cross-section.

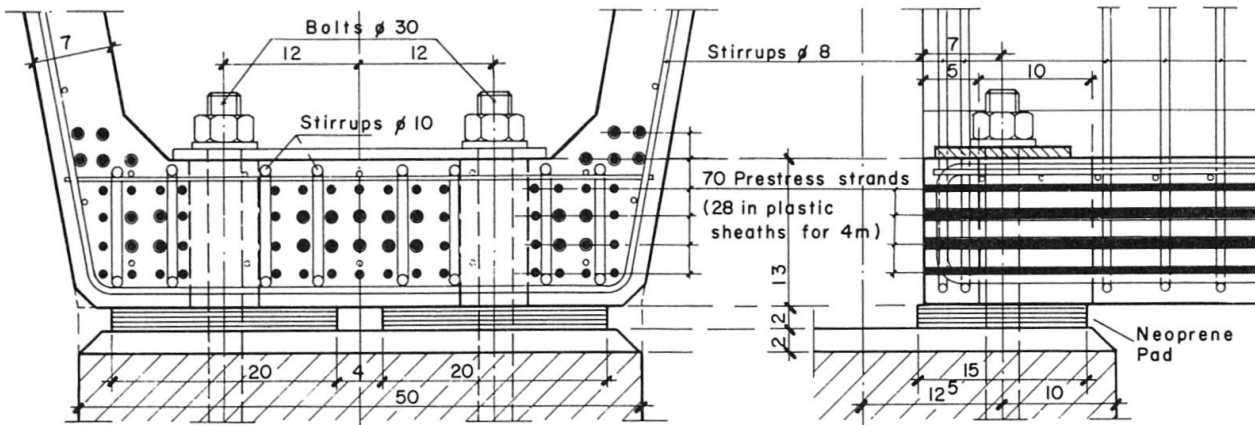
Fig. 6 Layout of the support region. Support in extreme situation.

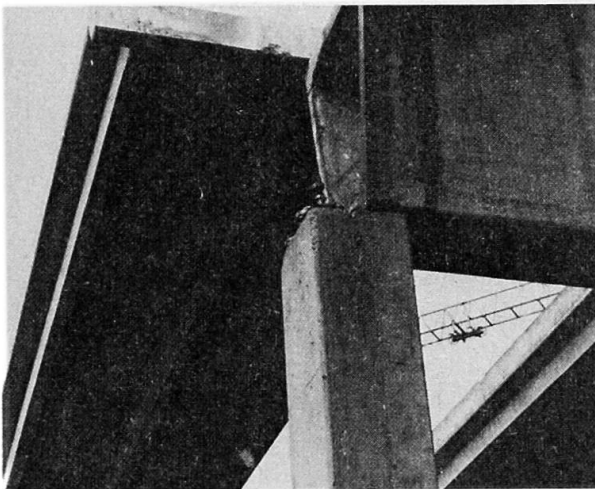
Fig. 7

The actual support consisted of two neoprene layers 200 mm x 150 mm x 21 mm provided with centre holes. After erection of the girder a steel plate and nuts were placed over the bolts. The arrangement is shown in Figs. 7 and 8.

View from beneath towards the column head E/10. Right is the girder 10/C-E. Left was the collapsed girder 10/E-G.

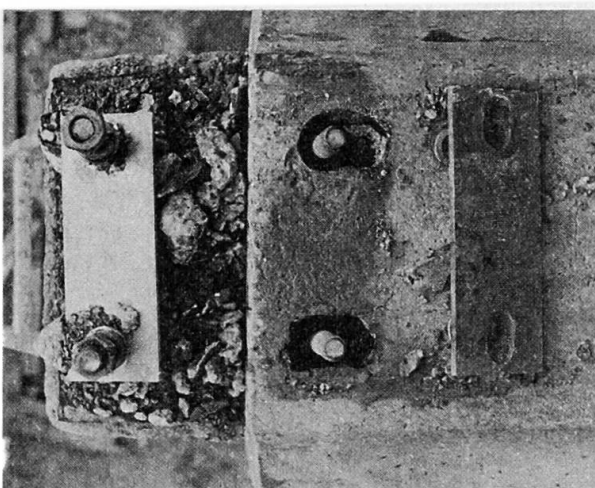
Fig. 8

View from above of the column head E/10. Righthand end of the beam 10/C-E with holes in the bottom flange and removed nuts and steel plate. Remainder of lefthand end of the collapsed girder 10/E-G with the still present nuts and top steel plate. Beneath the rubble are both the neoprene pads.

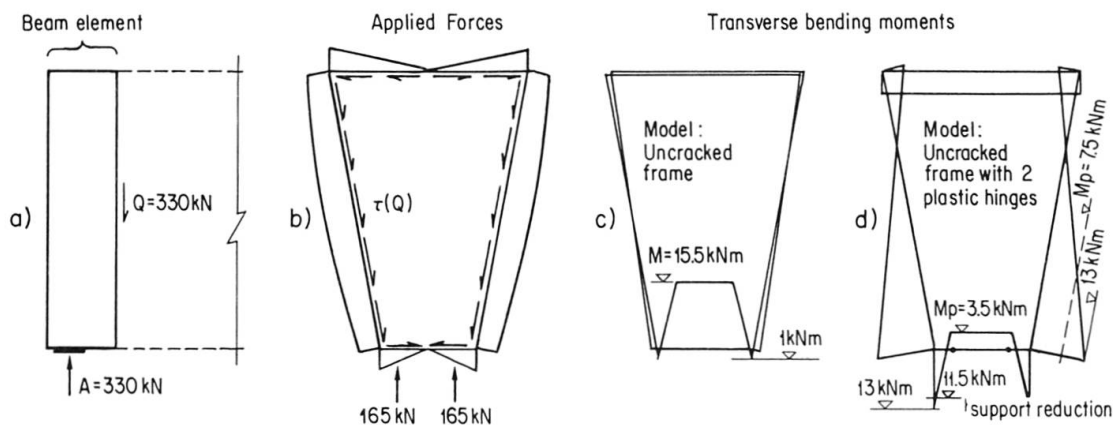
Firstly the transverse bending should be estimated for a concentric loading of the basic structural system's dead weight i.e. for a support reaction of 330 kN. A beam element at the end of the box-section girder, shown in Figs. 9a and 9b, is considered for this purpose. A closed frame is formed which is acted upon by the shear flow of the shear force and by the support reactions. Since both support bearing points are not located beneath the webs, considerable transverse bending moments arise. These, for the assumption of an uncracked section, are shown in Fig. 9c. The moment in the bottom flange comes to 15.5 kNm. With the reinforcement present over a locally supported width of 30 cm the corresponding yielding moment comes to only 3.5 kNm. This means that over both the support bearing points a plastic hinge must be assumed to occur. When one calculates for the remainder with the assumption of an uncracked frame, then the moment diagram of Fig. 9d results. Here the existent yielding moment in the web of 7.5 kNm is considerably exceeded. Thus a possible equilibrium condition can likewise not be found. That the beam did not collapse earlier with a smaller load therefore requires some explanation:

Due to the formation of the plastic hinges at the support bearing points considerable displacements arise. These cause a certain shifting through the neoprene pads of the produced reaction forces towards the webs. Thus the transverse bending is significantly reduced.

Fig. 9 Transverse bending of the support region after placement of the slab units on both sides (concentric loading).

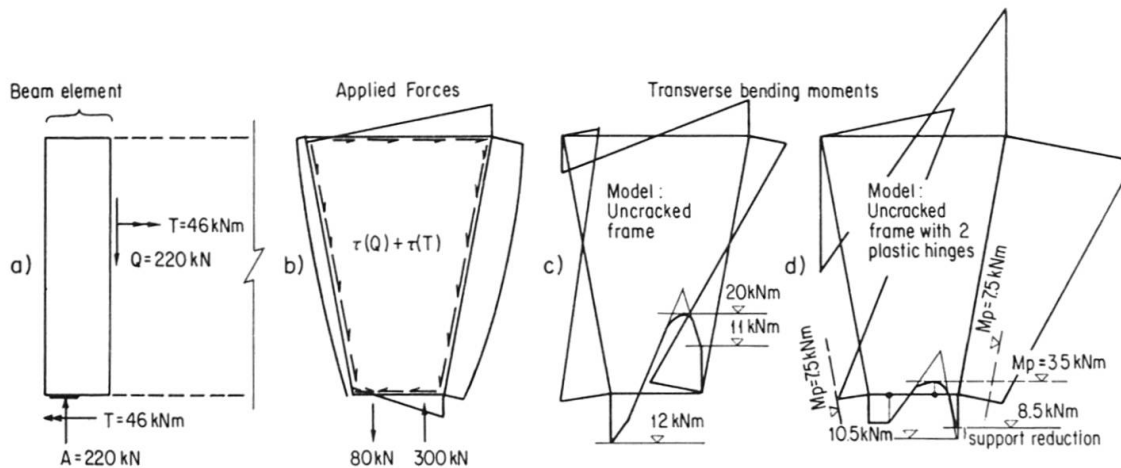
The concentric loading comes to  $220/330 = 2/3$  of the previously analysed loading. Each support reaction comes to +110 kN. The torsional loading consists of a constant shear flow  $\tau$  and equal but opposite reactions of  $\pm 190$  kN. Fig. 10b gives for the sum of both load cases the shear flow and support reactions of  $110 \pm 190 = +300$  kN or  $-80$  kN.

By a similar procedure to that in the previous section for firstly an uncracked frame, the moment diagram shown in Fig. 10c results. This however can not occur since the existent yielding moments (resisting) are exceeded. After the introduction of plastic hinges over the right support bearing point and at the transition of the bottom flange to the left web, the moment diagram in Fig. 10d results. This is however likewise not possible. As described in the previous section, there is a possible sideways displacement of the support reactions towards the webs. This is caused by plastic deformations and should be taken into consideration if an equilibrium condition is to be found.

Fig. 10 Transverse bending of support region after placement of the slab units on one side only (eccentric loading).

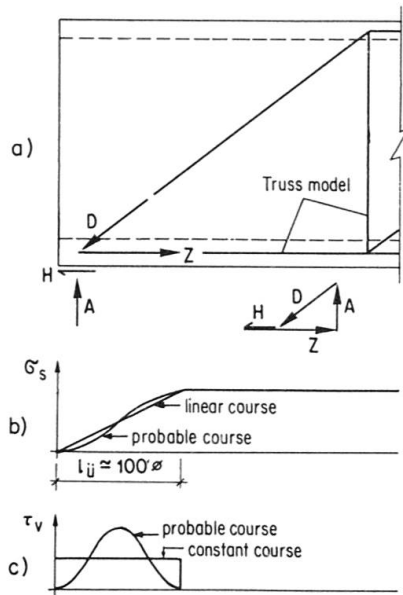
In Fig. 11a the force system in the web plane of the support region is schematically shown i.e. with a truss model that simplifies the actual situation. The inclined compressive force  $D$  stands in equilibrium with the tensile chord force  $Z$  and the support reaction  $A$ . If in addition there acts an external support force  $H$ , e.g. a secondary reaction, then  $Z$  must be increased with respect to  $H$ . If one takes an angle of inclination of  $40^\circ$  for  $D$  and ignores a possible  $H$ , then for a support reaction of 330 kN there results a  $Z$  of approximately 390 kN.

In order to determine these forces, the "truss nodal points" must be correspondingly developed. In particular the tensile force  $Z$  over the support must be dealt with through sufficient anchorage. For this purpose the prestressed wires can in certain circumstances be used. From Code SIA 162 [1], Art. 5.05, the transmission or anchorage length should not come to more than 100 wire diameters. In the discussed case this is 70 cm. If a linear stress distribution is assumed over this length, one obtains an anchorage bond stress of about  $2.5 \text{ N/mm}^2$ .

Fig. 11 End anchorage: internal forces following from the introduction of the support reaction (truss model); steel stresses and bond stresses from the prestress force.

These stipulations were in the discussed case either not at all or insufficiently fulfilled. The wires were cut through one after another with a power cutter. This led to a considerable disturbance of bond. Between various prestressed wires and parallel running end stirrups present the spacing was only a few millimeters. This did not everywhere keep to the well-known rule which states that the spacing of the placed steel should not be less than the the maximum aggregate diameter (here 15 mm).

From these points it can be assumed that the steel stress at the girder end was under proportional and only further into the girder interior increased to over proportional (Fig. 11b). Correspondingly the bond stress at the girder end was relatively small (Fig. 11c). With plausible assumptions the anchorage force comes within the region of 270 to 380 kN. Here the vertical end stirrups  $\varnothing$  8 mm lying parallel to the prestress wires were not investigated. The bond of this steel with the concrete must, in consequence of the small spacing, have been relatively bad.

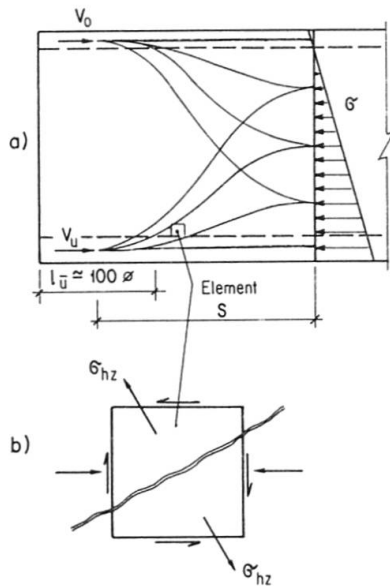
Fig. 12

In Fig. 12a the layout of the prestress wires in the upper and lower regions is schematically shown with respect to the introduction of the prestress forces. A part of these forces goes into the web (transition length  $S$ ) while the other part remains in the flanges.

At the transition of the lower flange to the webs there is a calculated shear stress  $\tau$  of 4.0 - 6.0 N/mm<sup>2</sup>. This is based upon reasonable assumptions for an uncracked concrete cross-section. The corresponding considerably smaller main tensile stress  $\sigma_{hz}$  has the tendency to produce the cracks shown in Fig. 12b.

Stresses and tendency to crack formation in consequence of introduction of pre-stress force.

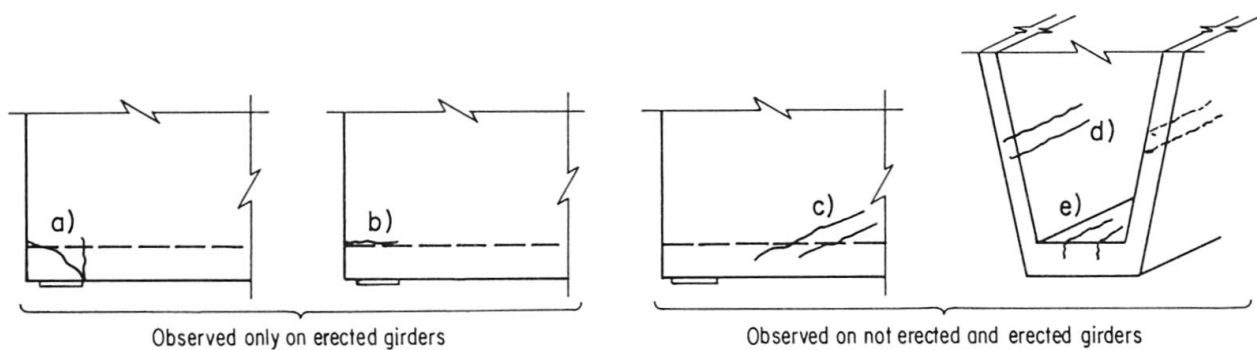
Fig. 13 Crack Types observed on the Girders.

These dangerous shearing-off cracks arise from insufficient end anchorage (cf. 3.4).

These cracks stem from the effects of transverse bending with concentric and eccentric loads (cf. 3.2 and 3.3).

These inclined cracks arise from the spreading of the prestress force from the bottom flange to the web.

Crack Type d): These longitudinal cracks arise probably through shrinkage. There was an adequately strong reinforcement only on the outside of the webs. In addition to this the girders during fabrication were warmed with steam from the inside in order to accelerate hardening.

These cracks can be explained in the same way as the Type d) cracks. They were however considerably wider and longer with the erected girders as with those not yet erected. This comes from the additional effect of the transverse bending (cf. 3.2 and 3.3).

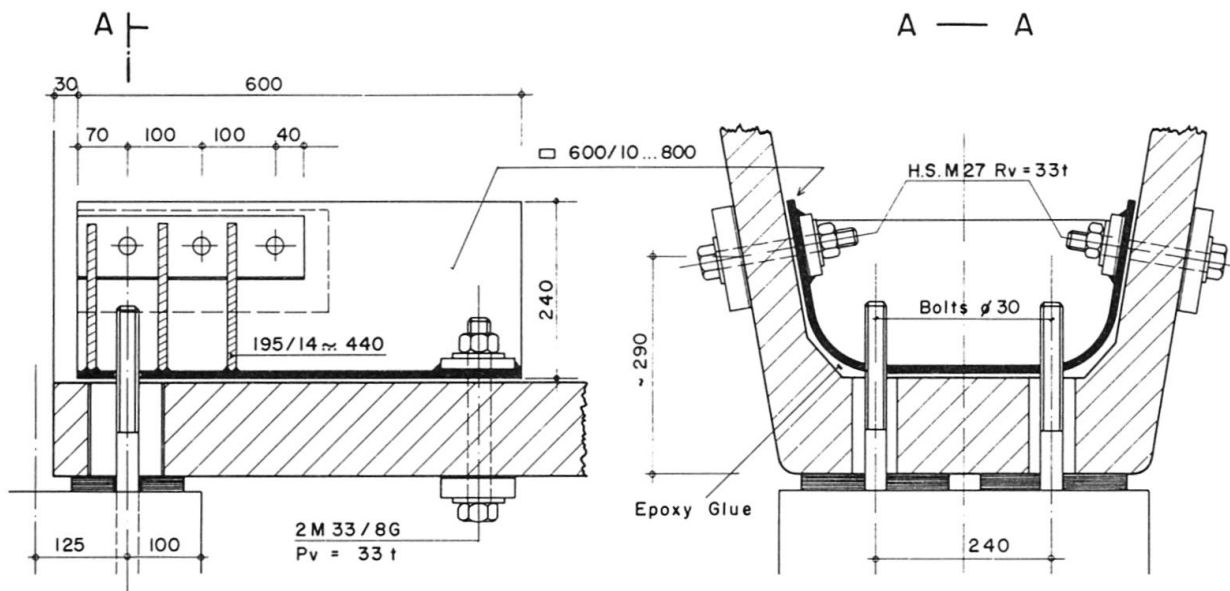
Fig. 14 Remedial solution "Steel Shoe"

The construction shown in Fig. 14 consists of a steel insert glued onto the inside of the girder and bolted with high tensile bolts through the girder walls and base. This solution was economically favourable. However it had to be put aside due to the large constructional and computational uncertainties (thick resin joints, creep, stress loss of high tensile bolts with a small elongation).

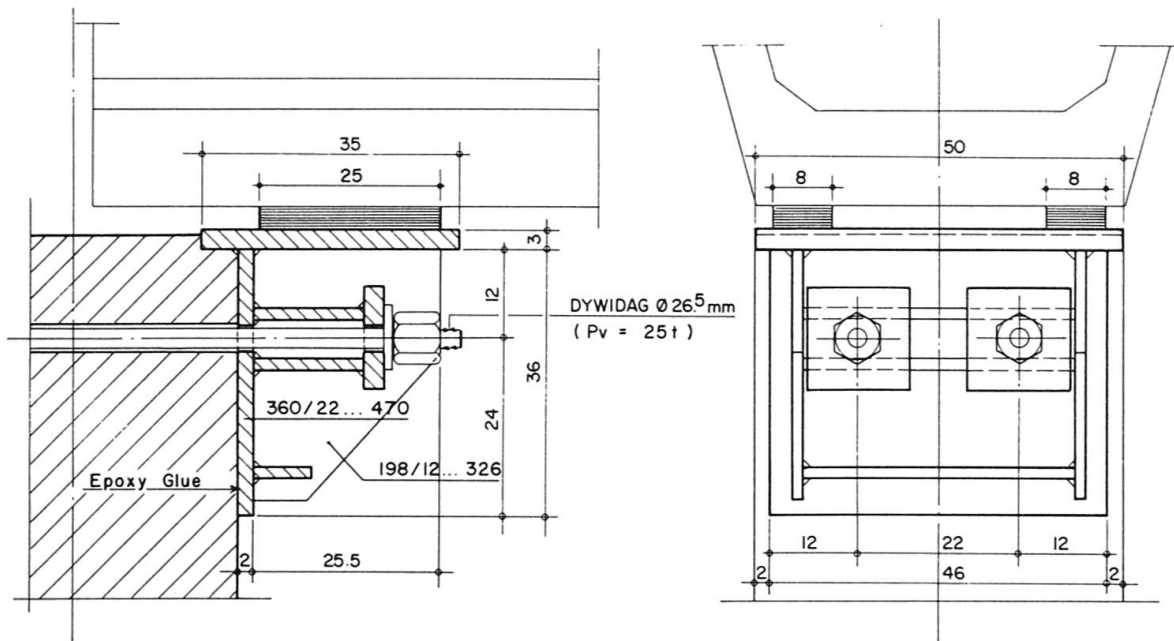
Two problems stand with this solution. Firstly, there is the introduction of eccentric nib loads to the edge columns. Then secondly there is the taking up of torsional effects on the girder stemming from one sided loading during erection. There are also the further disadvantages of high costs, difficult realisation with the already erected sections and dissatisfactory aesthetics. Therefore this variant was not taken any further.

Fig. 15 Remedial solution "Steel Nib"

A further possible remedial solution consists of sitting the girders upon steel nibs as shown in Fig. 15. If the deformation of the support surface is away from the end then sufficient end anchorage is guaranteed. The choice of special small neoprene pads allows the transference of the support forces directly beneath the webs. This largely eliminates the transverse bending. The steel nibs are connected to the in-situ concrete columns with post-tensioned rods.

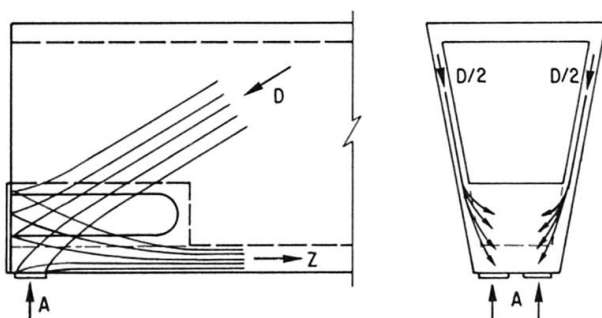
Fig. 16 Flow of the forces with the remedial solution "cast-in concrete strengthening at the support".

The inclined compressive force must be able to be in equilibrium with the support force and the bottom chord tensile force (truss model). The inclined compressive force transfers from the webs through the bond stresses (horizontal prestress) to the new concrete section. It is then taken out through the steel plate and the support. With this the transverse bending of the bottom flange is eliminated or carried by the new concrete section. The horizontal component of the inclined compressive force is taken by the end plate welded to

the longitudinal reinforcement into the girder. It is then transferred through bond stresses (vertical prestress) to the existent tension chord.

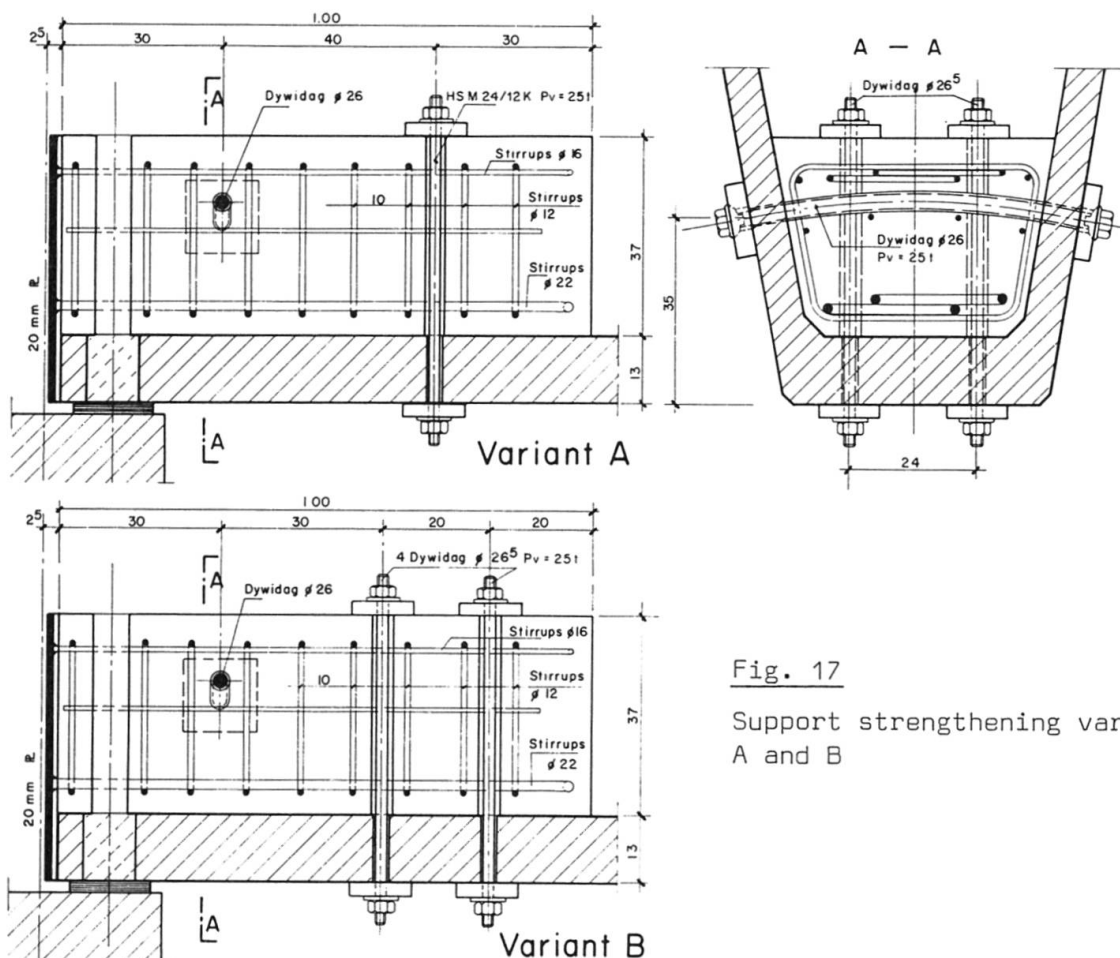
Fig. 17  
Support strengthening variants A and B

This proposal concerns strengthening of the inside of the box section girder in the support region (see Fig. 17, Variants A + B). The girder end is concentrated for a length of one meter with an internal depth of 37 cm. This new concrete is reinforced, the longitudinal bars having an end plate welded to them which spreads over the adjacent webs and also the bottom flange. The new concrete is connected to the girder with vertical and horizontal prestressed rods.

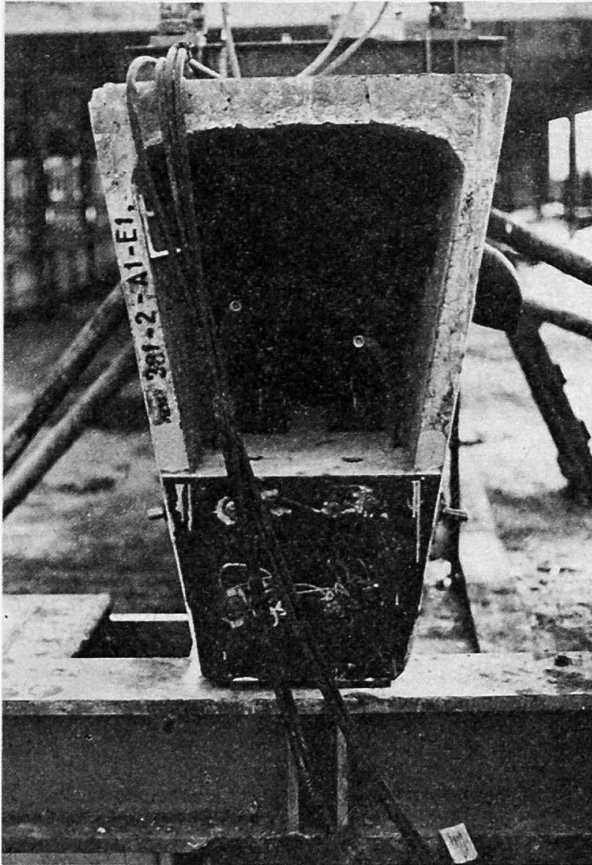
Fig. 18 Girder end, side B of the test girder

With variant A the girder end A was horizontally prestressed with a preliminarily bent Dywidag rod  $d = 26$  mm and vertically with two high strength bolts ( $d = 24$  mm). With variant B at the girder end B, in place of the two H.S. bolts, Dywidag rods were used. Using a prestressing jack the prestress forces in the Dywidag rods came to 250 kN. Through a torque wrench the prestress in H.S. bolts came likewise to 250 kN. The Dywidag rods and H.S. bolts were placed in plastic sheaths which were not grouted for the test. The contact surface between the girder and the concrete infill was scabbled so that an unevenness of about 3 mm depth was produced. The concrete of the new infill had a compressive strength of about  $32 \text{ N/mm}^2$  on the day of the test. Between the rear vertical end plate and the webs and also the bottom flange there was a space of 5 to 10 mm. This was carefully filled with epoxy cement. The design of the remedial construction for the girder end is shown in Fig. 18.

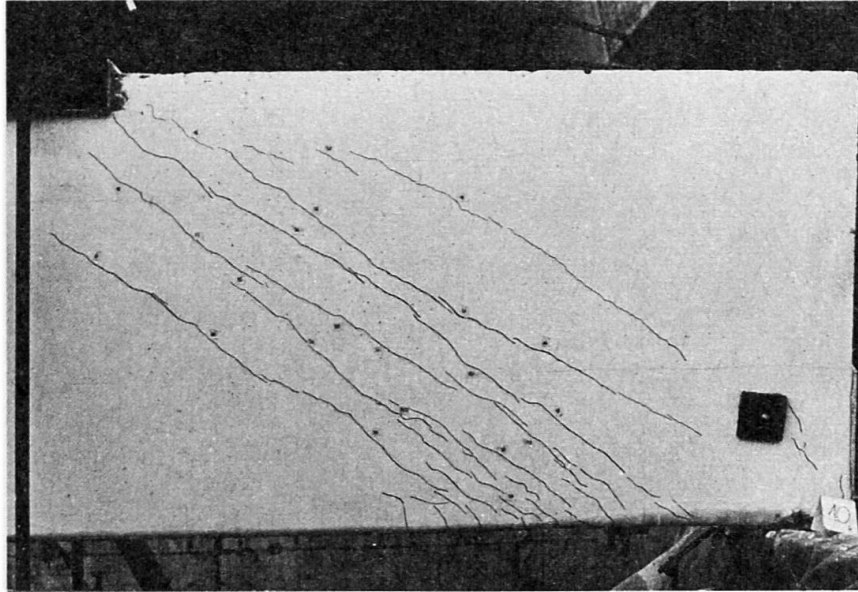
Fig. 21 Crack pattern at girder end A

In the inside of the beam cracks also occurred at the vertical contact surface between the concrete infill and the webs. They could be observed on the upper edge of the new concrete section. The cracking began at the girder end with about  $1.5Q(g+p)$ . With about  $1.9Q(g+p)$  the contact surface was cracked through right along the girder. A maximum crack width of 0.4 mm and significant deformations between the new concrete section and the web could be observed. Between the variants A and B there was no significant difference. There was no sign of a failure beginning in the support regions. The girder came through the test excellently and it was possible to use it again in the building.

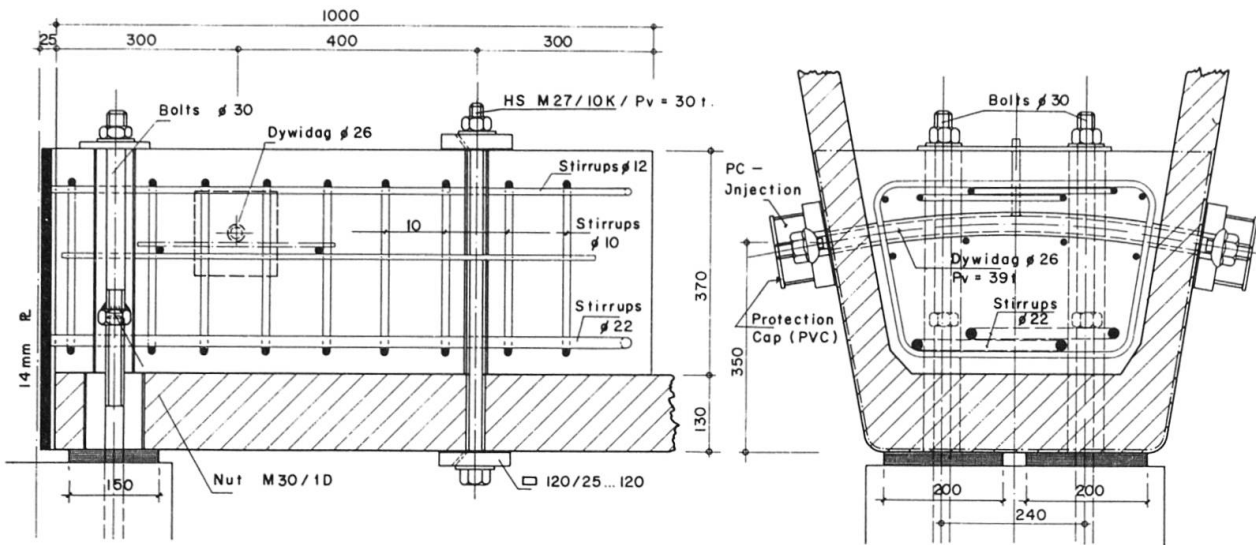
Fig. 22 Adopted remedial solution, end support

The observations and results of the building site test formed a very good basis for the establishing of a final solution. This solution is very similar to the tested variant A. In place of the H.S. bolts  $d = 24$  mm, material 12 K, two bolts  $d = 27$  mm and out of the tougher and less susceptible to corrosion material 10 K were used. The final solution is as in Fig. 22.

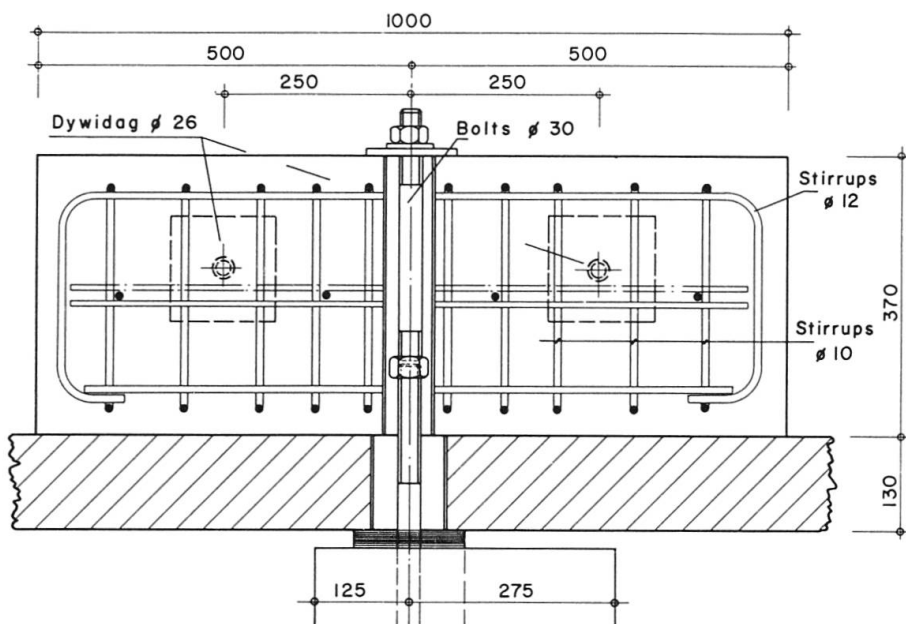
Fig. 23 Adopted remedial solution, internal support

The girders A and C show an internal support on grid line A as a result of the external cantilever. Here there was no problem of end anchorage. The girders needed only to be strengthened for transverse bending. Shown in Fig. 23, this solution is close to that for the end support.
