Zeitschrift: IABSE proceedings = Mémoires AIPC = IVBH Abhandlungen
Band: 11 (1987)
Heft: P-106: Flash floods on bridge piers

Artikel: Flash floods on bridge piers
Autor: Krumdieck, Alfonso
DOI: <https://doi.org/10.5169/seals-40366>

Flash Floods on Bridge Piers

Alfonso KRUMDIECK

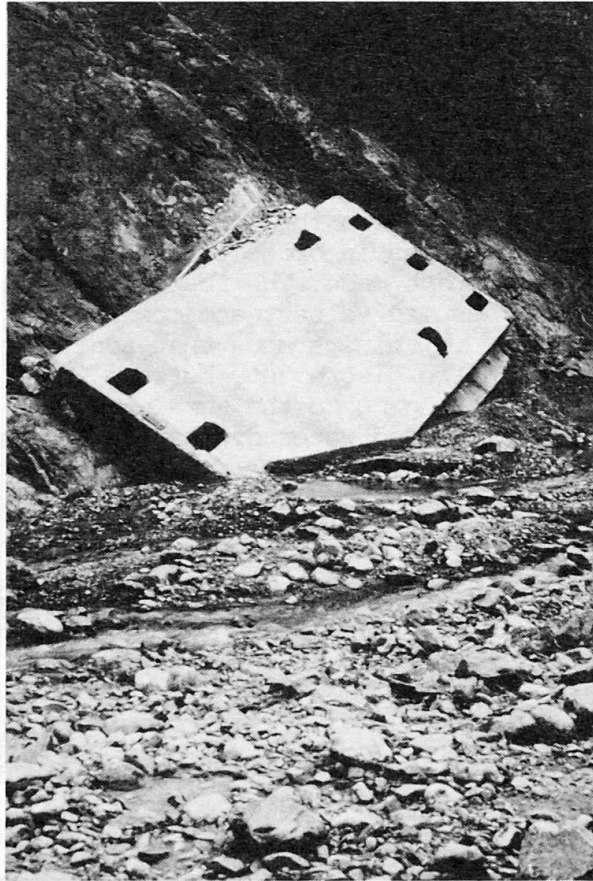
Huge quantities of bed material were reported to have been dragged along the river bed. The peak velocities which occurred during the event could not be directly measured. From eye witness accounts these were estimated to be about 30 to 60 km/h, however these must be judged critically. Taking into consideration that huge bridge slabs of 200 tons of weight or more were moved hundreds of meters downstream, it can be safely assumed, that peak velocities of approximately 50 km/h occurred, (see Fig. 2).

FIG. 2 200 Ton Bridge slab after the flash flood.
