Artikel: Assessment of existing structures for their rehabilitation

Assessment of Existing Structures for their Rehabilitation
Evaluation de structures existantes en vue de leur assainissement
Beurteilung von Bauwerken und deren Instandsetzung

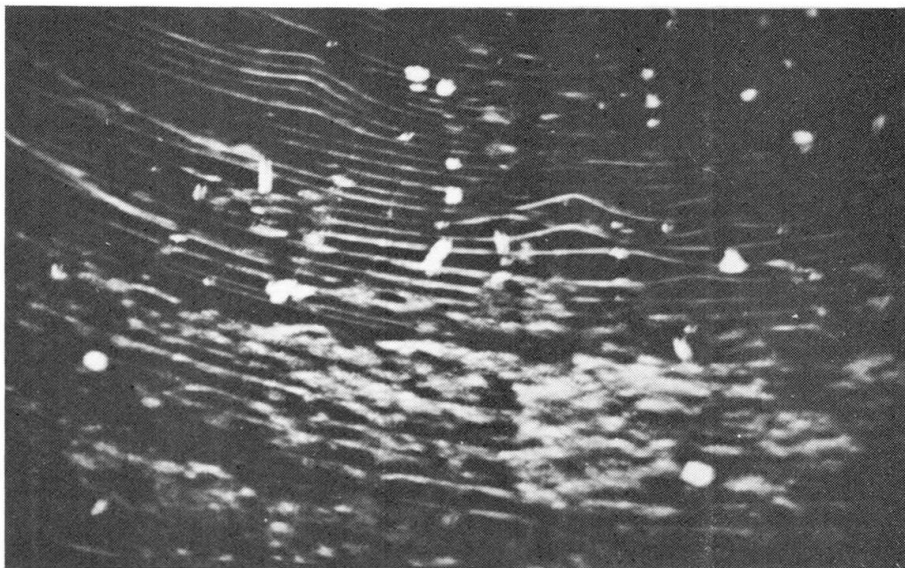
Area D - very high degree of concrete degradation, loose and twisted reinforcement (Fig. 1).

Sclerometric tests were made along the total length of the gallery. They showed that superficial concrete in Area D (next to where the fire broke) had a lower residual resistance. To quantify more precisely the heat effect in depth, some cores were taken out and tested in compression (Fig. 2). The results varied between $\sigma_{ck} = 30,6$ MPa and $\sigma_{ck} = 22,8$ MPa in Area D for concrete not directly exposed to the fire. As all these values were superior to the one used in the initial design ($\sigma_{ck} = 22,1$ MPa), it was considered that the existing concrete presented no safety problems for the structure.

Fig. 1 [2] Damage in the cross-section of the tunnel (Area D)

Some steel cores from the various areas were also taken out and tested. Only the reinforcement in Area D showed some decrease in its mechanical characteristics ($f_{s0,2k} = 350$ MPa < 400 MPa). As its residual extensions were substantial, the reinforcement was replaced. Adhesion tests were also performed before repair took place.

Area D - the reinforcement was replaced, about 3 cm of the surface concrete were removed and the cover was replaced by shotcreting. To efficiently verify the bond between old and new concrete, some cores were taken out and tested to quantify the bond strength of the joint. The ultimate shear stress was about 2,3 MPa, similar to that of 0,00the concrete used in the tunnel construction.

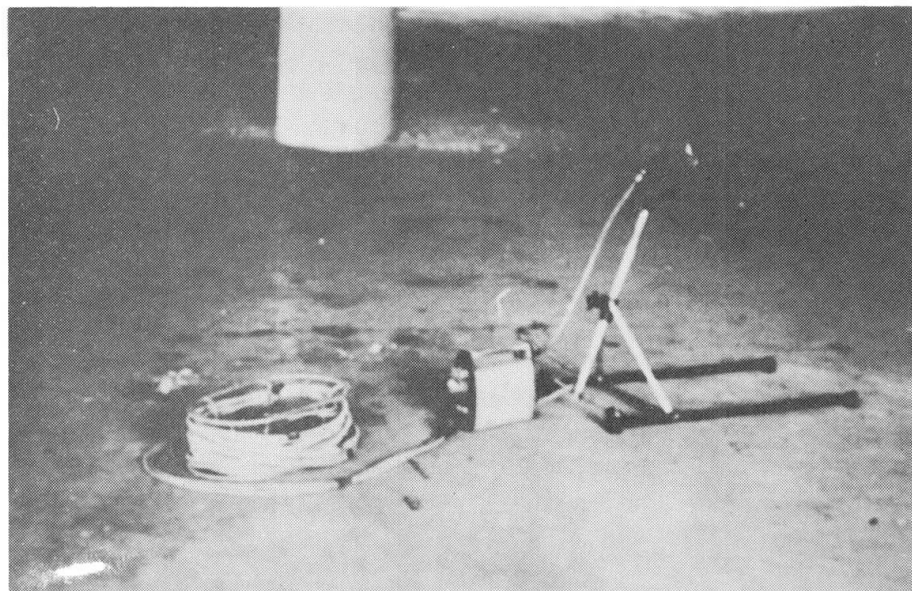
- groove making in concrete beams to determine the number and size of the reinforcement.
- non-destructive in-situ testing using X Rays to detect and identify the reinforcement in some slabs (Fig. 2). It proved to be efficient in the analysis of slabs up to 30 cm deep with the equipment used and the safety conditions imposed [3]. The radiographies showed the reinforcement layout and size.

According to the results obtained, it was not possible to guarantee analytically the safety factors in the dimensioning of the slabs with the new in-service loads. It was then decided to resort to a full scale load test of the slab with the least favourable conditions. The load consisted of water contained by a small wall specially built for the effect (Fig. 2).

The results showed a good behaviour of the slab with almost no visible cracking for the future in-service loads with a factor $\gamma_f = 1,25$. One of the main reasons for this was the good quality of the mortar layers used on top of the slabs that functioned monolithically with the concrete. There was then no need to strengthen the slab.

Fig. 2 X Ray equipment and full scale load test of slab
