Zeitschrift: IABSE reports = Rapports AIPC = IVBH Berichte
Band: 57/1/57/2 (1989)

Rubrik: Workshop 3: Durability of suspended structures

Inspection Evaluation, and Rehabilitation of Suspension Bridge Cables

Inspection Program for the Lisbon Suspension Bridge
Programme d'inspection pour le pont suspendu de Lisbonne
Untersuchungsprogramm für die Hängebrücke in Lissabon

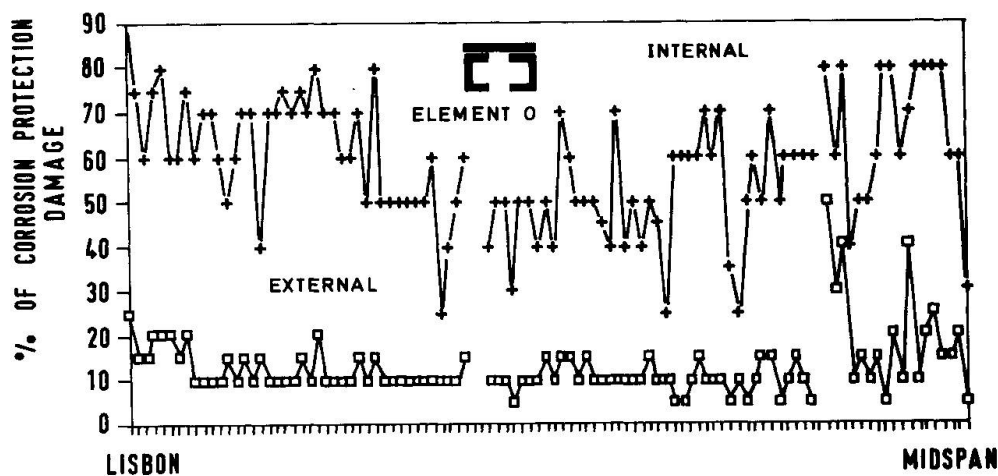
Fig. 3 - ANTICORROSION PROTECTION DAMAGE AT ELEMENT 0, ALONG THE SPAN.

At the first stage of the program, the corrosion inspection was implemented. At the columns only superficial corrosion was found, mostly at the interior of the base section. The concrete caissons were also observed and filmed under water to check for concrete degradation, but no relevant findings were obtained. At the cables hangers and cable bands, and with an external observation, only small spots of superficial corrosion were found. Due to the good external condition, an internal observation with electromagnetic techniques was not considered necessary at this stage. All the bars of the deck truss were also inspected and plots of the superficial corrosion along the bridge were drawn for each element (Fig. 3). Structural damage by corrosion was found only in a few nuts of the bolted connections which presented section reductions of more than 20%. It is estimated that about 2% of the deck bolts will need to be replaced shortly. During deck inspection some transversal bars located over the longitudinal girders (shown in Fig. 2 by A). It is estimated that 13% of the total number present this problems.

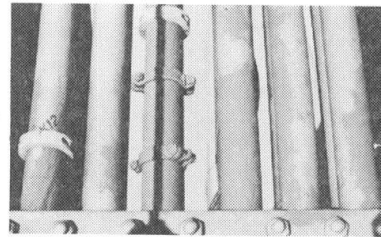
Treten die Drahtbrüche vereinzelt auf, so genügt eine Sanierung der klaffenden Bruchstellen durch Plombieren mittels Kunstharz. Dadurch wird das Eindringen von Feuchtigkeit verhindert. Tritt Drahtbruchhäufung auf oder befinden sich die Bruchstellen in benachbarten Z-Drähten, besteht die Gefahr, daß Z-Drähte aus dem Seil treten und sich auf weite Strecken aus dem Verband schälen. Um dies zu verhindern, sind im Bereich der Schadensstelle Schraubklemmen zu montieren. (Fig. 2)

Fig.2 Drahtbruchhäufung in verschlossenen Tragseilen einer Hängebrücke im Bereich einer Hängerklemme

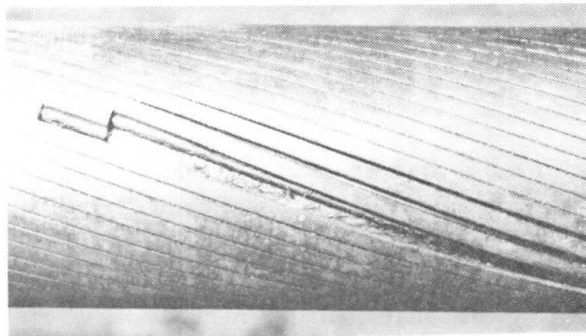
Um das zehn Meter lange verschlossene Tragseil, 63 mm Durchmesser, belasten zu können, wurde es an beiden Enden mit Vergußköpfen versehen. Die äußere Z-Drahtlage weist in Seilmitte zwei nebeneinander liegende Drahtbrüche auf. (Fig. 3)

Fig.3 Verschlossenes Tragseil, 63 mm Durchmesser, mit zwei nebeneinander liegenden gebrochenen Z-Drähten, Belastung des Seiles in der Seilreckanlage: 1430 kN

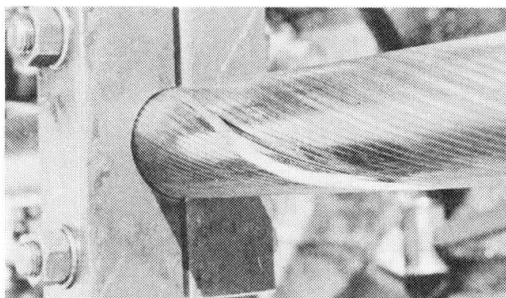
Fig. 6 Einpressen der Drahtüberlänge (Schleife) in den Seilverband mittels einer Schraubklemme

Im zweiten Arbeitsgang wurde der neue Z-Draht mittels einer gut passenden Schraubklemme in den Seilverband gepreßt und zwar vorerst bis zur ursprünglichen Schadensstelle. Im weiteren Verlauf der Sanierung wurde das zweite Bruchende des Z-Drahtes Nr.1 aus dem Seilverband gehoben und in Richtung Klemmenwagen, auf eine Länge von 2240 mm, aus dem Seilverband geschält. Anschließend wurde der neue Z-Draht von der ursprünglichen Schadensstelle mittels Schraubklemme in den Seilverband gepreßt. In einer Entfernung von 2800 mm von der ersten Lötung wurde die zweite Lötung mit kurzer Drahtüberlänge vorgenommen. (Fig.6) Nach Behandlung der Lötstelle mit Spezialwerkzeugen wurde im dritten Arbeitsgang die Drahtschleife mittels Schraubklemme bis zum Verschwinden in die Außenlage des verschlossenen Tragseiles gepreßt. (Fig.7) Hierzu war eine Wegstrecke von ein Meter Länge erforderlich. Die Gesamtlänge zur Sanierung eines gebrochenen Z-Drahtes beträgt in diesem Falle 3800 mm, das sind ca. sechs Seilschlaglängen. Mit der Sanierung des zweiten Drahtbruches wurde in gleicher Weise wie beim Drahtbruch Nr.1 verfahren.

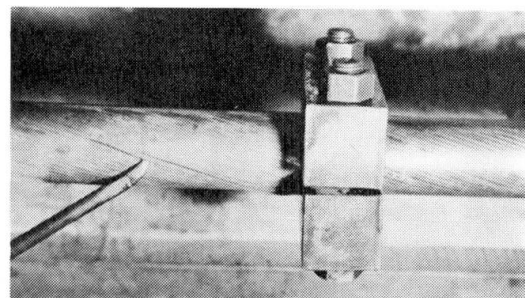
Fig. 7: Seilzustand nach dem Einpressen der Drahtüberlänge in den Seilverband, Entfernung von der sanierten Bruchstelle: 2800 mm

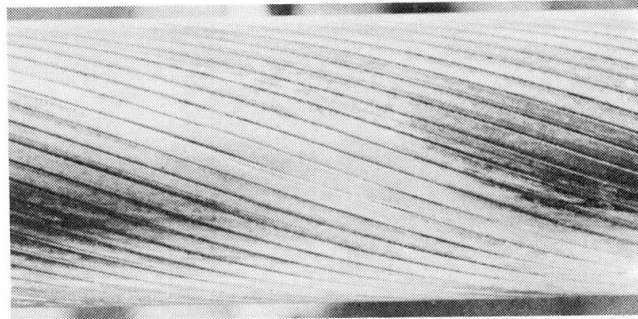
Aus Fig.8 ist der Seilverband im sanierten Bereich ersichtlich. 'Alle Z-Drähte der Außenanlage liegen fest im Seilverband. Unmittelbar nach der Sanierung tragen die eingepreßten und gelöteten Z-Drähte nicht voll mit. Ein weitgehender Spannungsausgleich zwischen den Z-Drähten tritt jedoch nach mehrmaliger Be- und Entlastung auf.

Fig.8 Verschlossenes Tragseil, 63 mm Durchmesser, Seilzustand im sanierten Bereich

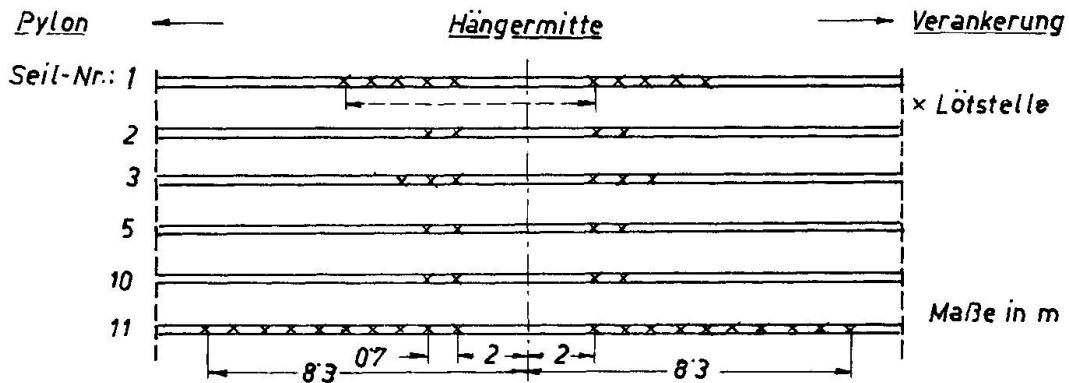
Im Bereich einer Hängerklemme wurden in 6 von 12 Tragseilen insgesamt 24 Drahtbrüche festgestellt. Die Lage der Drahtbrüche in den einzelnen Seilen ist aus dem Lötstellenplan ersichtlich. (Fig.9) Die Verteilung der Lötstellen wurde so festgelegt, daß der Abstand zwischen zwei benachbarten Lötstellen 700 mm beträgt. Im Bereich der Hängerklemme wurde eine lötstellenfreie Zone von 4 m geschaffen. Aufgrund der Drahtbruchverteilung ergaben sich im zu sanierenden Bereich folgende maximale Einziehlängen bzw. Sanierungslänge: Seil Nr. 11: Einziehlänge 10,3 m und Länge des sanierten Bereiches 16,6 m.

Fig.9 Lötstellenplan zur Sanierung der verschlossenen Tragseile im Bereich einer Hängerklemme
