**Zeitschrift:** IABSE reports = Rapports AIPC = IVBH Berichte  
**Band:** 73/1/73/2 (1995)

**Artikel:** Reinforced concrete framed building strengthened by prestressing  
**Autor:** Najdanovic, Dusan / Alendar, Vanja  
**DOI:** <https://doi.org/10.5169/seals-55296>

## Reinforced Concrete Framed Building Strengthened by Prestressing

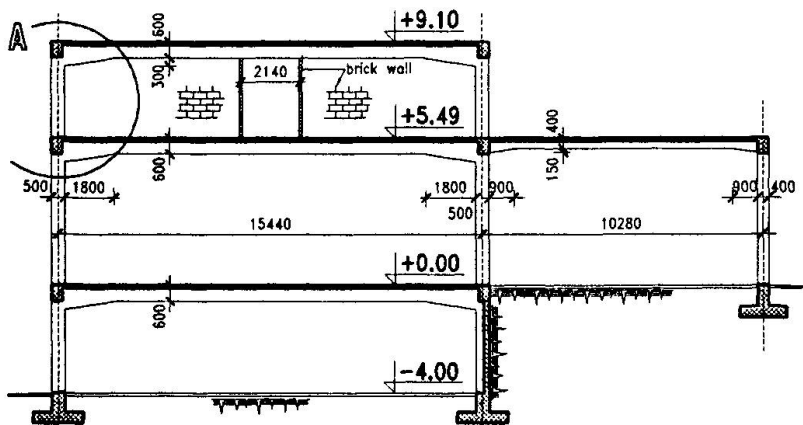
Fig. 1 Disposition of a transverse structure frame

The building is a three-story reinforced concrete frame structure with an annex, with dimensions 73,440 x 26,160 mm in plan, and clear story heights 3,400 + 4,890 + 3,061 mm. The span of the transverse frames, mutually spaced at 5,200 mm, is 15,440 mm in the main bay and 10,280 mm in the annex, Fig. 1.

Frame beams are haunched, of rectangular cross-section, dimensions 400 x 600 mm in the main bay and 400 x 400 mm in the annex. Frame columns, dimensions 400 x 500 mm are founded on strip foundations. Floor structure consists of semi-prefabricated solid reinforced concrete one-way slab, total thickness 120 mm.

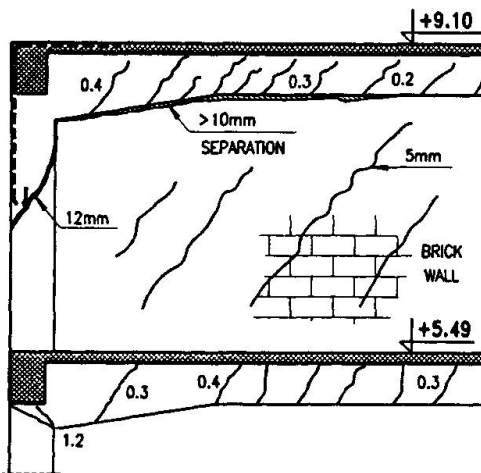
Fig. 2 Characteristic detail 'A' of damages

The most outstanding cracks, up to 0.5 mm wide, appeared in the structure beams. In the span cracks spread in vertical direction along the entire depth of the beam, up to the roof slab. Towards the ends of the beams, the cracks gradually incline up to an angle of approximately 60 degrees regarding the horizontal plane, Fig. 2.

Appearance of inclined cracks at the top of the short columns in the top story, up to 12 mm wide, indicates failure of the column, Fig. 2. Due to increased deflections of frame beams, up to 60 mm in case of roof beam (span-deflection ratio 255), the functionality of the structure was violated, specially at the top story: appearance of doors and windows distortion and jamming, discomfort while walking, separation of partition brick walls from frame beams and columns, in some places more than 1 cm which violated their lateral stability as well as functionality of the installations. Excessive deflections of the roof beams caused loss of the draining layer slope and therefore retaining of water on the roof.

Subsequent structural analysis showed that, due to omission in load estimation and pattern, safety coefficients regarding the ultimate limit state in the large part of the structure are considerably smaller than required, and that the cross-sections are under-reinforced. For example, original structural analysis was carried out with assumption of uniformly distributed load, which underestimated "concentrated" effect of load from partition brick walls 120 mm thick, which are perpendicular to transverse frames in the corridor zone, Fig. 1. During service of the building, permissible tensile stresses in reinforcement in a large number of beam and column sections were exceeded, and notable cracks and deformations appeared.

The intensity of columns loading was additionally underestimated, since the stiffness of the beam haunches was not taken into account. As it is common in design of buildings, control of shear strength of columns was not carried out. In case of the third floor 'shallow frame' columns, that was an unacceptable oversight. Inspection of performed column reinforcement details showed that the tensioned reinforcement at the column-roof beam joint was not anchored deep enough into the column, which created conditions of "pulling out" the beam from the column, Fig. 2. At the same time, the lateral reinforcement of the columns is not sufficient to resist developed large shear forces, therefore, failure of column, decrease of rigidity of this story and increase of deformations of roof frame beam occurred.

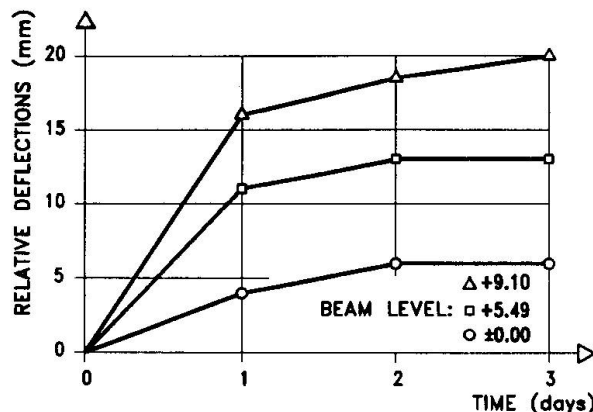
Fig. 6 - Stabilization of deflection in course of time

Results of performed measurements show good correspondence between measured and calculated relative deflections, with average stabilization time of three days following tensioning, Fig. 6. Measured values of change in strains of steel elements indicate well spreading of prestressing force, with expected level of friction, as well as that glued lateral steel sheets become activated.
