**Zeitschrift:** IABSE reports = Rapports AIPC = IVBH Berichte  
**Band:** 73/1/73/2 (1995)

**Artikel:** Renovation of Seattle's historic Paramount Theatre  
**Autor:** Lundeen, Terry R. / Harriott, James D.  
**DOI:** <https://doi.org/10.5169/seals-55172>

## Renovation of Seattle's Historic Paramount Theatre

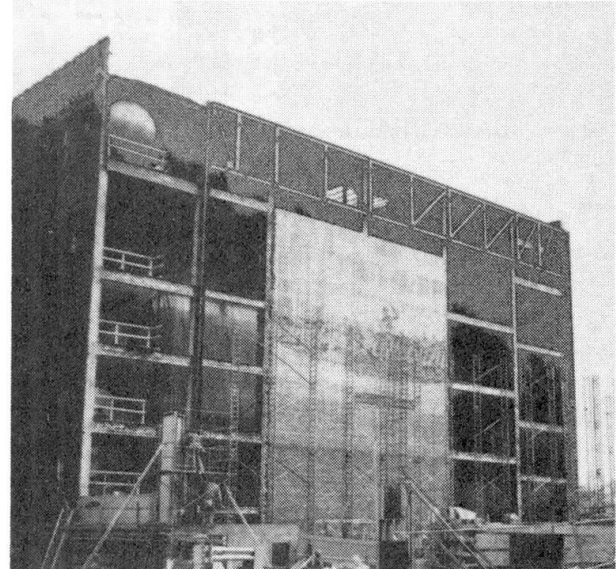
Fig. 2: New Truss

With the necessary removal of the back wall structure, the existing roof structure required new support. New support was provided by installation of a 3 m deep steel truss spanning 27 m over the new stage. The new truss can be seen in Figure 2. This photo was taken prior to demolition of the rear wall and existing columns.

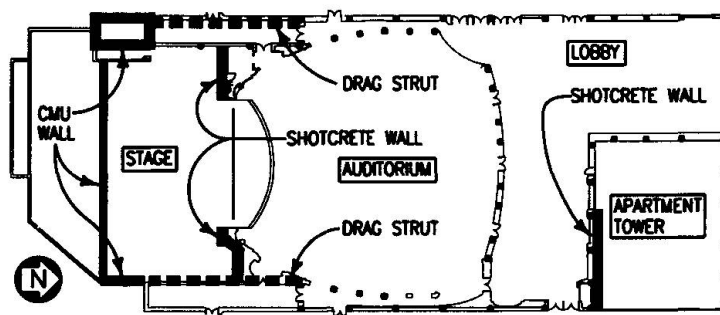
Fig. 5: New Seismic Elements

- The roof parapets were unbraced unreinforced masonry.
- The span of some URM walls between supporting steel girts or columns was excessive.
- The projection room above the auditorium was an unbraced hanging structure.
- Hollow clay tile walls existed at several locations above the auditorium.
- A weak story condition existed at the theatre lobby / apartment section of the building.
- There was excessive shear demand at the URM proscenium wall.
- There was excessive shear demand at the URM east and west exterior walls.

For seismic loads in the transverse (east/west) direction, new reinforced masonry and concrete shearwalls were designed to resist the entire seismic base shear. Since the existing backstage (south) wall was removed to accommodate the stage expansion, the new backstage wall of reinforced masonry was designed to resist the seismic forces from the southern portion of the combined building. A new shotcrete wall was placed against the demising wall between the theatre and apartment tower and was designed to resist seismic forces from the northern portion of the theater as well as the apartment tower. This wall eliminated the weak story condition in that portion of the building. In addition to the two main walls, the proscenium wall was strengthened. This strengthening was designed only to provide some measure of ductility at the proscenium opening. This wall was not designed to carry any of the building seismic forces apart from its own weight.

The new concrete shearwalls were located at the walls demising the different functions of the building in order to minimize the impact to the architectural program. A key plan showing major lateral force resisting elements is given in Figure 5.
