Zeitschrift: **IABSE congress report = Rapport du congrès AIPC = IVBH
Kongressbericht**

Band (Jahr): **14 (1992)**

Seismic Damage and Retrofit to California's Urban Concrete Bridge Structures

Frieder SEIBLE

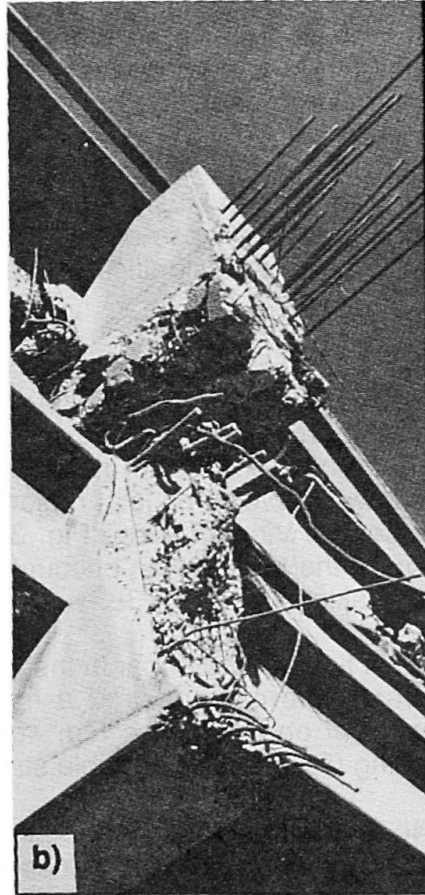
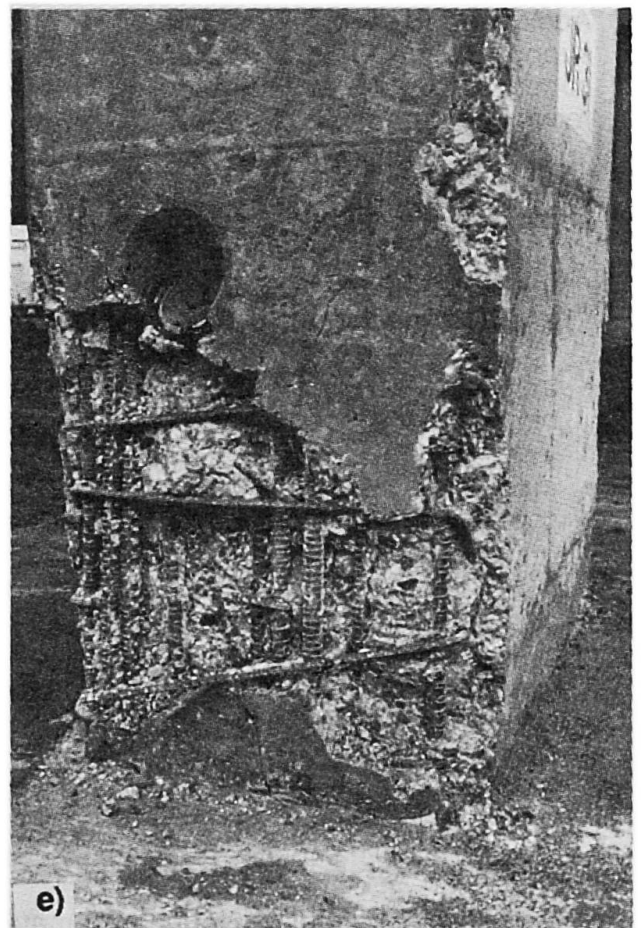
Fig 3. Bridge Damage, Loma Prieta 1989 (M7.1)

Finally, Loma Prieta (1989) revisited all previously encountered problems with emphasis on double-deck viaduct structures through the collapse of a 1 km (0.7 mile) long section of the upper deck of the Cypress Viaduct in Oakland, and significant damage to other double-deck viaduct sections in San Francisco.

The collapsed upper deck of the Cypress Viaduct in Oakland is shown in Fig. 3a, featuring columns and pedestals reinforced with 12 mm \varnothing ties @ 300 mm (#4 @ 12 in.) and joint regions without joint shear reinforcement. Figure 3b depicts a lower cap/column connection with pullout failure of top and bottom cap reinforcement due to inadequate anchorage length and Fig. 3c shows a typical joint failure of the lower cap/column joint region. Typical column shear failure was encountered on Highway 101 – Central Viaduct – see Fig. 3d, and lap-splice failure of column bars in the plastic hinge at the top of the footing was encountered in single-column bents on the West Grand Avenue Connector in Oakland, see Fig. 3e.

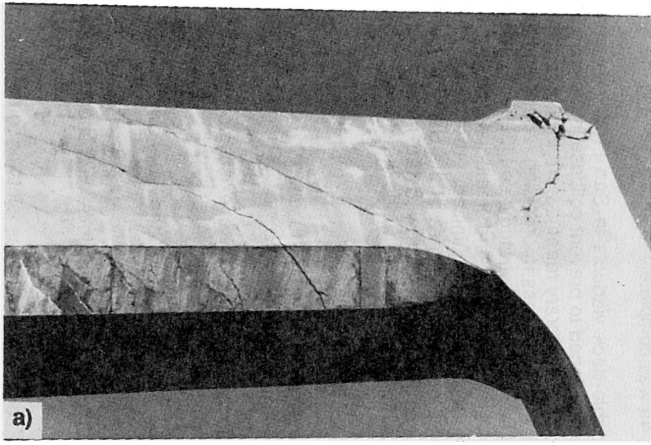
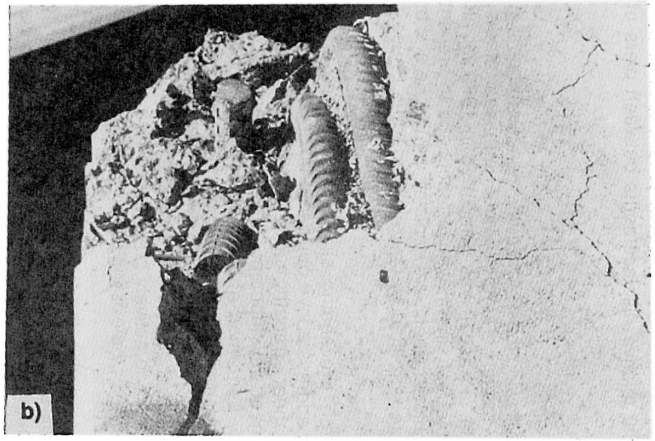
Fig 4. Knee Joint and Plastic Hinge Failure, Loma Prieta 1989

Outrigger bents showed problems in flexure and shear in the cap and shear failure of knee joints, see Fig. 4a, due to lack of shear reinforcement, and a fractured 57 mm \varnothing (#18) bar was encountered in a damaged knee joint on I-980, see Fig. 4b, which can be attributed to large strains introduced during bar bending (6.25%) and possible strain aging effects.

A flared pier wall which experienced shear distress during the Loma Prieta earthquake was repaired and retrofitted with a full height steel jacket, see Fig. 5c, for increased shear capacity. The previously discussed joint shear failure in an outrigger knee joint of I-980, see Fig. 4b was repaired by full replacement of the joint concrete, see Fig. 6d, and added joint shear reinforcement, while the outrigger bent shown in Fig. 4a was completely replaced, see Fig. 5e.

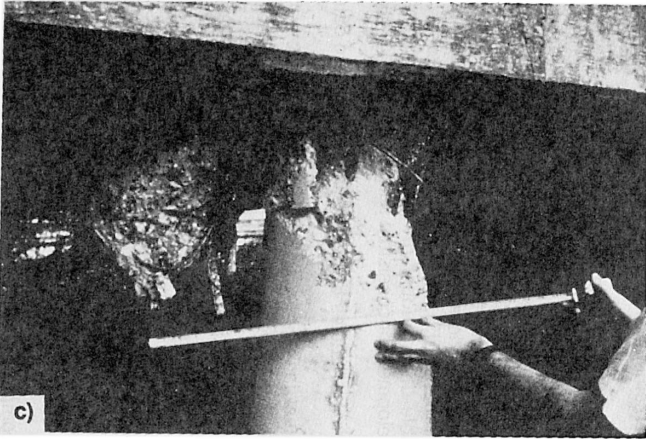
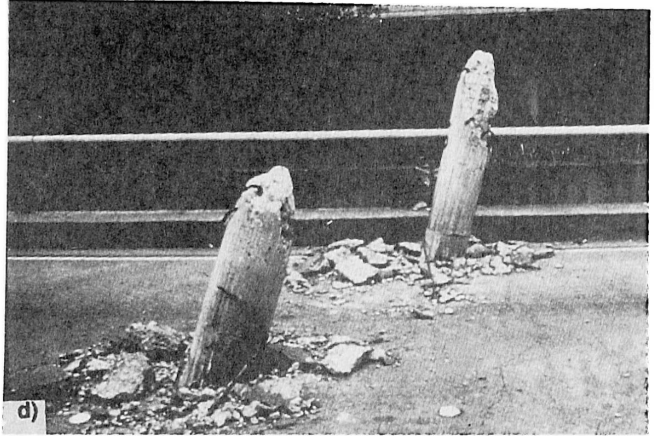
Finally, on struve slough, Figs. 4c and d, the plastic hinge at the column top sheared off and the column offset in the longitudinal bridge direction and punched through the reinforced concrete deck slab.
