Recorded Failures of Electrically Welded Wrought Iron and Mild Steel Bridges.

H. J. L. Bruff,

Bridge Engineer, North Eastern Area, London & North Eastern Railway. York.

The failures occurred in the course of carrying out the repairs to an old Wrought Iron plate girder bridge in the City of Leeds, which, apart from having suffered very badly from corrosion needed to be strengthened, as it was considered of inadequate strength to carry modern traffic.

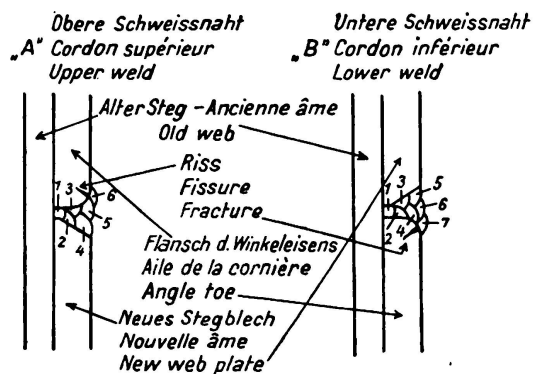
Fig. 2.

Details of Web Butt Welds as designed.

The most difficult portion of the work was the welding in of new web plates, as these had to be fitted in between the vertical flanges of the cross girder angles, which necessitated using fairly large butt welds. The procedure of carrying out this work was to tack weld the new web plates to the angle toes and then to weld alternately the top and bottom butts in runs of six inches, the number of runs being in some cases as many as seven. The butts when prepared were of the usual form adopted by my Chief for welds of this kind and the welding was as indicated in Fig. 2, A and B.

since been adopted instead of the form shown in Fig. 2 above, as it secures better fusion at the junction of the plates.
