Artikel: Maintenance of steel structures: discussion

Autor: Berridge, P.S.A.

Maintenance of steel structures

Discussion

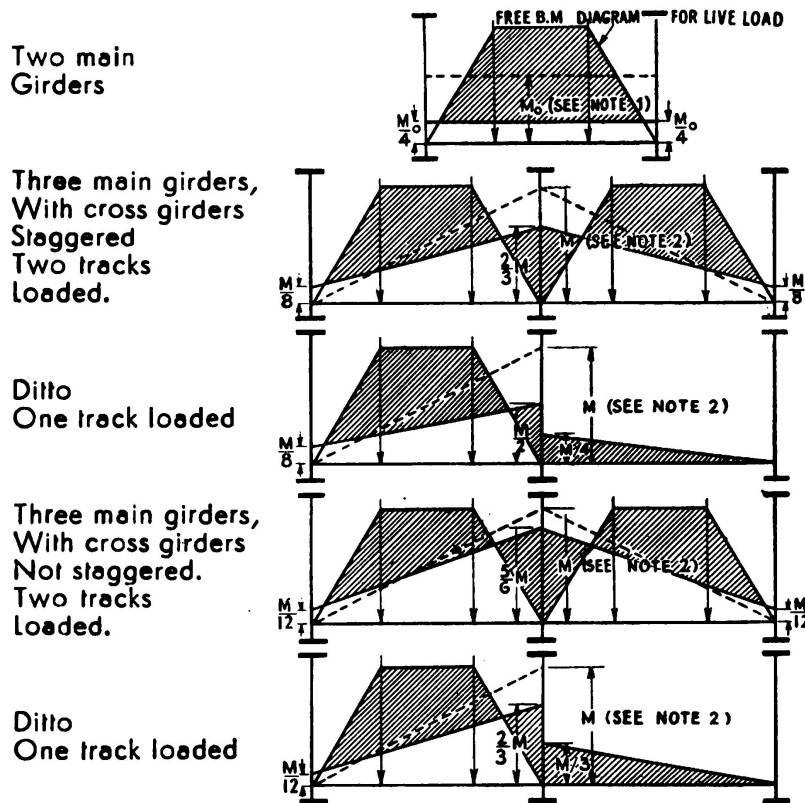
FIG. 3. Diagram indicating the end fixing moments on cross girders in half-through type spans
