### **The Development of Asphalt Surfacing for Steel Bridge Decking**

J. J. TROTT

D. S. WILSON

Road Research Laboratory, Department of Scientific and Industrial Research,  
United Kingdom

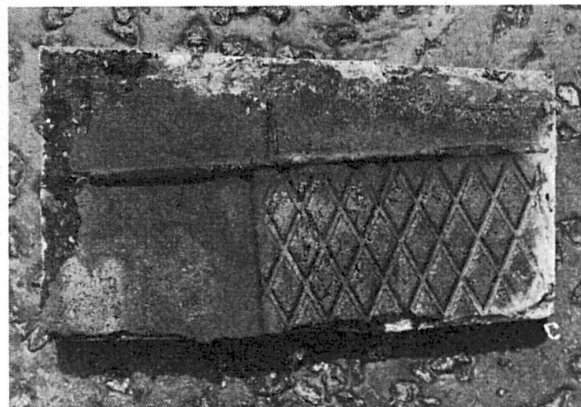
Fig. 3. The Underside of the 1½-in. Surfacing Removed From the Junction of the Smooth and Chequered Plate Panels.

By January, 1950, three weeks after opening to traffic, cracks began to appear at the junction of the panels and the side plates, and, by April, 1950, the side plates on all the sections, except that with a 2-in. surfacing, were outlined by cracks. A crack also appeared between the 1-in. and 1 1/2-in. sections, no cracks were detected in the surfacing proper, although on that with a 1-in. surfacing, cracks appeared to be working in from the edges. In June, 1950, patches were cut from all sections and showed that rusting was occurring at the edges of the plates near the cracks. This spread under the bituminous

paint and caused failure of the bond between the surfacing and the deck plate (see figs. 3 and 4). Where the bond had failed, traffic caused "pushing" of the asphalt (see fig. 5); the general appearance of the surfacing is shown in fig. 6.

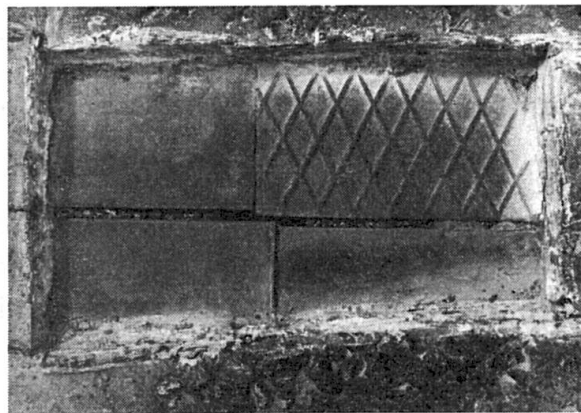
Fig. 4. Deck Plate on the Smooth and Chequered Plate Panels After Removing the 1 1/2-in. Surfacing. Rusting Can Be Seen Round the Edge of the Plates.

5. It was found advantageous to sand-blast the steel plate, spray it with metallic zinc, and to prime it with bituminous paint to minimise rusting and corrosion and to improve the bond between the surfacing and the plate.

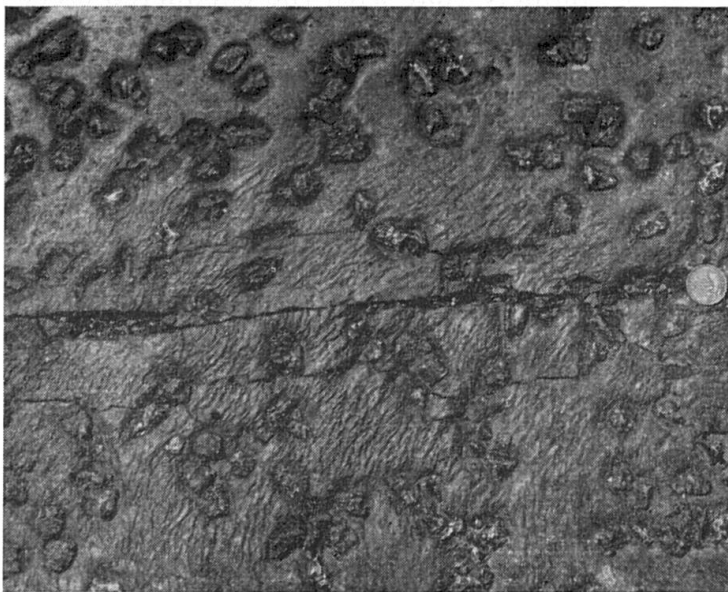
Fig. 5. Pushing of the 1-in. Mastic Asphalt Surfacing on the Side Plate Due to the Bond Being Broken Between the Surface and the Steel.

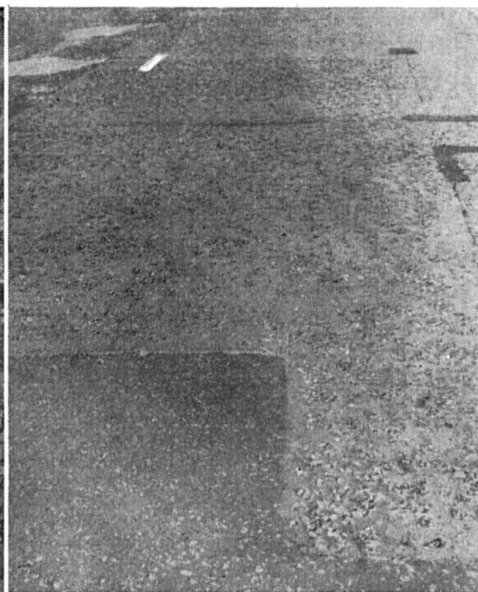
Fig. 6. View of the Surface on the Panels, Showing the Cracking Round the Side Plates.

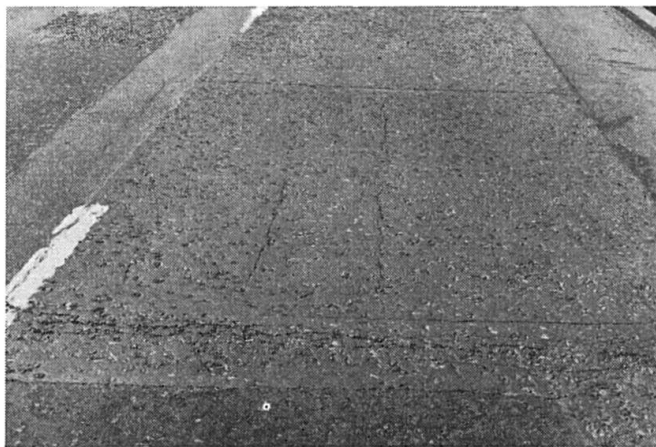
The cracks formed over the stiffeners are shown in fig. 8. On stripping the surfacing it was found to be cracked right through over the three central stiffeners for nearly the whole distance between the transverse supports. The

Fig. 8. General View of Bridge Panels After 2<sup>1</sup>/<sub>2</sub> yr. with 1-in. Surfacing in Foreground. Note the Pronounced Cracks Over the Three Central Stiffeners and Incipient Cracks Over the Outer Stiffeners.

cracks over the outer stiffeners were found to be in the form of a "vee", the point of the "vee" just touching the steel over a short distance. Where the cracks penetrated to the steel, and all around the edges of the panel, water had entered and caused considerable rusting. Fig. 9 shows the extent of this corrosion and also shows that, over the main area of the panel where the adhesion to the mastic had remained good, no penetration of water had occurred and hence no rusting. The considerable crack over the central transverse support did not extend through the surfacing and no water had penetrated to the steel.

1. A 1-in. thickness of stone-filled mastic asphalt would be too thin for use on the deck of the proposed bridge. Cracks would probably form over the longitudinal stiffeners and permit water to penetrate through to the steel plate.

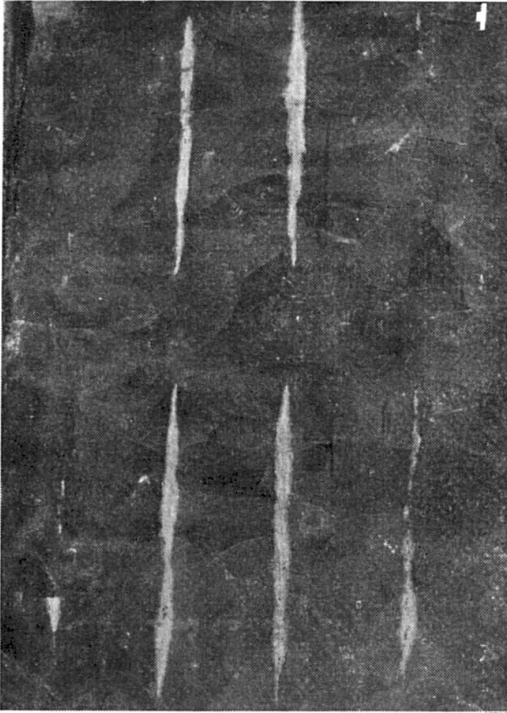
Fig. 9. The Steel Deck-Plate After Removal of 1-in. Surfacing. Note the Corrosion After  $4\frac{1}{2}$  yr. Owing to Water Penetrating Through the Cracks Shown Above.

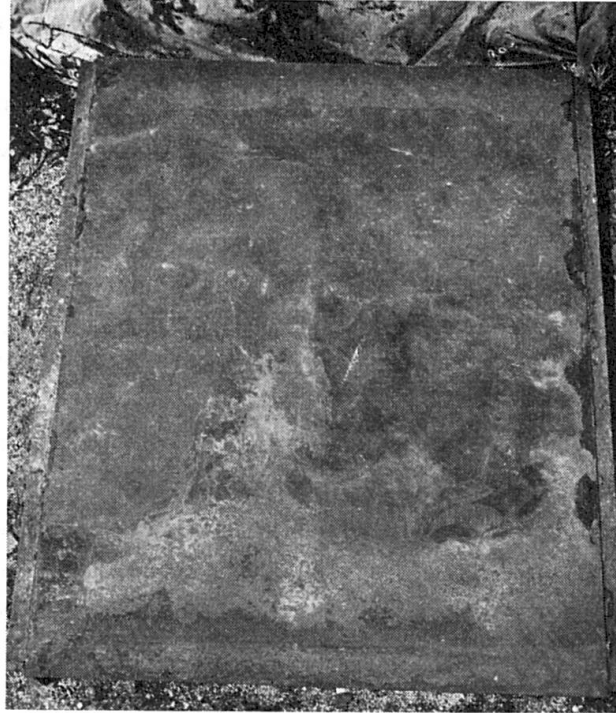
Fig. 10. The 9 ft. By 7 ft. Deck Plate After Removal of the  $1\frac{1}{2}$ -in. Surfacing. Note Absence of Any Corrosion After  $4\frac{1}{2}$  yr., Due to Cracking; and Also the Very Considerable Corrosion Where the Mastic Asphalt Had Not Adhered Properly Over the Front and Centre Portions of the Plate.

There was a fairly well defined crack about  $\frac{1}{16}$  in. wide over the central stiffener and a very short, faint crack over each of the two adjoining stiffeners. None of these cracks penetrated to the steel plate. As with the 1-in. surfacing, water entered all around the edges of the plate and caused considerable corrosion, particularly at the west end of the panel (on which traffic first runs). Approximately a quarter of the whole area had no adhesion between the

mastic asphalt and the steel. Here the plate was extensively rusted and the mastic asphalt was widely cracked over its underside. The cracks were filled with rust and slime, but did not penetrate to within  $\frac{1}{2}$  in. of the top surface. No cracks were detected in the region where the adhesion to the steel was good. Fig. 10 shows a photograph of the steel plate after the  $1\frac{1}{2}$ -in. surfacing had been removed.

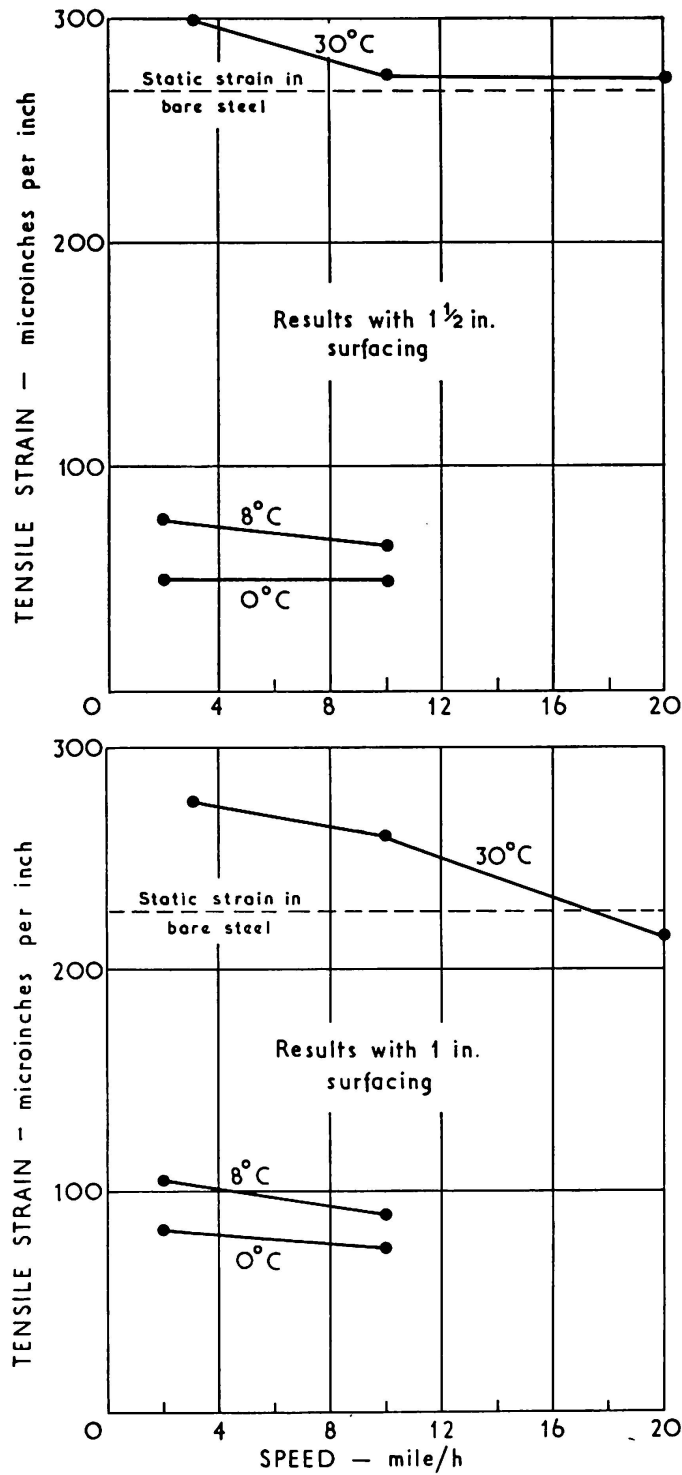
Fig. 15. Effect of Vehicle Speed and Temperature on the Dynamic Strains in Bridge Panels Caused By a Wheel Load of 11 000 LB.

Values of the peak tensile strain recorded by gauge No. 6 in each test run are shown in fig. 15 plotted against the vehicle speed, separate curves being shown for the three surfacing temperatures studied. Separate sets of curves are shown for each panel, and each diagram shows the tensile strain deduced from the static tests at a load equal to that applied by the rear wheel of the moving lorry, i. e. 11,000 lb. The distribution of strain occurring under the load applied by the jack to a rubber disc 11 in. in diameter and that applied by the vehicle tyre having an elliptical contact area about 12 in. by 8 in. will not be identical. The static strains have been included in fig. 15 merely as a yardstick by which to judge the strains recorded under the moving vehicle. The fact that, at 30° C, the dynamic strain recorded with, say, a surfacing 1½ in. thick, was actually greater than that recorded statically, with the load applied to the bare steel, therefore, has no significance.

Both sets of diagrams on fig. 15 show much larger strains in the steel when the surfacings were at a temperature of 30° C than at 0 and 8° C. The diagrams indicate that at 30° C, the surfacings made only minor contributions to the rigidity of the steel plate, whereas at the lower temperatures, their contributions were appreciable. If it is assumed that the strains measured in the static test were directly comparable with the dynamic values, it would appear that, at 0° C, the 1½-in. surfacing contributed about 80 per cent as much as the steel plate to the overall rigidity, while the contribution of the 1-in. surfacing was 60 per cent. If the mastic asphalt behaved elastically under the stresses and rates of loading applied by the moving vehicle, it would be expected that the elastic modulus would be higher at the low temperature than at 30° C. Tests on bituminous materials have indicated that the change of modulus corresponding with this temperature change may be of the order of three to four times greater and this would largely explain the recorded differences in strain at summer and winter temperatures.
