# Behaviour of Four Prestressed Concrete Platform Roofs Between 1955 and 1963

P. W. ABELES

Two pairs of two platform roofs were built at Potters Bar near London in 1954/55. As seen in Fig. 1, each of the four roofs is 130 ft. long and approximately 36 ft. wide supported by four columns. Each roof consists of a cantilever slab of a thickness of 3—4 in., supported by two main beams, the slab being prestressed by means of post-tensioned four-wire cables placed in grooves 12 in. apart. Each of the two main beams of 130 ft. length, cast and prestressed in situ, is supported by two columns 65 ft. apart. Thus in both cases for the slab as well as for the beams there are only negative bending moments with tension at the upper sides under uniformly distributed load which allowed the provision of straight posttensioned tendons.

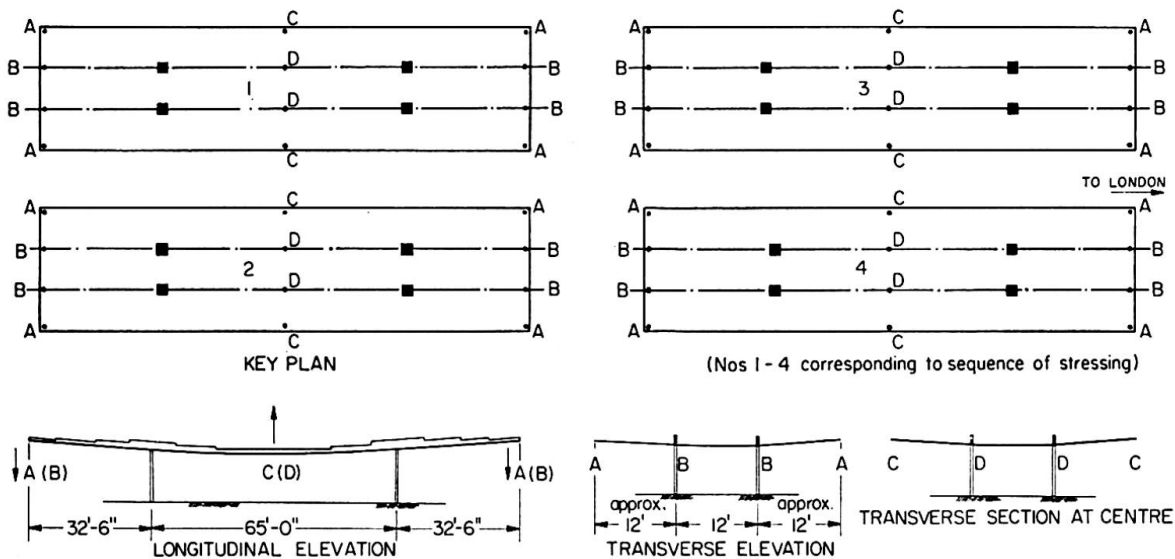
The four platform roofs had been built in the sequence 1 to 4, as indicated in Fig. 1, and the temperature conditions varied to a very great extent during this time, with the consequence that quite different deformations of the roofs occurred owing to different shrinkage and creep. This was particularly conspicuous along the two pairs of edges of adjacent roofs where different deformations occurred and the two adjacent levels did not meet. This difference in age and shrinkage and creep history between the individual roofs has remained quite apparent all the time, although the degree of discrepancy was slightly reduced by the end of 1955.

It was considered as possible that the excessive deformations (comprising upward deflections at the cantilevers and downward deflections at the centres of the roofs) might even increase in the course of time in consequence of further creep and shrinkage of the concrete and relaxation of the steel. However, the measurements, as shown in Fig. 5, indicate that there has, in principle, not been an excessive increase in the deformations. In general, it can be seen that with increasing temperature a relief in deformation takes place, the cantilever ends lowering and the centres of the beams rising, as indicated in Fig. 1.

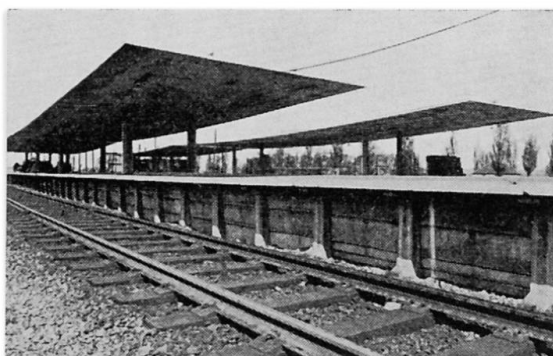
Fig. 2.

Prestressing was applied when the concrete test specimens showed sufficient strength. However, the strength in the roof beams must have been much less than that of the well compacted test specimens made on the ground in which the water content was not increased by rain. In consequence of the reduced strength, difficulties occurred during prestressing, particulars of which are described by the author elsewhere<sup>1)</sup>, which required some repair work at the anchorages. When the prestress was applied, excessive deformations took place.

This was almost twice the amount of the values expected, based on an assumed instantaneous  $E$ -value of  $5.25 \times 10^6$  psi corresponding to the specified cube strength of 6500 psi. Thus, the actual strength at transfer in the beams must have been appreciably less. The instantaneous deformation at transfer increased further due to creep, but this was again much more than originally expected for the specified strength. The photo Fig. 2 shows the deformations of the roofs in Summer 1955.

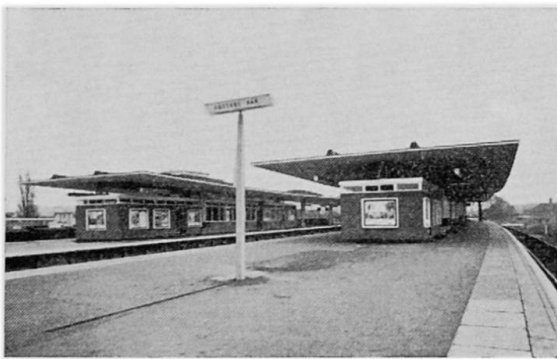
Fig. 3.

excessive deformation and by the infiltration of water into a lightweight concrete topping (which was afterwards provided at the centre portion to improve the drainage), the deadload was appreciably increased and exceeded there the working load with the consequence that cracks developed at the underside i. e. where compressive stresses were expected, as described in more detail elsewhere<sup>1</sup>). Consequently, modifications were made by removal of the "lightweight" concrete topping and roofing cover over the centre portion of the roof and ensuring satisfactory drainage, thereby keeping the dead load within the design value, when all cracks at the underside closed. Figs. 3 and 4 show the

roof after this modification, when the deformations were greatly reduced and the recoveries were in good agreement with the anticipation based on the calculation with an  $E$ -value more appropriate to the actual strength.

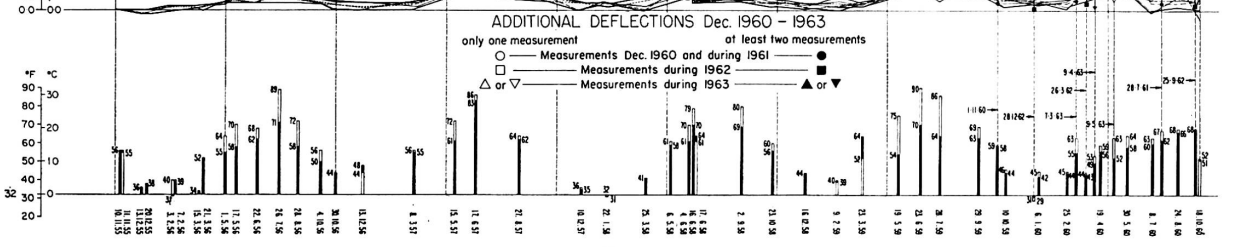
Fig. 5.

Measurements of the levels of the four corners  $A$ , of the four cantilever ends  $B$  and of the two points  $C$  and  $D$  at the centre of the roofs have been made for all four roofs at certain intervals. In Fig. 5 the maximum and minimum levels of each roof have been plotted for the time between November 1955 and November 1960. The abscissa representing the time is divided into 10 divisions, each of which indicates half a year, and the date is given underneath. The maximum and minimum of deflections of all four roofs are shown by solid lines when at least two readings were available and by dotted lines where only a single reading applied. Fig. 5 relates to the measurements of 16 points each at the corners  $A$  and the cantilever ends  $B$ , and covers the points  $C$  and  $D$  at the centres where eight readings each were taken.

heit, plotted from 32 deg. F. (zero C). Two different temperatures are given in each case, one measured below the roof and the other above. The temperature below the roof is indicated by blacking-in the rectangle drawn, whereas the upper level is shown without the blacking-in. Normally the temperature was higher above the roof and thus in the diagrams 5 the positions shown in black usually terminate below those given for the top. In a few instances these two temperatures were equal, in which case the entire rectangles are blackened. In a few other instances the temperature was higher below than above the roof, in which case the lower portions of the rectangles are left white, whereas the upper portions are shown black.

It is seen that the deflections varied to a great extent during each year and were mainly dependent on the temperature. Obviously, also, sunshine and relative humidity are of some influence. However, it was impossible, as originally intended, to make some distinction between the effect of temperature, sunshine and relative humidity. The latter was ascertained since Autumn 1959 and varied between 36 and 88 per cent relative humidity. The weather in England, as is well known, is very changeable and thus appreciable differences in temperature and humidity occurred often between the levelling of the first and last roof. This accounts for great variations between the minimum at individual measurements.

Sudden changes in temperature caused immediate deviation in deflections as can be seen for the measurements on 4, 16 and 17 June 1958. The sudden increase in temperature on the 16th June and the subsequent reduction brought about immediate changes in the deflections.

Greater variations between maximum and minimum deflections occurred in 1963 after a prolonged sustained loading due to snow in January and February 1963. Already at the loading on 28th December 1962 snow was on the roof, but the deformations differ relatively little from those obtained at investigations without live load. However, greater deviations occurred at the measurements in March 1963. For this reason further investigations were carried out in April and May 1963.
