Fracture and retrofit of Dan Ryan Rapid Transit Structure

Fracture and Retrofit of Dan Ryan Rapid Transit Structure

J.W. FISHER

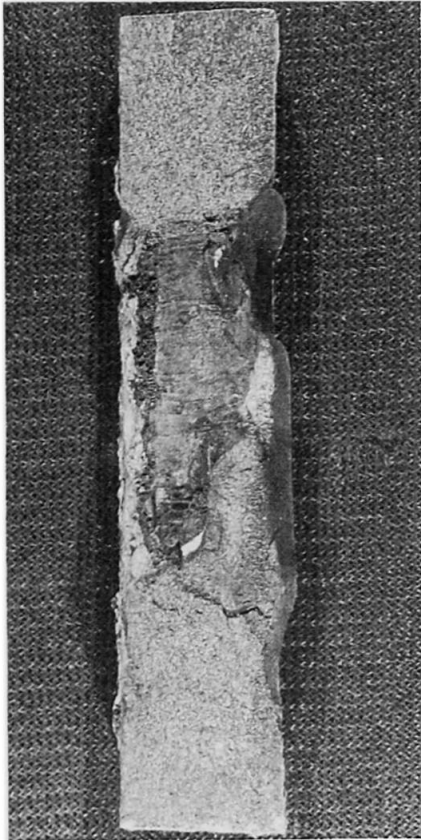
The crack surfaces of the side plates of the box girders adjacent to the flange tip were examined. Chevron markings found on the fracture surface indicated that the crack originated near the tip of the girder flange. A photograph and schematic of one fracture surface are shown in Figs. 3a and 3b. The overall fracture surface shows that the weldment connecting the flange tip to the box had a large lack of fusion area. Paint was found in some of these areas, which had penetrated from the inside of the box. The largest lack of fusion area was approximately 18 mm by 83 mm and was approximately elliptical shaped.

Fig. 3a Fracture Surface of Box Girder Web Plate

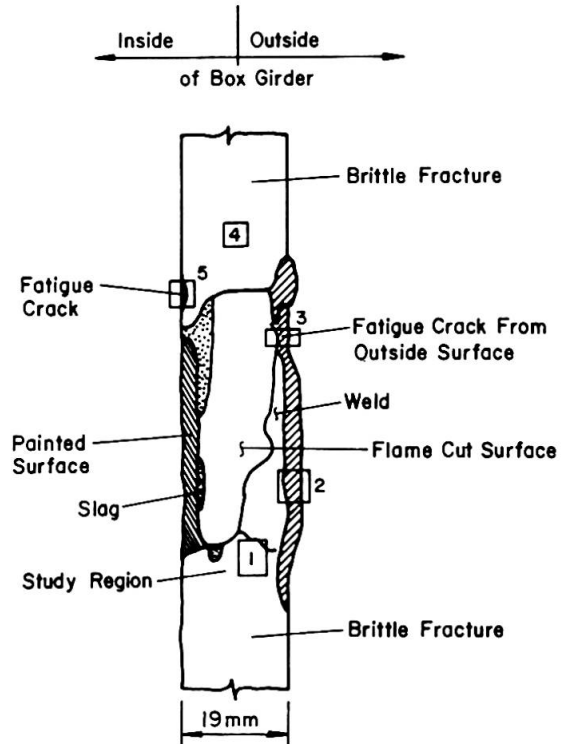
Fig. 3b Schematic of Fracture Surface

Surface replicas were prepared from different locations of the crack surface indicated in Fig. 3b and investigated with the transmission electron microscope. Fatigue striations (see Fig. 4) were found on all three fracture surfaces. These striations represent the extension of the crack front during one load cycle and confirmed the development of fatigue crack growth. Striation markings were found in regions 2 and 3 in Fig. 3b; the measured growth rate was 2.10^{-5} mm/cycle near the exterior surface and 5.10^{-5} mm/cycle near the lack of fusion area. The examination of region 4 near the upper end of the discontinuity showed mainly cleavage fracture with river patterns. The examination of each fracture surface confirmed that fatigue crack growth originated at the lack of fusion area and at the exterior weld surface at the weld toe on the box side plate. It was estimated that about 6 mm of fatigue crack growth was experienced before the cracks became unstable.

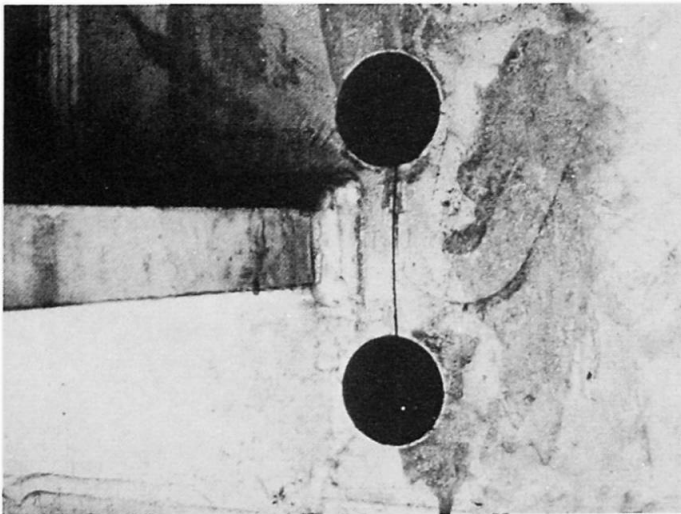
Fig. 6a Retrofitted Box Side Plate

Fig. 6b Schematic of Retrofitted Detail

Any retrofit must minimize the severe stress concentration at the intersection of the girder flange and the box girder webs and reduce the high residual stresses from the weld shrinkage. To accomplish this aim, those locations with small or negligible cracks at the flange tips were retrofitted by cutting holes and sawing between them to create a "dumbbell" configuration in the box side plates near the edges of the girder flanges, as shown in Fig. 6. This method of retrofitting was considered to release the residual stress field at the flange tip and to shield the critical location from the bending stresses.
