Damages Due to Snow Loads

Germund JOHANSSON
Tekn. lic., Lecturer
Chalmers Univ. Technol.
Göteborg, Sweden

Bengt JOHANNESSON
Civ. Eng., Ph.D.
Chalmers Univ. Technol.
Göteborg, Sweden

Structural failures caused by snow loads are discussed. Nearly one hundred failures have been investigated and some examples are given. Nearly all of the structures involved were light-weight steel or timber structures. The failures are mostly due to mistakes in the design or manufacture.

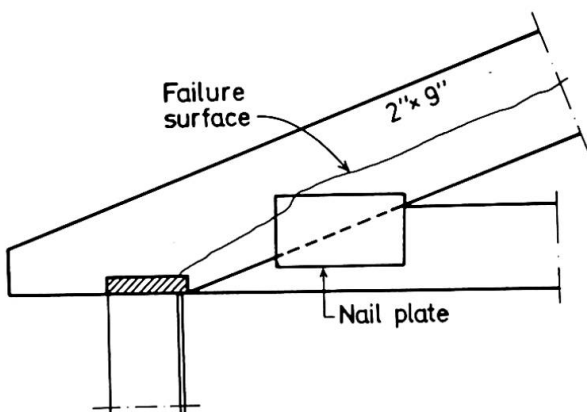
Timber connections with *nail plates* (punched metal plates) are sensitive to misplacements of the nail plates since the plate size often is small. Collapses of roof trusses were found to be due to too small nail plates at the heel joint. These small plates were placed so that cracks could develop in the rafter and then cause a collapse. When nail plates are used it is necessary not only to determine the minimum size of the plate but also to take into consideration the possibility for cracks to develop.

Fig.2 Heel joints with a too small nail plate.

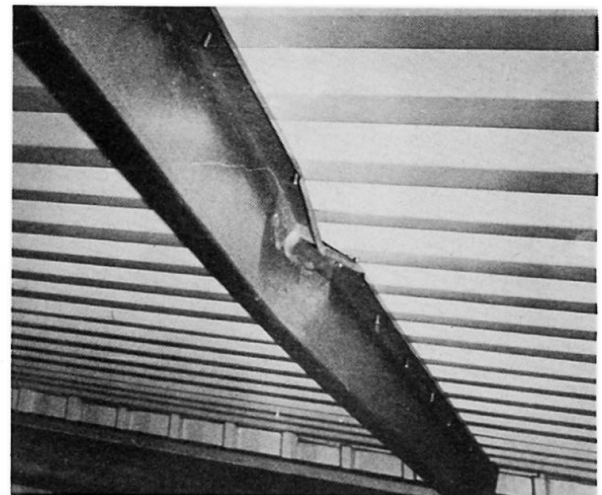
Fig.3 Buckled Z-purlin.

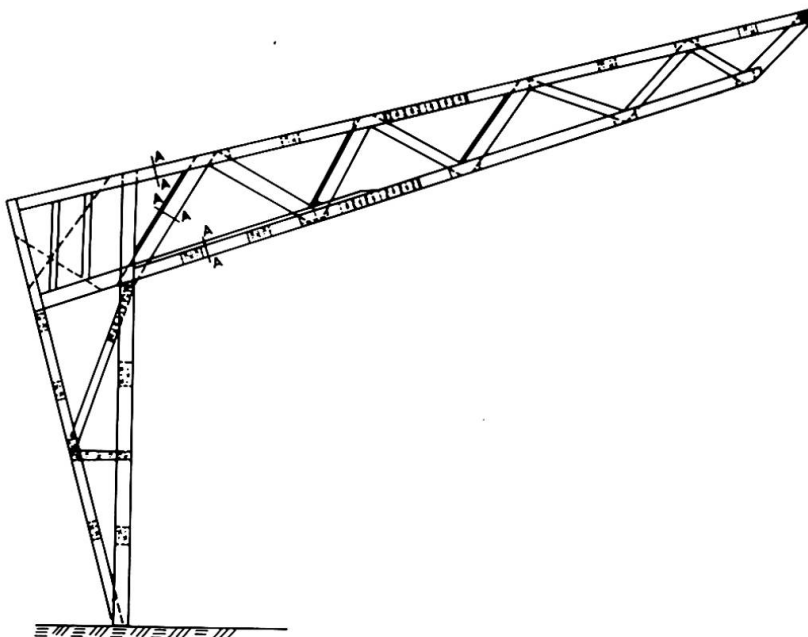
This building was used as a cold storage. The primary structure was a three-hinged wooden truss frame. After about 20 years of service in one place the building was moved to another place. A drawing of one-half of the truss is shown in Fig.4. The flanges in the truss-beam were made of two 2"×5". When the building was moved the contractor cut the frames in the sections A-A (Fig.4). In these joints lap splices of 2"×5" were nailed with just a few nails to each part. The lengths of the lap splices were about 1 m.

The whole building collapsed due to failure in the joints A-A. Probably this was a progressive failure starting in one frame. At failure the snow load was estimated at 1.1 kN/m^2 based on in situ measurements. According to the Swedish Building Code the joint in the tension flange should have been nailed with about 130 nails. The estimated number of nails actually used in the joint correspond to an *allowable* load of $0. \text{ kN/m}^2$ which is less than the dead load $.4 \text{ kN/m}$. 0.3 kN/m^2 . The total load at failure was estimated at 1.4 kN/m^2 .

Fig.4 One half of a three-hinged truss frame, spanning 15.5 m, with joints at A-A.

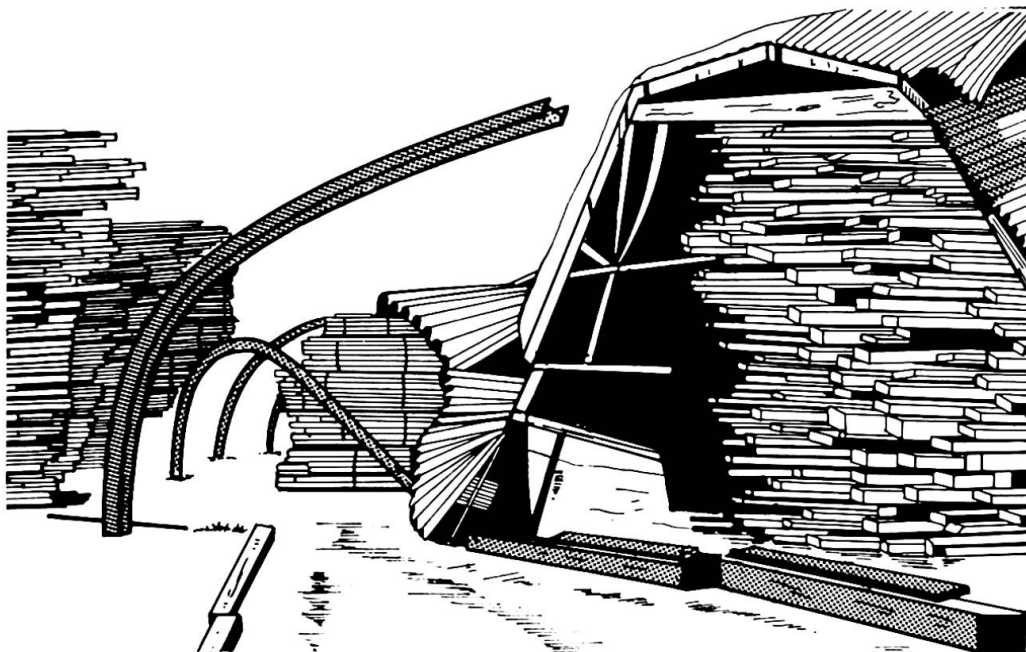
The whole structure collapsed due to overall column buckling (Fig.5). The roof snow depth was 0.55 m. The unit weight of snow varied between 2.6 and 2.9 kN/m³ which means that the roof was subjected to a snow load of approximately 1.5 kN/m².

The column load caused by dead load and snow load was estimated at 360 kN. Assuming Eulers *first* buckling case the column buckling load is 105 kN and the slenderness ratio about 400. On the other hand the buckling load 360 kN corresponds to the buckling length 1.08 times the column length. That is very close to Eulers *second* buckling case. This means that the stiffness of the connections between the columns and the roof girders have a certain influence on the buckling load. It probably also means that the columns were bracing each other due to smaller differences in loads etc.

This case is an example of a poor design. With diagonal bracings the collapse should probably have been avoided.

Fig.5 Buckled columns.
