Seminar 3: Structures to withstand natural disasters: experiences and applications

Zeitschrift: **IABSE congress report = Rapport du congrès AIPC = IVBH
Kongressbericht**

Seismic Damage and Retrofit to California's Urban Concrete Bridge Structures

Frieder SEIBLE

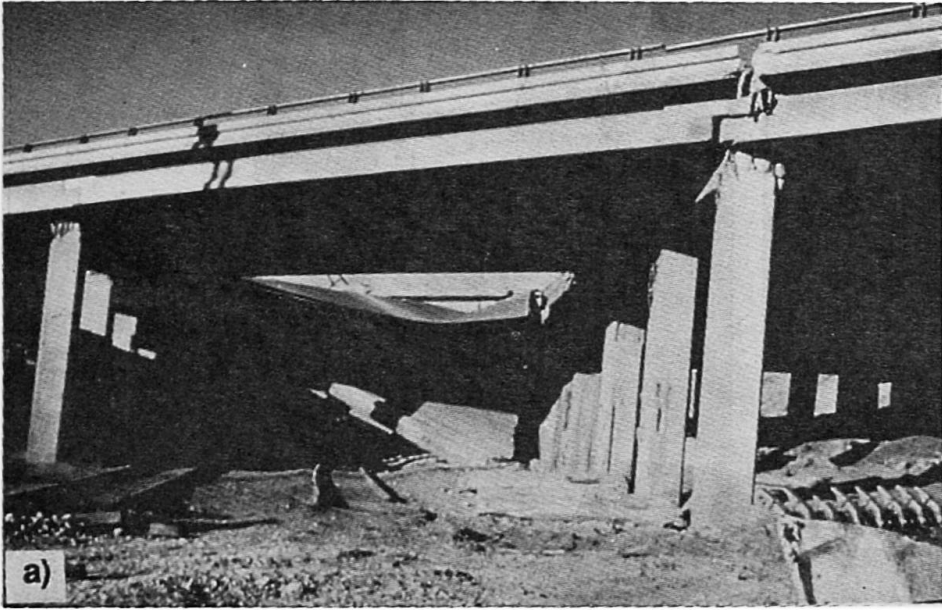
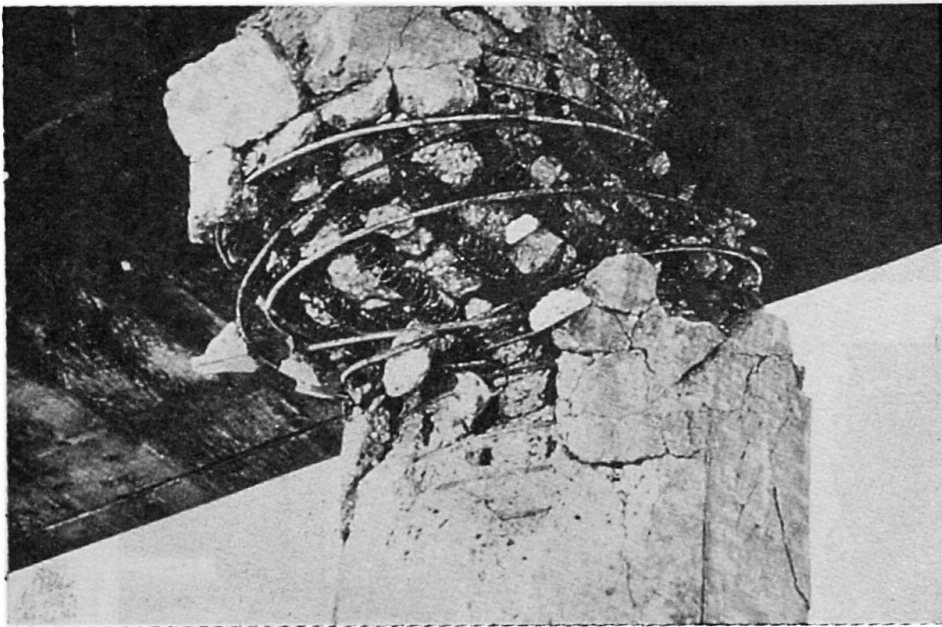
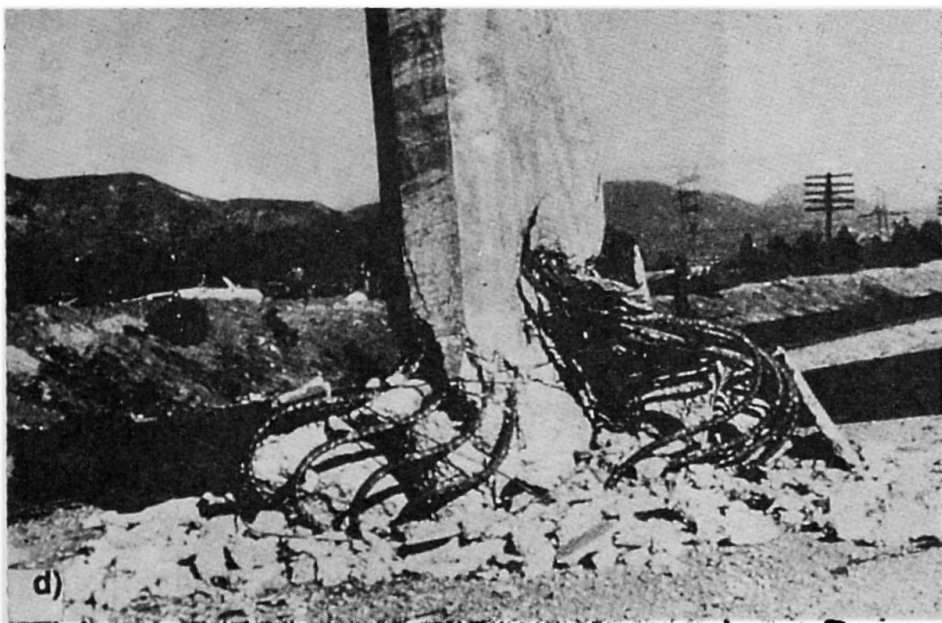
Fig 1. Bridge Damage During the 1971 San Fernando Earthquake

The 1971 San Fernando earthquake caused significant bridge damage, particularly to newly constructed interstate bridges. Key problems identified ranged from excessive seismic displacements and subsequent unseating of complete bridge spans at movement joints, see Figs. 1a and b, inadequate confinement of flexural plastic hinge regions in columns, see Figs. 1c and d, and Figs. 2a and b, anchorage problems with large diameter \varnothing 57 mm (#18) column reinforcement into the footing, see Fig. 2d, brittle shear failure of short columns with insufficient shear reinforcement, see Fig. 1e, and joint failures of knee joints due to the lack of joint shear reinforcement, see Fig. 2c. It is of interest to note that subsequent earthquakes such as Whittier (1987) and Loma Prieta (1989) did not uncover completely new problem areas which were not already identified in San Fernando (1971) but rather reemphasized some of the above mentioned problems.

While design guidelines for new bridge structures were immediately changed to reflect higher seismic force levels, confinement of column concrete particularly in potential plastic hinge regions and increased force and displacement requirements for movement joints, seismic retrofitting of existing bridge structures focussed initially on movement joint restrainers to prevent unseating and span collapse.

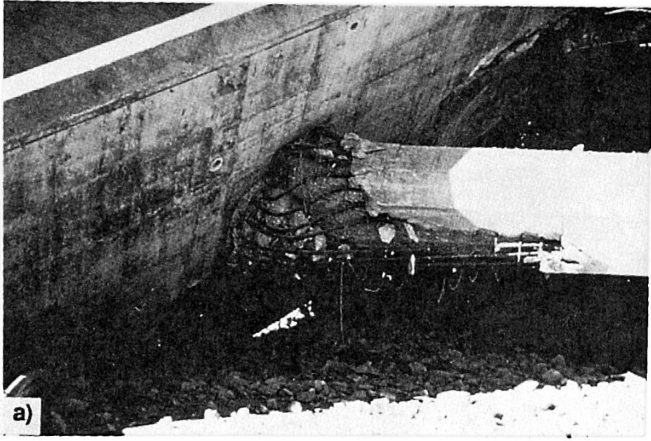
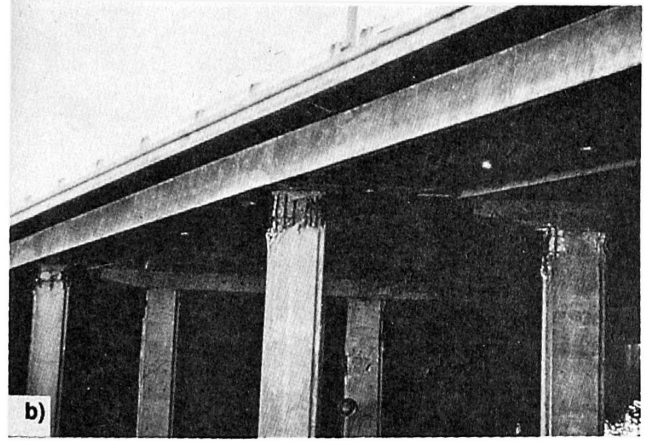
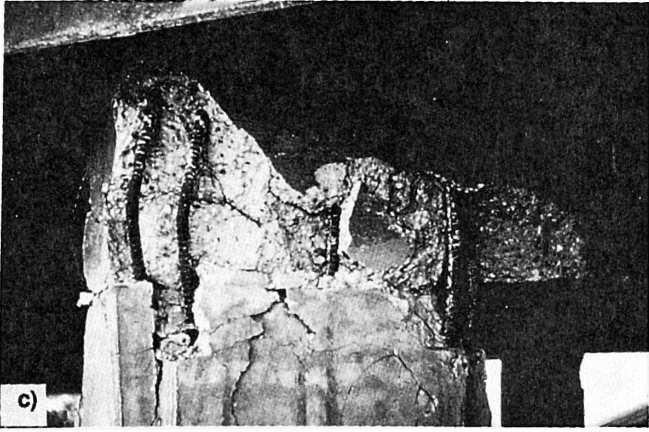
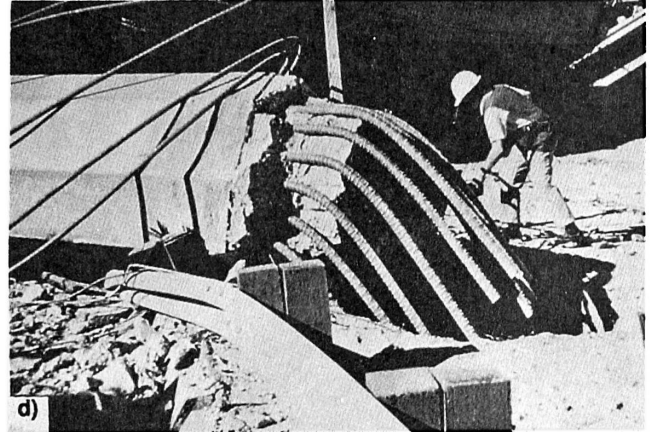
Fig 2. San Fernando Earthquake Bridge Damage (continued)

The Whittier earthquake (1987) caused significant damage only to one urban concrete bridge structure, the I-5/605 crossing where short piers of a skew multi column-bent bridge structure failed in shear. The large number of existing freeway overheads which feature these short piers, designed and constructed prior to 1971, pose probably the most severe seismic bridge hazard in
