Seismic Damage and Retrofit to California's Urban Concrete Bridge Structures

Frieder SEIBLE

Prof. of Struct. Eng.
Univ. of California
San Diego La Jolla, CA, USA

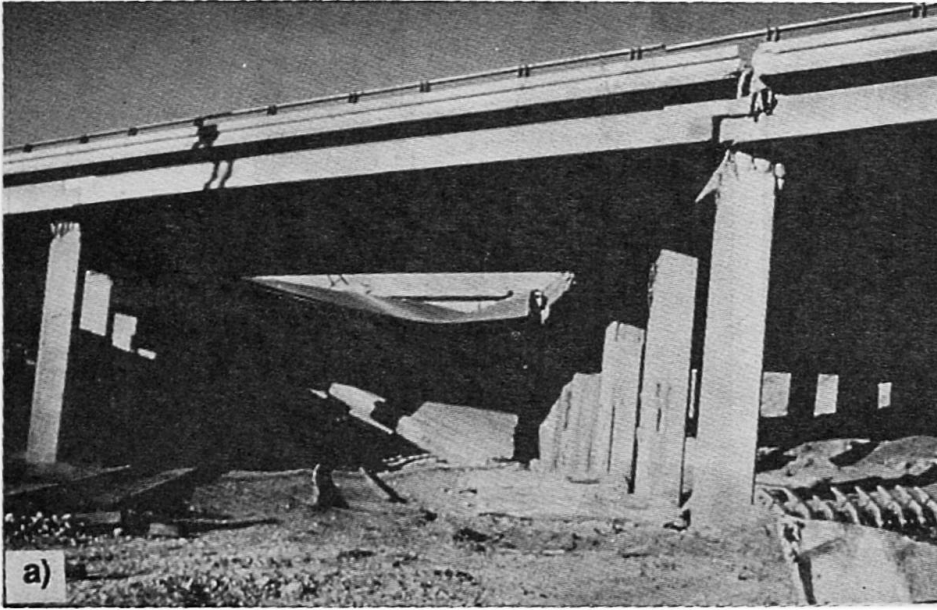
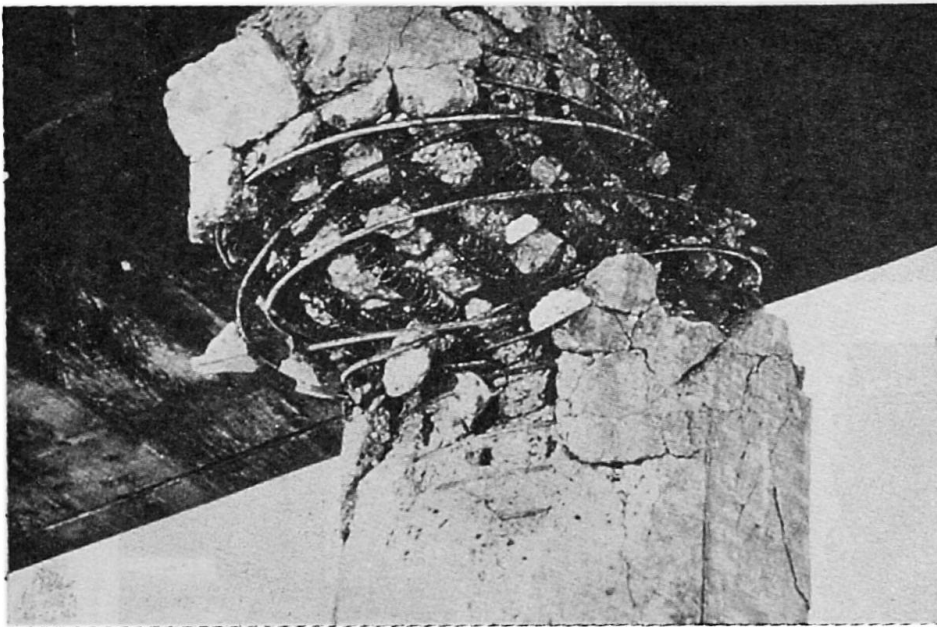
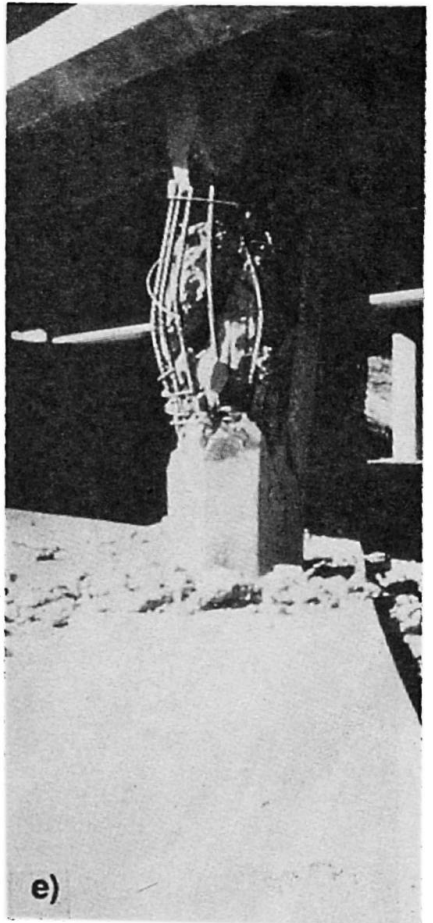
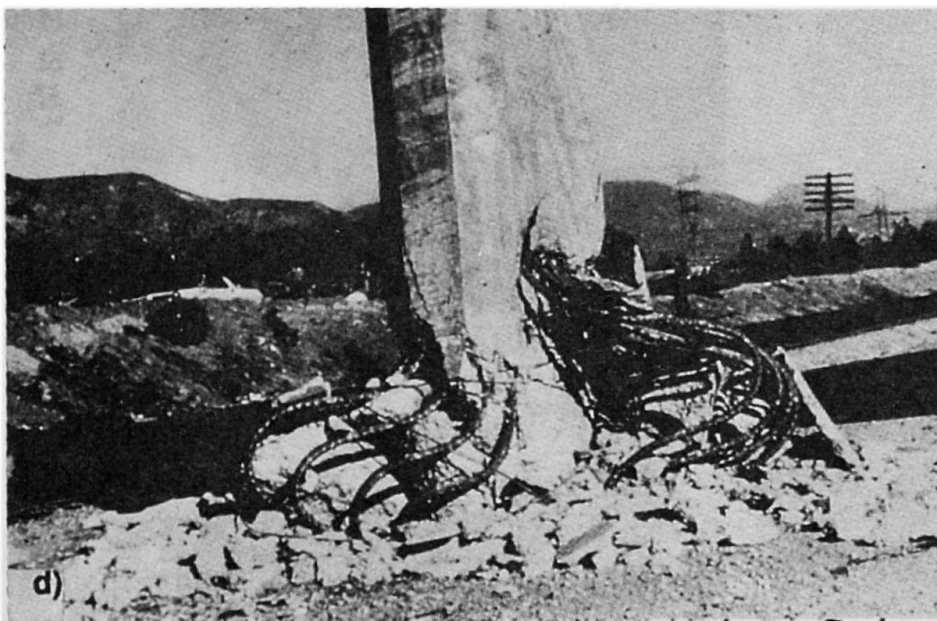
Fig 1. Bridge Damage During the 1971 San Fernando Earthquake

The 1971 San Fernando earthquake caused significant bridge damage, particularly to newly constructed interstate bridges. Key problems identified ranged from excessive seismic displacements and subsequent unseating of complete bridge spans at movement joints, see Figs. 1a and b, inadequate confinement of flexural plastic hinge regions in columns, see Figs. 1c and d, and Figs. 2a and b, anchorage problems with large diameter \varnothing 57 mm (#18) column reinforcement into the footing, see Fig. 2d, brittle shear failure of short columns with insufficient shear reinforcement, see Fig. 1e, and joint failures of knee joints due to the lack of joint shear reinforcement, see Fig. 2c. It is of interest to note that subsequent earthquakes such as Whittier (1987) and Loma Prieta (1989) did not uncover completely new problem areas which were not already identified in San Fernando (1971) but rather reemphasized some of the above mentioned problems.

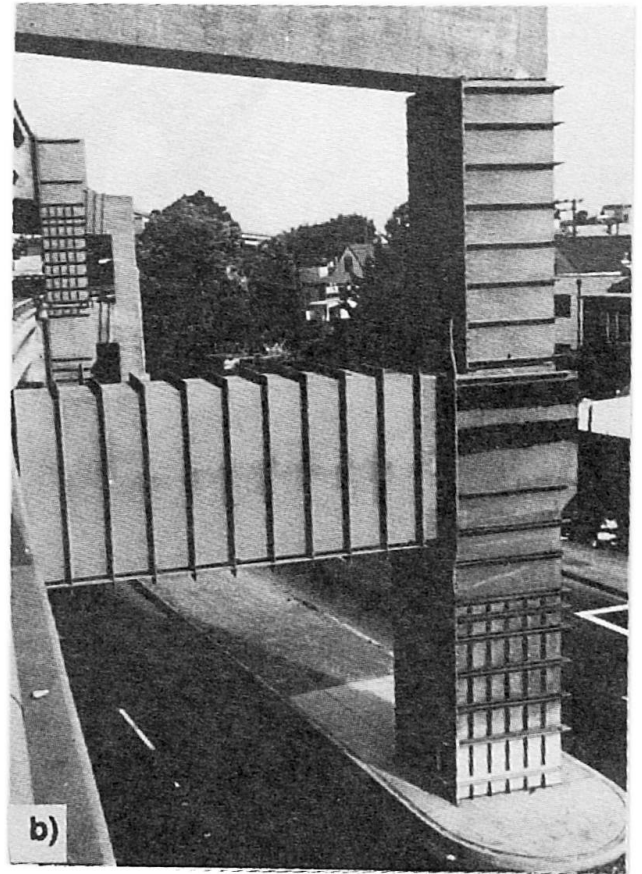
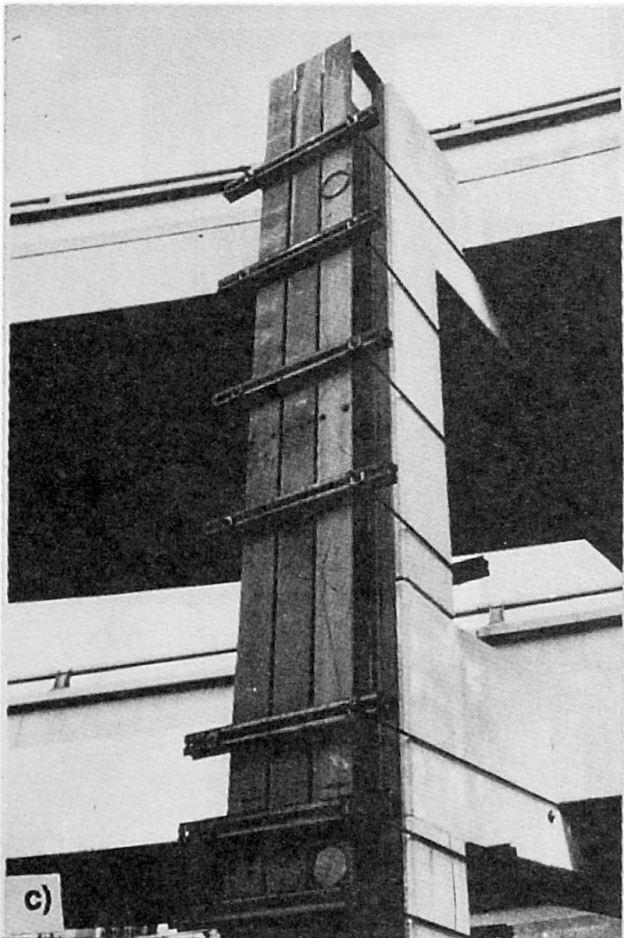
Fig 6. Temporary and Permanent Retrofit Measures

**Full joint replacement
I-980, Oakland, CA**

Following the Loma Prieta earthquake, several double-deck viaducts in San Francisco were closed to traffic and temporary retrofit strategies were designed to prevent collapse in the case of additional seismic activity in the near future. Some of the temporary retrofits were fully or partially implemented, see Figs. 6a, b and c. However, their ineffectiveness in providing required lateral confinement levels and their lack of global structural seismic retrofit strategy, see [3], prompted a reevaluation of these temporary retrofit schemes and resulted in the immediate design of permanent and final retrofit measures, which are currently being scrutinized, proof tested and implemented [3]. The difficulties encountered during the design process of the San Francisco double-deck viaduct retrofits and other ongoing retrofit projects showed the need for the development of consistent seismic assessment and retrofit strategies for bridge structures.
