Zeitschrift: **IABSE publications = Mémoires AIPC = IVBH Abhandlungen**

Band (Jahr): **4 (1936)**

RECORDED FAILURES OF ELECTRICALLY WELDED WROUGHT-IRON AND MILD STEEL BRIDGES.

H. J. L. BRUFF, Bridge Engineer, North Eastern Area, London and North Eastern Railway,
York.

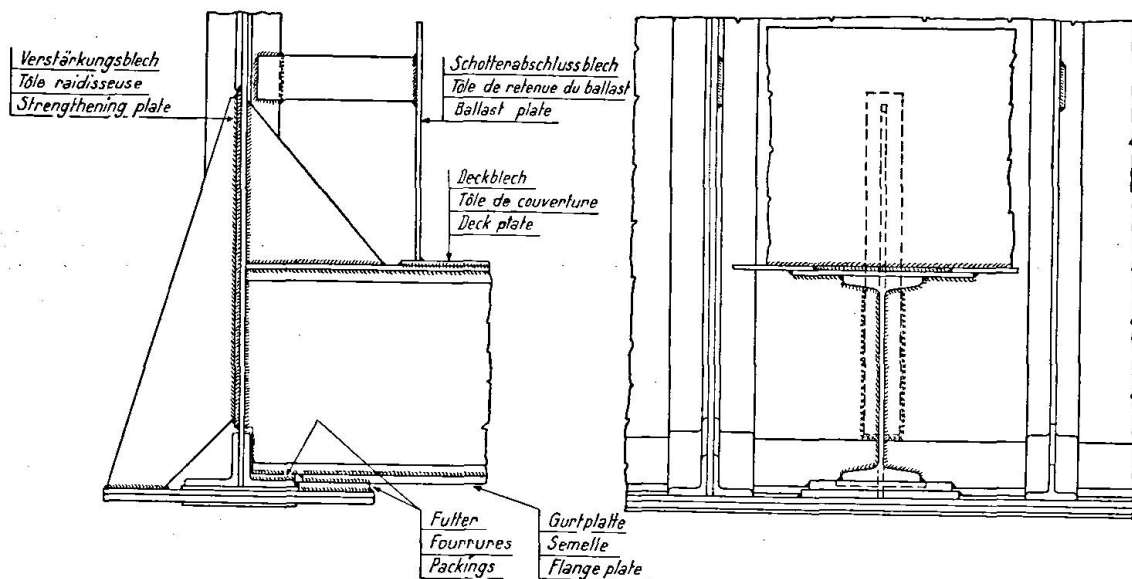
Einzelheiten von Knotenblech- und Stegblechsaussteifungen (Brücke No. 32, South shields Linie).
 Détails des goussets et raidisseurs de l'âme. (Pont n° 32, ligne South shields).
 Details of gussets and web stiffeners. (Bridge N° 32, South shields branch).

The first experience of this type of failure occurred in the case of the reconditioning of a large plate main girder of a wrought iron bridge the floor of which was entirely renewed. As it was necessary to place the new cross girders between the old cross girders, where there were no web stiffeners, provision had to be made at these points for proper distribution of end fixing moments and shear from the cross girder ends. A strengthening plate was therefore welded to the outside of the web of the main girders and a triangular gusset plate welded on to it directly opposite the new cross girder end, as shown on Fig. 1.

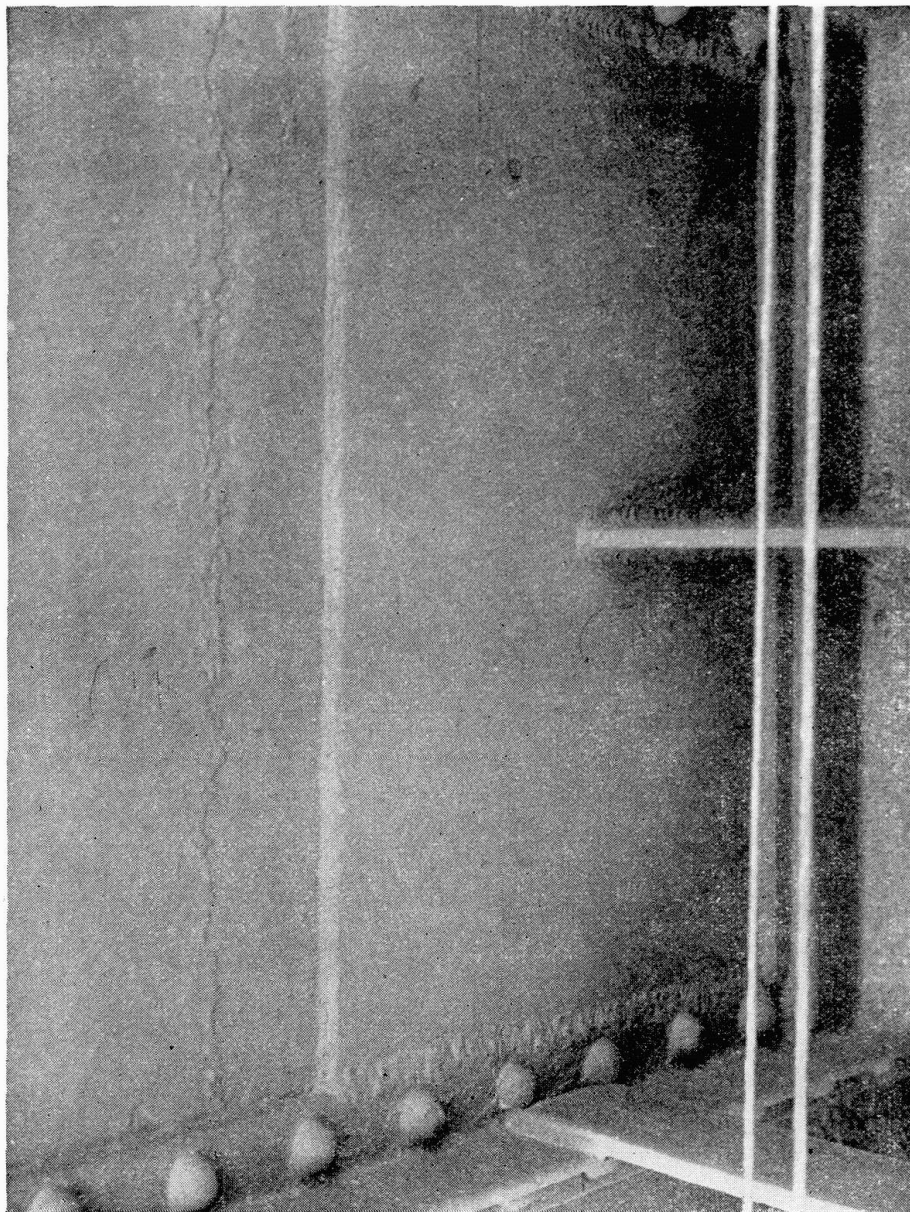
Fig. 4.

In another instance where the webs of the main girders had been holed through corrosion and the webs required to be repaired, fractures took place along the welded seams which were probably due to the contraction of the heated parts of the girder. The failures which were fairly numerous were all identical, being fractures of the vertical butt welds between the new web streng-

thening plate and the toes of the "T" and angle stiffeners. Fig. 4 shows details of construction.

As will be seen from the section it was intended that the welds should not only unite the strengthening plates and the toes of the "T" or angle stiffeners, but also the old web itself. On cutting out the fractured welds, as shown in Fig. 5, it was found, that good penetration had been obtained between the strengthening plate and the "T" but that there was no penetration in the case of the web, as will be seen from the photograph of a part of the "T", strengthening plate and web which were cut out in order that the cause of the fracturing might be ascertained.

The gap between the strengthening plate and the "T" had been prescribed to be $1/16$ ", but apparently this had not been worked to in all cases, the weld cut out was barely $1/16$ " and it appeared that the strengthening plate had not

been in full contact with the web plate. Out of 48 welds 17 were found to be fractured, these were all cut out and in not a single instance had penetration with the web been secured. The practice is now to make the gap $1/16''$ min. the face of the chamfer the same, using a No. 10 electrode with a slightly higher

Einzelheiten von Stegblechreparaturen. (Brücke No. 2, Monkwearmouth Güter-Linie).
 Détails de réparations de l'âme. (Pont n° 2, ligne Monkwearmouth — trains de marchandises).
 Details of repairs to web. (Bridge N° 2, Monkwearmouth Goods Branch).

amperage than normal, which in the case of so light a run is not likely to overheat the mild steel. Fig. 6 shows the repaired girder with removed section (Fig. 5) which was not replaced, the hole was merely fillet welded round the edges as there was ample section left for strength. The bottom flange, which the photo shows covered with gunite, was badly wasted by blast from engines,

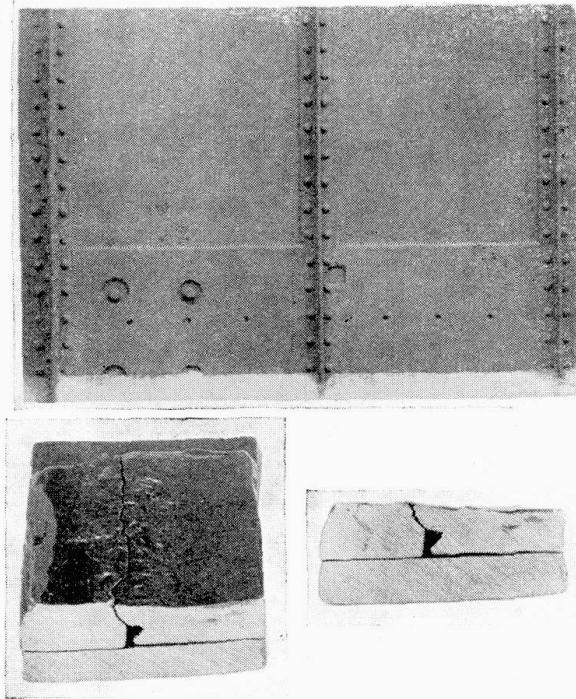
Fig. 5.

Schnitt durch die gerissene Schweißung.
Coupe à travers la soudure rompue.
Section of fractured weld.

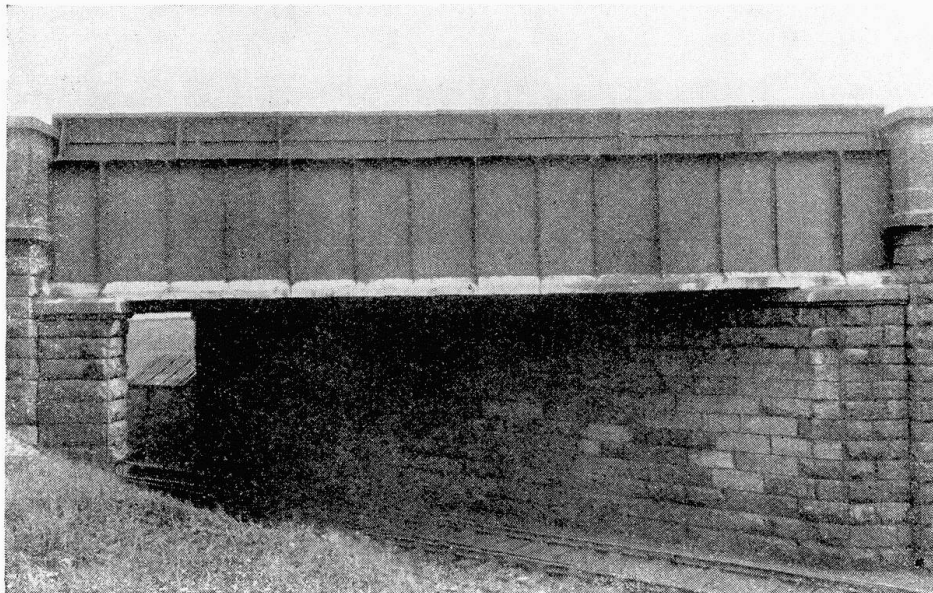
Fig. 6.

Träger mit repariertem Stegblech. — Poutres dont l'âme est réparée.
Girders showing repaired web.

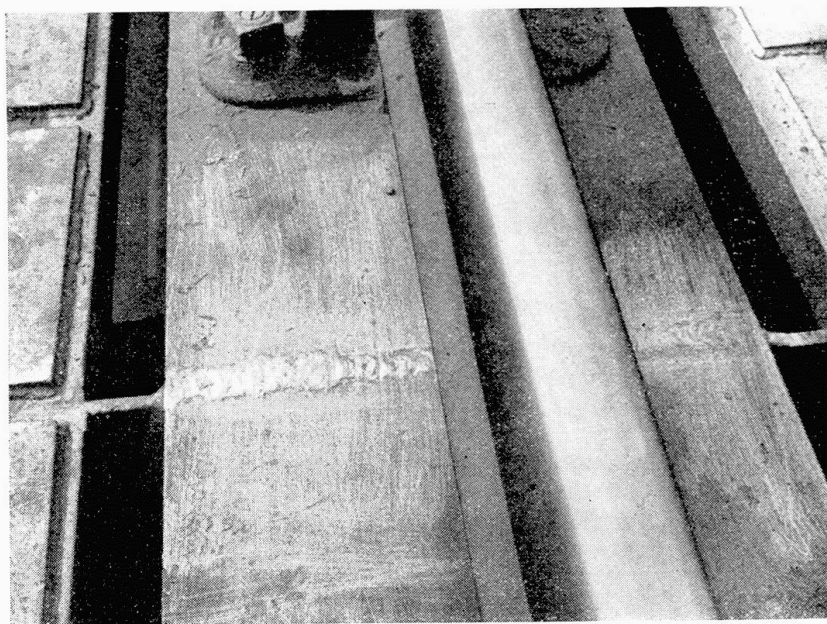
Another failure of similar nature was the fracturing of the butt weld between two channel way beams, of construction as shown in Fig. 7.

The gap intended to be $1/16$ " wide was somewhat wider when fitted and to expedite the work two welders were put on to make the weld. One of the

men had advanced further than the other when they left off for a meal, when shortly afterwards the weld fractured with a loud report. The weld after all the old weld metal had been removed and the butt prepared afresh was rewelded by one man commencing at the centre, working slowly without unduly heating the channels, as it was thought that the unequal and rapid cooling off of the overheated weld had been the cause of the fracture. As this, as well as all the other welds of this construction, all have remained perfect, it is clear, that butt welds of free ended sections must not be allowed to become too hot when being run.

Stumpfschweißung an Längsträger (Schienenträger). (Brücke No. 41, Denaby Linie).
Soudure bout à bout des longerons (sous les rails). (Pont n° 41 de la ligne Denaby).
Butt weld of way beam. (Bridge No. 41 Denaby Branch).

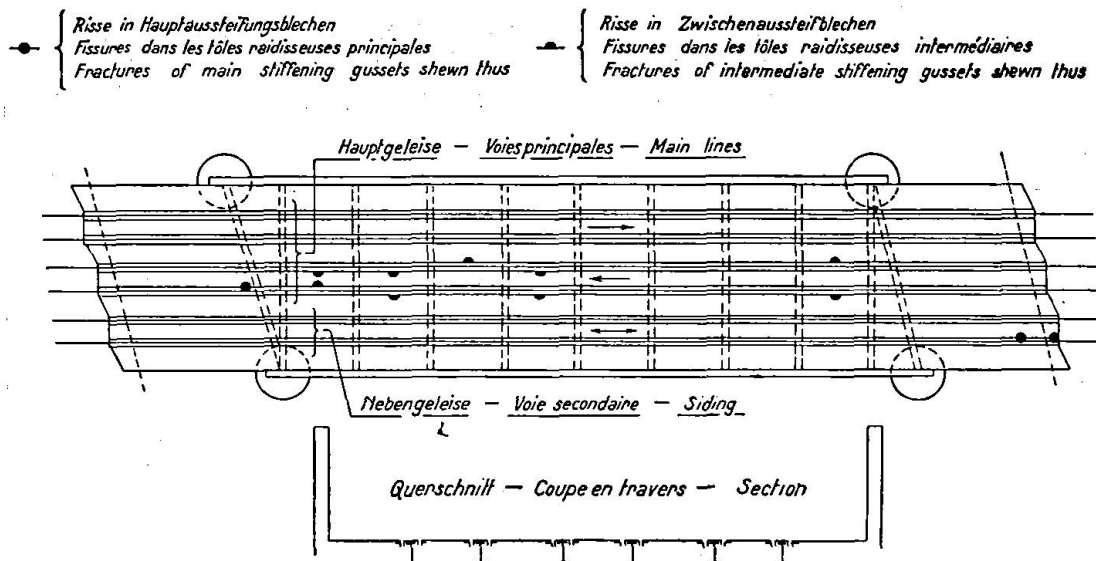
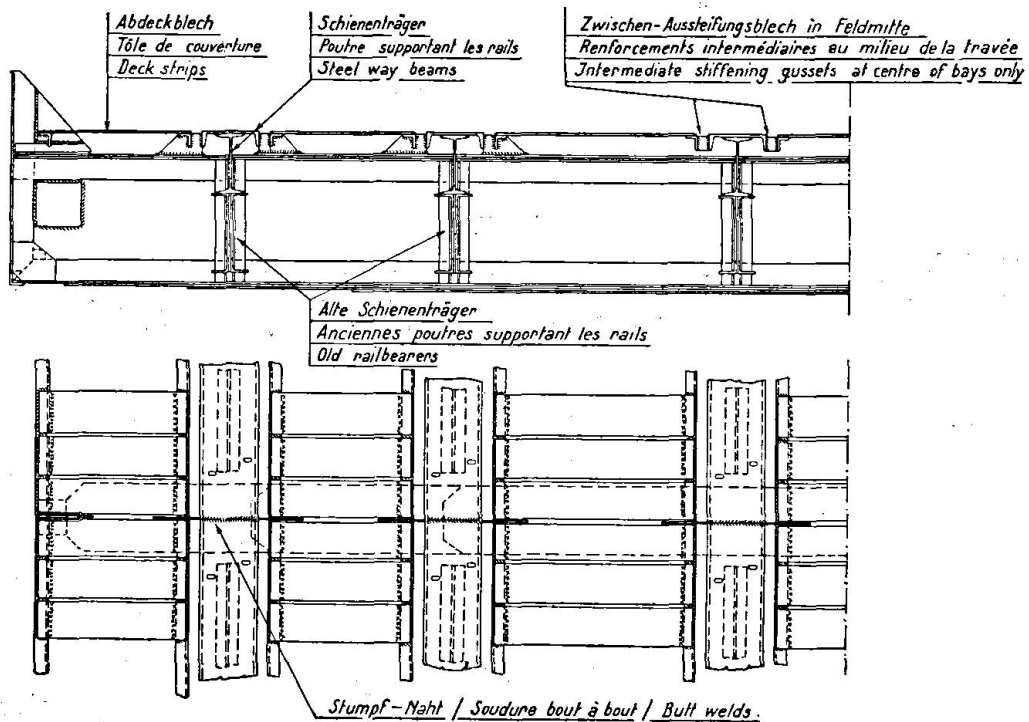
Fig. 8 a

The welded work in question comprised the connections of a welded way beam, illustrated in Fig. 7, further details are shown in Fig. 8.

As will be seen the rails and chairs were bolted to the webs of the steel channels, which again were welded to rolled steel beams resting on the top flanges of the old rail bearers to which they in turn were welded. At each cross girder gusset plates were welded to the vertical channel flanges and to the top flange plates of the cross girders, for the purpose of taking up any side sway

Grundriß und Einzelheiten der Brücke. — Plan et détails du pont.
 Plan and details of bridge.

Similar fractures have also developed where some small tie plates have been welded on to the way beam channels, for the purpose of adding support to the angles carrying the deck strips, the ties being welded on between the deck angles and the channel flanges along four of the channels (see Fig. 8). These ties also take up some side sway of the way beams. Of 348 welds (two to each tie) 10 have fractured, probably due to shock, as they fractured shortly after the centre track, where they were located, was brought into use. On close examination of the fractures it has been found that the welds are all indifferently

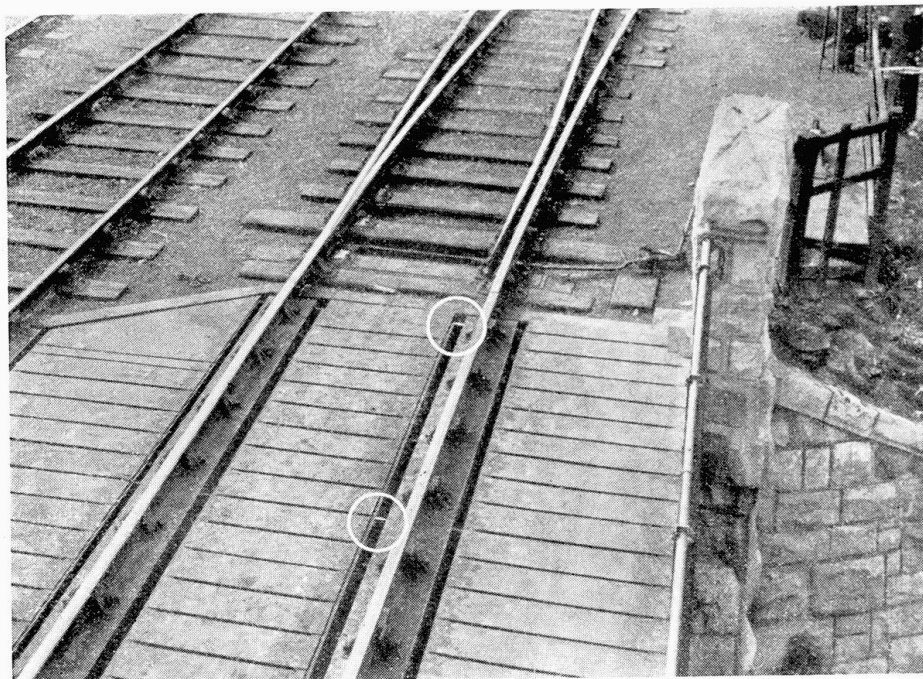
of the steel way beams (consisting of the rolled steel beam and the channel). Two of these gussets at one end of the bridge, where there is a switch, have fractured. The position of the fractures are indicated on Fig. 7 and on the photograph of the bridge end, Fig. 9.

As will be noted the position of the fractured gussets occur on the convex side of the curve, where tension will be produced through the rigidity of the wheel base of engine counteracting the centrifugal action. A close up photograph of the fracture is shown in Fig. 10.

Brückenende und Weiche. Lage der Risse.
Extrémité du pont et aiguille. Emplacement des fissures.
Bridge end and switch. Position of fractures.

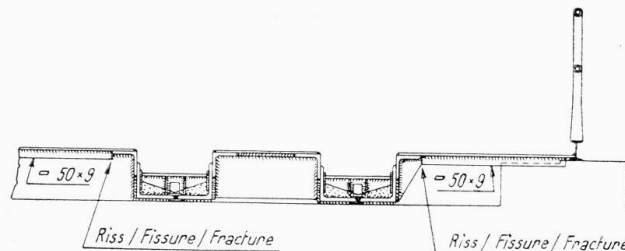
Fig. 11.

The bridge shown in Fig. 11 has a steel deck which is stiffened with $2" \times 3/8"$ flats on edge. Besides these there are transverse diaphragms between the two sets of troughs. When erected it was found that the brick abutments

when bared were not very good, showing fractures below the bedstones on which the troughs would be seated. The bedstones were carefully levelled before the girders were erected on them, but possibly owing to the more rigid construction and absence of cushioning due to steel bearers instead of timber way beams in the troughs, the fractures in the abutments increased and caused unequal depression of the girder ends which set up transverse bending moments

in the deck stiffeners, which were not anticipated. Such transverse bending moments would be additional to the bending moments caused by deflection of one set of troughs when one trough was loaded and the other was not simultaneously loaded by passing traffic.

Halber Schnitt durch die Brücke. (Brücke No. 25, York und Doncaster).
 Demi-coupe à travers le pont. (Pont n° 25, York et Doncaster).
 Half section through bridge. (Bridge N° 25, York and Doncaster).

As mentioned above the bridge carries two separate main lines, and is therefore very busy, the average number of trains per 24 hours being 250 representing about $5\frac{1}{2}$ million stress variations annually, the traffic being about the same in both directions. Under these circumstances it will be realised that the enormous frequency of stress reversals which occur will tend to produce fatigue effects in parts unduly stressed. From the construction it will be appreciated that severe stresses must be set up in the transverse stiffeners of the deck plates duo to such unequal deflections, which are enhanced by the settlement of the bedstones.

The welds connecting the deck plates and the $2" \times 3/8"$ stiffeners are not very large and even normally they are rather heavily stressed, with the consequence that 19 out of 20 have fractured.

heavy steel grillages embedded in concrete are now always provided. These grillages are most carefully and truly set, so as to reduce unequal settlement of adjoining troughs to a minimum. In addition to the grillages the stiffeners for the deck plates are not carried through and welded to the flanges, thereby permitting the deck plates to flexure and so give a little play which absorbs unequal deflections.

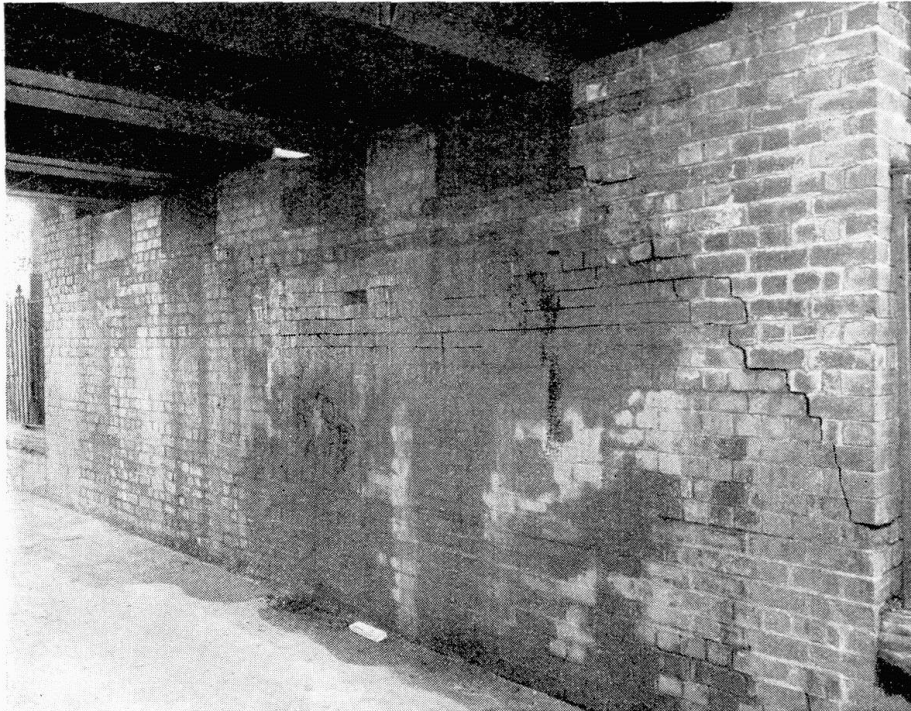
Fig. 12.

Gerissenes Widerlager. — Culée fissurée. — Fractured abutment.
