**Artikel:** Strengthening the foundations of a building in Helsinki (Finland)  
**Autor:** Varstela, I. / Roitto, P. / Haapala, M.  
**DOI:** <https://doi.org/10.5169/seals-20917>

## 8. Strengthening the Foundations of a Building in Helsinki (Finland)

**Owner:** *Säästöpankkien Keskus-Osake-Pankki SKOP*

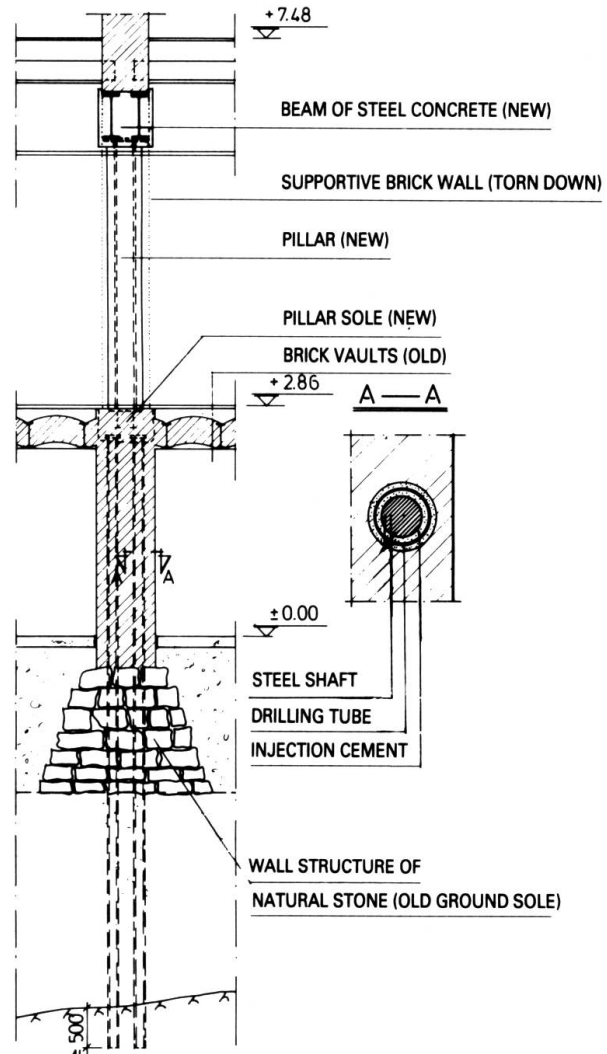
*Fig. 1 Location of piling in the basement wall*

The solution finally adopted was that the piles were driven from the ground floor level, through and within the walls of the basement restaurant level. Fig. 1 shows the applied solution. Through excavations in the supportive brick walls, later to be removed, holes were sunk vertically through the basement walls. The drilling was continued through the old foundations of natural stone, and further down, each drilling to penetrate no less than

0.5 metres into solid bedrock. The tubes used in the drilling process,  $\varnothing 140 \times 4.0$ , were left in position. The actual supportive piles, steel shafts, were then sunk into these holes, with each hole being filled with injection cement before insertion of the piles. Each steel concrete pillar is supported on a group of 3-5 such piles. The total length of piling was some 700 metres, with an average pile length of 7 metres, 2.5 metres of which was contained inside the brick walls of the basement restaurant. The piles were assembled on site from lengths of 1.5 metres, joined together by welding fig. 2.

The pile material was  $\varnothing 100$  solid steel shaft with the tensile strength classification Fe 37 B (lower yield point limit  $220 \text{ N/mm}^2$ ). The pile was dimensioned to form a slim supportive structure, with the surrounding earth as a flexible support. The permissible pile stresses thus achieved were 400 and 570 kN, depending on the length of the subterranean portion of each pile. The geotechnical supportive properties of such a pile is, according to Finnish regulations,  $90 \text{ MN/m}^2$ , which gives a permissible P value/pile ( $\varnothing 100 \text{ mm}$ ) of 707 kN.

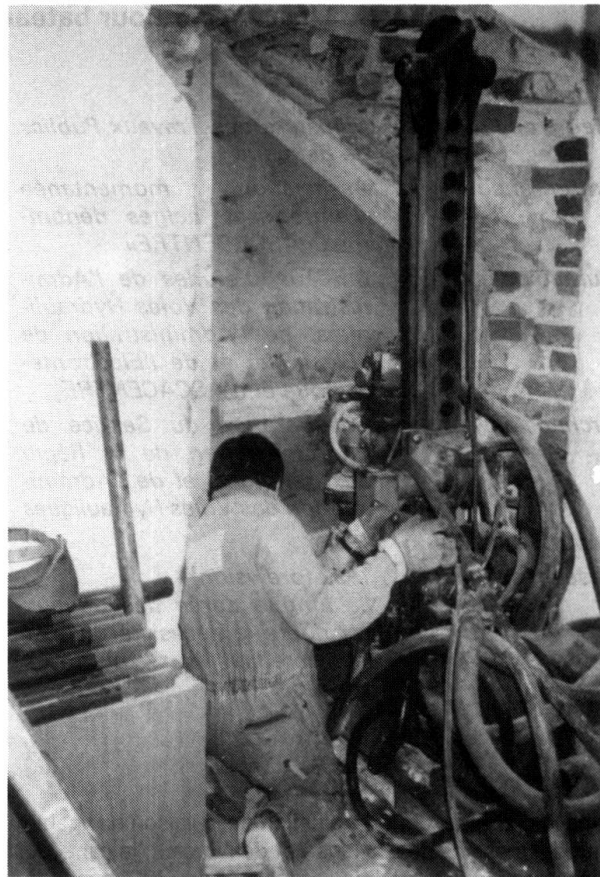
*Fig. 2 Through excavations in the supportive brick walls holes were sunk vertically through the basement walls.*
