Artikel: Repairing work of the Käyräjoki Bridge (Finland)
Autor: Huura, Jorma / Falck, Kalevi
DOI: <https://doi.org/10.5169/seals-20923>

4. Repairing Work of the Käyräjoki Bridge (Finland)

Owner and contractor: Roads and Waterways Administration
District of Kymi

Designer of the repairing works: Consulting Engineering Company
Jorma Huura Ky, Tampere, Finland

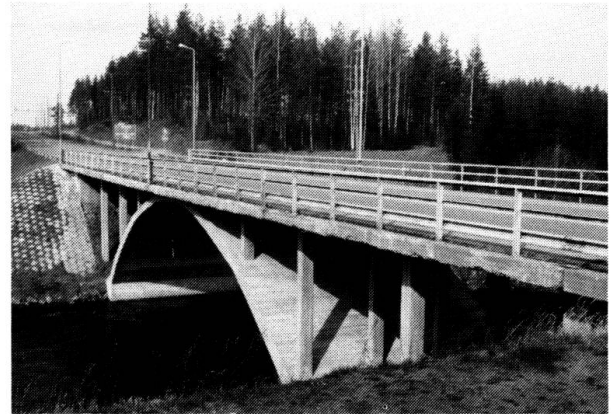
Fig. 1 The Käyräjoki bridge before repairing

The Käyräjoki bridge (Fig. 1) is located in a dell which causes that water is flowing on to the bridge more than otherwise. During wintertime the bridge is exposed to the salt-frost action. The bridge was built in 1963 when concrete was not air entrained. Consequently the concrete in the edge beams was scaling very badly twenty years after construction of the bridge.

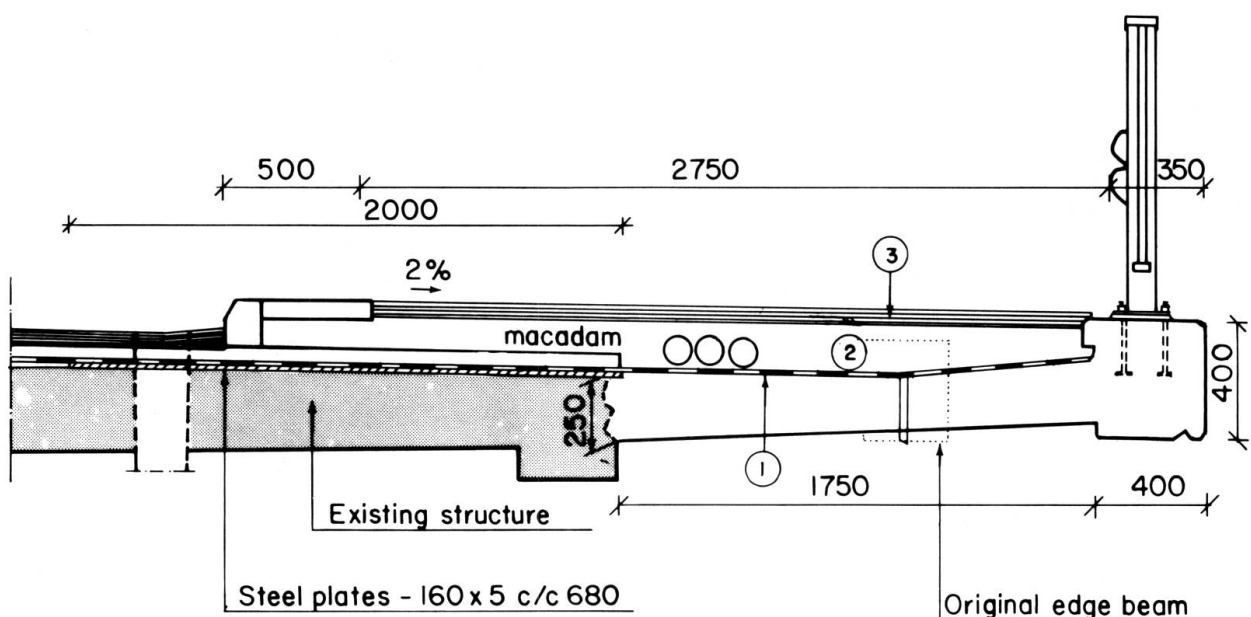
Fig. 2 The cross section of the cantilever edge with the clued steel plates

The edge of the existing structure was strengthened by two-meter-long steel plates which were clued by epoxy resin to the surface of the bridge deck (Fig. 2). The thickness of the joint between the plate and the concrete surface was 1 mm. Epoxy resin was injected into the joint. The shear strength requirement of the epoxy resin was 1.0 MN/m^2 . The injection was done before removing the moulds and the scaffoldings. The work was based on the research done by Technical Research Centre of Finland. The corresponding method has been used afterwards successfully in various repairing works.

The protecting and surfacing layers of the repaired bridge deck were accomplished as follows (Fig. 2):

1. The waterproofing was made of rubberbitumen membrane, which was covered by ordinary bitumen sheets.
2. The levelling and drainage layer was made of macadam (without binder).
3. The wearing course was laid of asphaltic concrete.

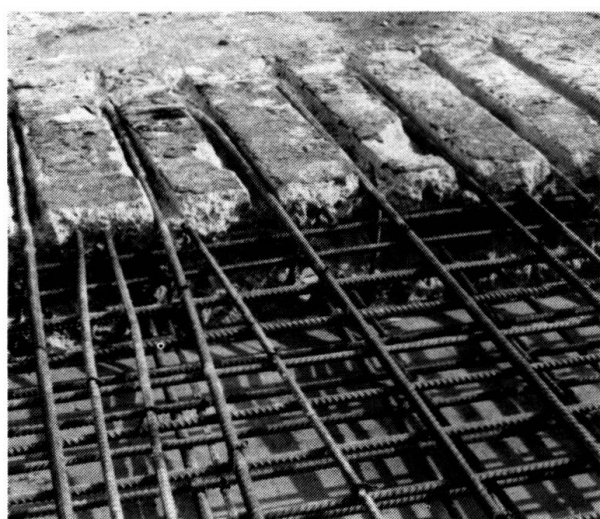
Fig. 3 The reinforcement of the cantilever

The reinforcement bars of the old structure were exposed about one meter and the new bars were anchored into the old concrete structure (Fig. 3). The quantity of the cement in concrete was 300 kg/m^3 and the water-cement ratio was 0,50. The size of the aggregate was between 0 and 16 mm. Air entraining agent (aircontent 4,5–5,5%), plasticizer and retarder (retardation 24 h) were used. The concreting work started at noon and the work was finished the following morning at 6 o'clock. The air temperature was between +15 and +18°C.

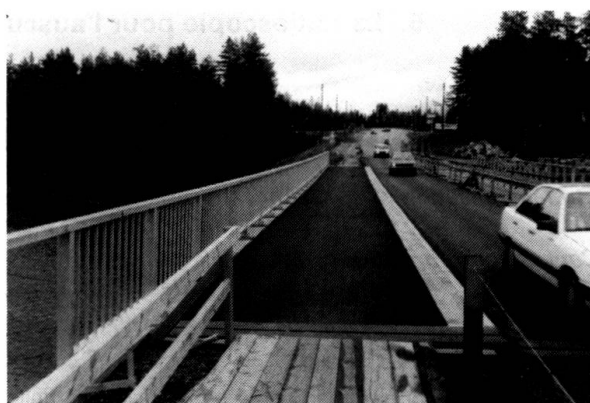
Fig. 4 The new sidewalk after the repairing work

The repairing work was made five years ago and the concrete structures are still in good condition. It is amazing that there are no cracks in the slender edge cantilever whatsoever.
