Repairing work of the Käyräjoki Bridge (Finland)

4. Repairing Work of the Käyräjoki Bridge (Finland)

Owner and contractor: Roads and Waterways Administration
District of Kymi

Designer of the repairing works: Consulting Engineering Company
Jorma Huura Ky, Tampere, Finland

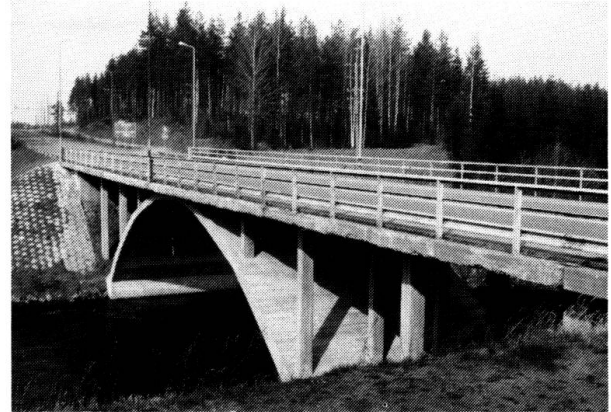
Fig. 1 The Käyräjoki bridge before repairing

The Käyräjoki bridge (Fig. 1) is located in a dell which causes that water is flowing on to the bridge more than otherwise. During wintertime the bridge is exposed to the salt-frost action. The bridge was built in 1963 when concrete was not air entrained. Consequently the concrete in the edge beams was scaling very badly twenty years after construction of the bridge.

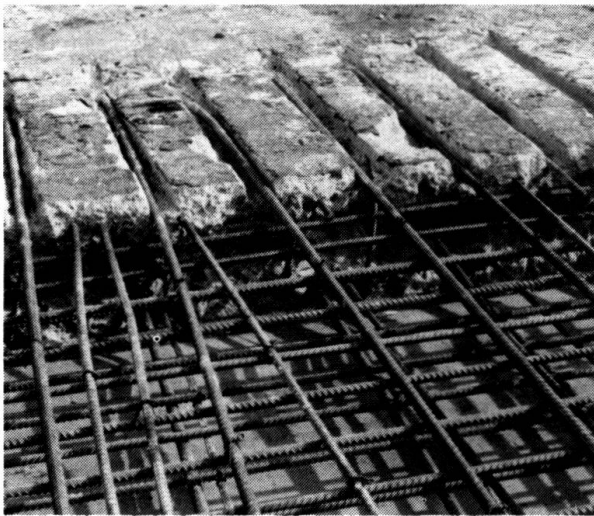
Fig. 3 The reinforcement of the cantilever

The reinforcement bars of the old structure were exposed about one meter and the new bars were anchored into the old concrete structure (Fig. 3). The quantity of the cement in concrete was 300 kg/m^3 and the water-cement ratio was 0,50. The size of the aggregate was between 0 and 16 mm. Air entraining agent (aircontent 4,5–5,5%), plasticizer and retarder (retardation 24 h) were used. The concreting work started at noon and the work was finished the following morning at 6 o'clock. The air temperature was between $+15$ and $+18^\circ\text{C}$.
