Repairing work of the Käyräjoki Bridge (Finland)

4. Repairing Work of the Käyräjoki Bridge (Finland)

Owner and contractor: Roads and Waterways Administration
District of Kymi

Designer of the repairing works: Consulting Engineering Company
Jorma Huura Ky, Tampere, Finland

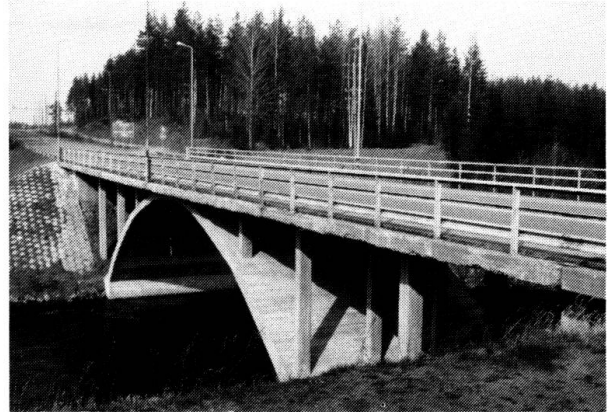
Fig. 1 The Käyräjoki bridge before repairing

The Käyräjoki bridge (Fig. 1) is located in a dell which causes that water is flowing on to the bridge more than otherwise. During wintertime the bridge is exposed to the salt-frost action. The bridge was built in 1963 when concrete was not air entrained. Consequently the concrete in the edge beams was scaling very badly twenty years after construction of the bridge.
