# Off ramp of Hanshin expressway in Osaka (Japan)

## 7. Off Ramp of Hanshin Expressway in Osaka (Japan)

**Owner:** Hanshin Expressway Public Corporation  
**Consultant:** Prof. Dr. K. Horikawa  
**Contractor:** Takara Giken Co. Ltd.  
**Work's duration (Field work):** 4 months (2 weeks)  
**Repair date:** 1985

### Reshape of End Part of Plate Girder Bridge

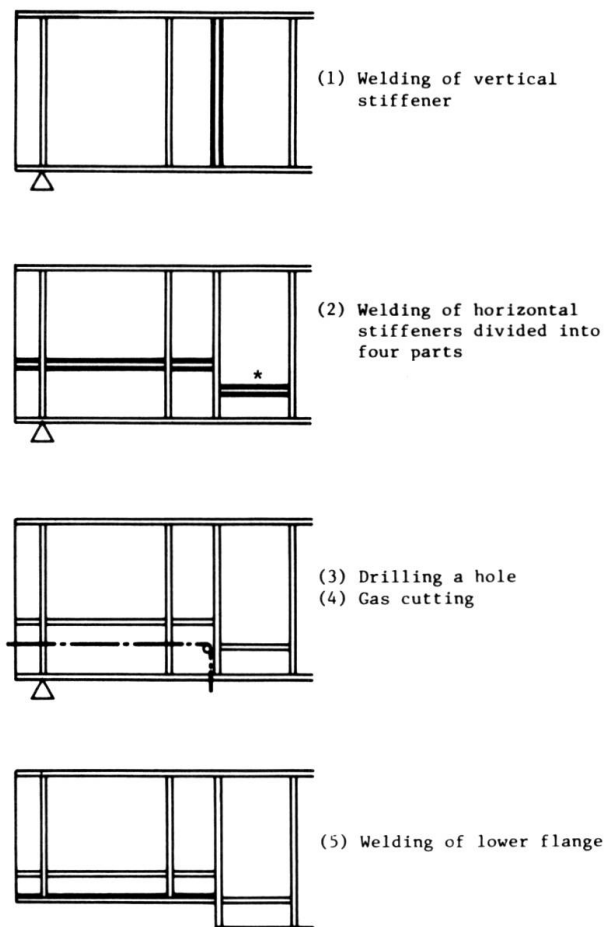
Fig. 2 Recommended procedures

From the above results, the procedures for the repair to be recommended are as shown in Fig. 2.

- 1) Firstly, welding of vertical stiffener
- 2) Secondly, welding of horizontal stiffeners  
It is desirable that the stiffeners marked by \* in Fig. 2 is welded on the same level as the lower flange fixed in stage 5) and welded to the next vertical stiffener.
- 3) Then drilling of a hole
- 4) And gas cutting
- 5) Finally, welding of lower flange

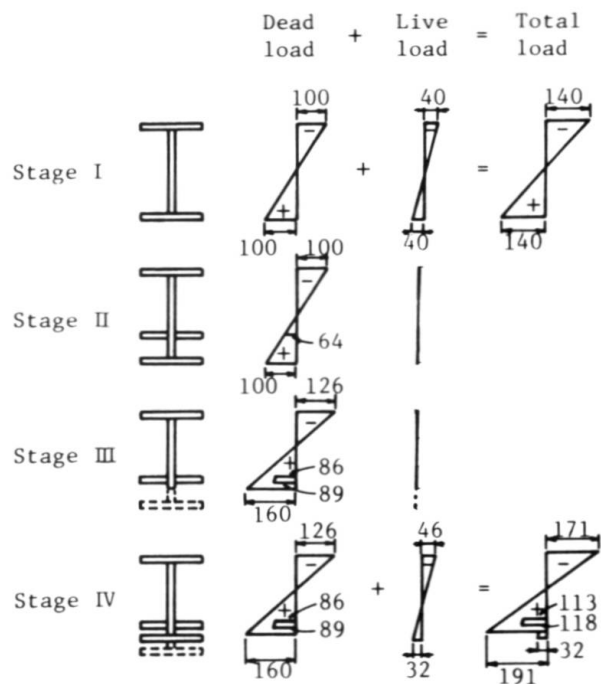
Assuming an existing girder with the same proportion as the model, the stresses on each stage are considered to be as shown in Fig. 3.

- Stage I: Original section.  
Assume the stresses due to the dead load and the live load as shown in the figure.
- Stage II: Welding of stiffeners.  
The live load is not considered, because there is no traffic. The stress due to the dead load does not change.

- Stage III: Gas cutting.  
The stress, that exists in the section to be cut off, is redistributed. Also, the force is shared by horizontal stiffeners. The stress after redistribution can be calculated from the following three conditions.

- 1) Difference of strains exists between stiffeners and web.
  - 2) The integral of moment by the stresses equilibrates with the external moment.
  - 3) The integral of the stresses is equal to zero.

- Stage IV: Welding of lower flange.  
The stress due to the dead load does not change. The entire section is effective to resist the live load.
- The existing bridge after the repair is shown in Fig. 4.

Fig. 3 Schematic example of stress (MPa)

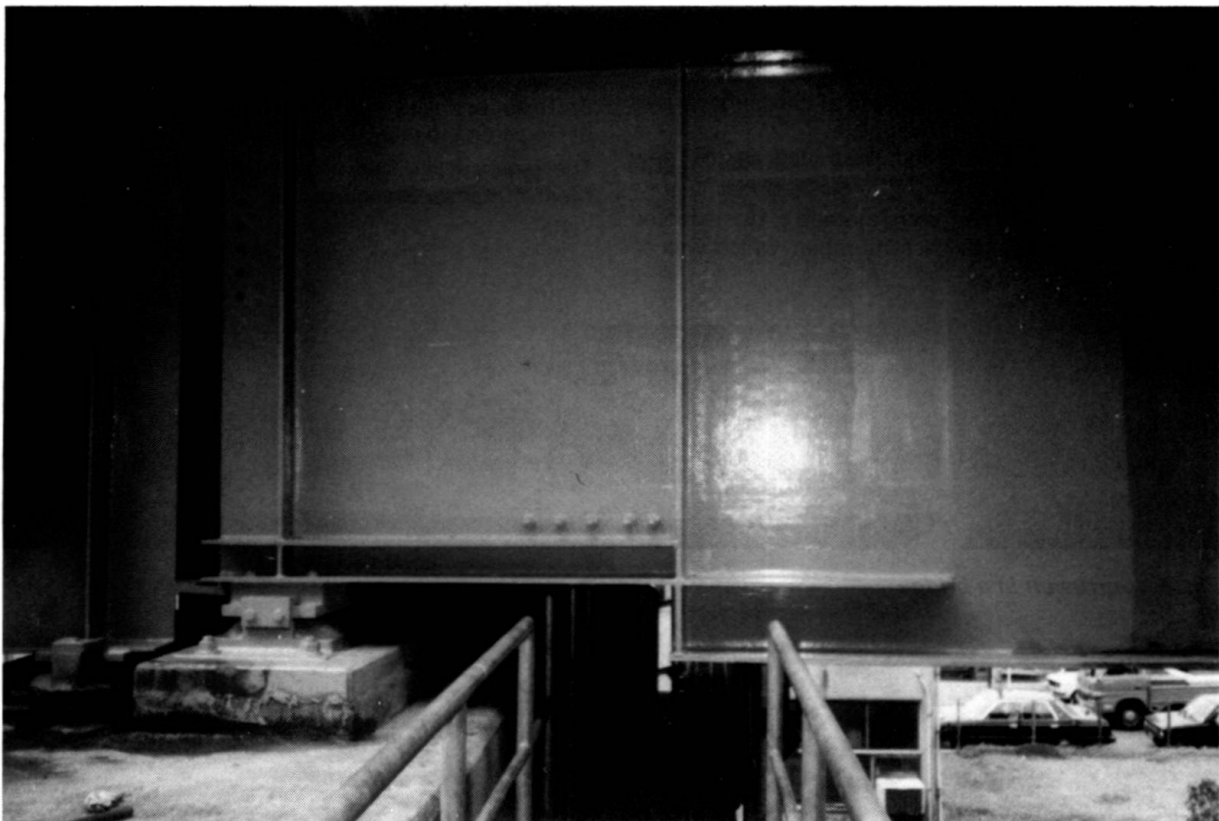
Fig. 4 Existing bridge after remedy
