Off ramp of Hanshin expressway in Osaka (Japan)

7. Off Ramp of Hanshin Expressway in Osaka (Japan)

Reshape of End Part of Plate Girder Bridge

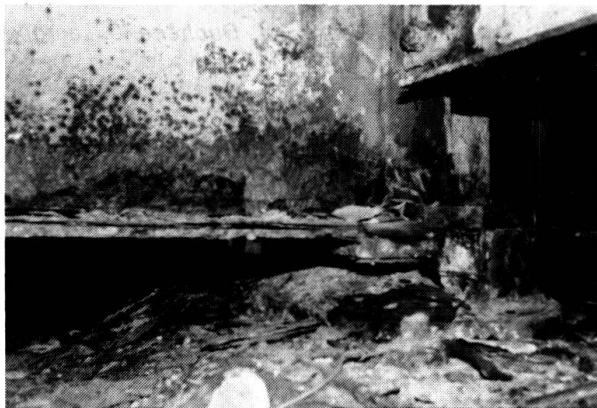
Corrosion is one type of damages in steel bridges in service and is apt to occur near expansion joints, bearing shoes and so on. In these parts, the thickness of members decreases by corrosion. In an extreme case, the fillet welds between web and lower flange are lost, as shown in Fig. 1. The cause of this example was considered to be the leakage of water with free lime because stalagmite was found on the lower surface of slab and water dropped even on a fine day.

Fig. 1 An example of corrosion

- 1) Cutting off the corroded part, then a new member with T section is connected using H.T. bolts.
- 2) Cutting off the corroded part, then a new member with T section is connected using welding at site.
- 3) Cutting off the corroded part, then only a new lower flange is connected using welding at site. As a result, the plate girder is reshaped from uniform section to non-uniform section.

These procedures have both merits and demerits. However, procedure 3) has merit for repair of bearing shoes, because the working space is secured after the reshape work, and the safety of structure is maintained during the repair.

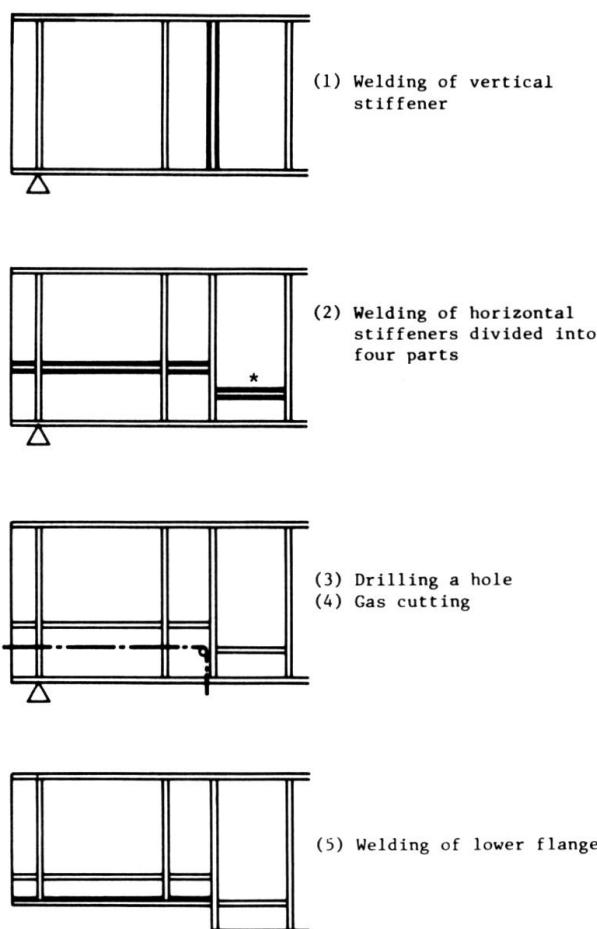
Fig. 2 Recommended procedures

From the above results, the procedures for the repair to be recommended are as shown in Fig. 2.

- 1) Firstly, welding of vertical stiffener
- 2) Secondly, welding of horizontal stiffeners
It is desirable that the stiffeners marked by * in Fig. 2 is welded on the same level as the lower flange fixed in stage 5) and welded to the next vertical stiffener.
- 3) Then drilling of a hole
- 4) And gas cutting
- 5) Finally, welding of lower flange

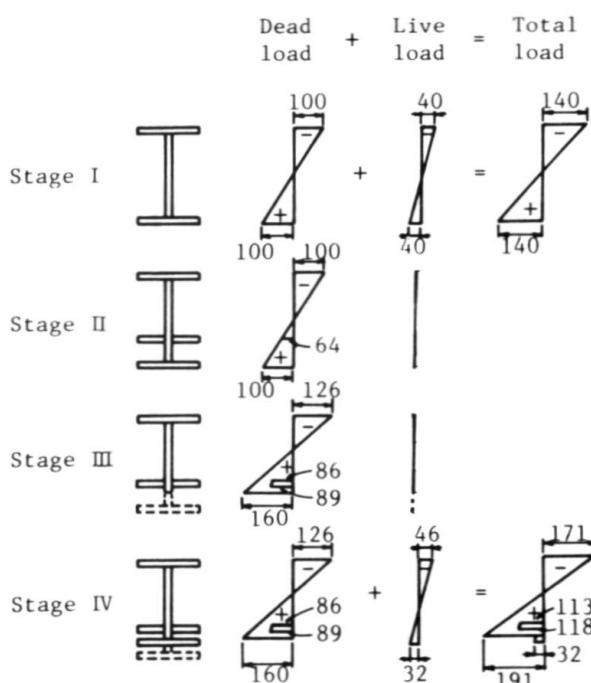
Assuming an existing girder with the same proportion as the model, the stresses on each stage are considered to be as shown in Fig. 3.

Stage I: Original section.

Assume the stresses due to the dead load and the live load as shown in the figure.

Stage II: Welding of stiffeners.

The live load is not considered, because there is no traffic. The stress due to the dead load does not change.

Stage III: Gas cutting.

The stress, that exists in the section to be cut off, is redistributed. Also, the force is shared by horizontal stiffeners. The stress after redistribution can be calculated from the following three conditions.

- 1) Difference of strains exists between stiffeners and web.
- 2) The integral of moment by the stresses equilibrates with the external moment.
- 3) The integral of the stresses is equal to zero.

Stage IV: Welding of lower flange.

The stress due to the dead load does not change. The entire section is effective to resist the live load.

Fig. 3 Schematic example of stress (MPa)
