# **Elevated bridge in Hanshin expressway in Osaka (Japan)**

## 8. Elevated Bridge in Hanshin Expressway in Osaka (Japan)

**Owner:** Hanshin Expressway Public Corporation  
**Consultant:** Prof. Dr. K. Horikawa  
**Contractor:** Takara Giken Co. Ltd.  
**Work's duration (Field work):** 6 months (2 weeks)  
**Repair date:** 1986

### Replacement of Flange without Traffic Interruption

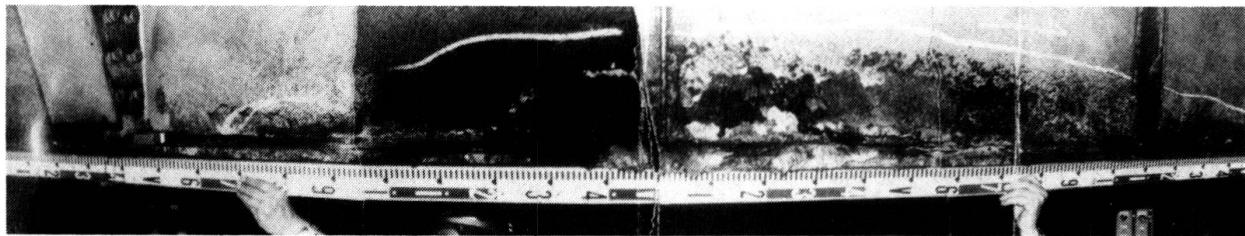
Heavy corrosion appeared at the lower flange plate, the lower end of web plate and one of the vertical stiffeners of a plate girder bridge (Fig. 1). It was caused by leakage of water through the timber plate used for a mold, which had been left in the concrete slab after completion. The location of the corroded area was the main girder near the span center of a 2-span continuous girder bridge for highway. The bridge was an elevated bridge in such a heavy traffic urban area (Fig. 2), that it was impossible to use any intermediate supports for the girder during repair and also impossible to suspend the traffic on the highway. Thus, the corroded area had to be repaired under loading and vibration.

Fig. 1 Corrosion in a bridge

Thinking of the heavy corrosion, method 3) was adopted in the repair using a by-pass member, which was to

carry the force that was carried by the part to be removed, during the repair. This repairing method is named «By-pass Method». Connections of the new part were of both welding and fastening with H.T. bolts; the lower flange was welded and the web was fastened with H.T. bolts.

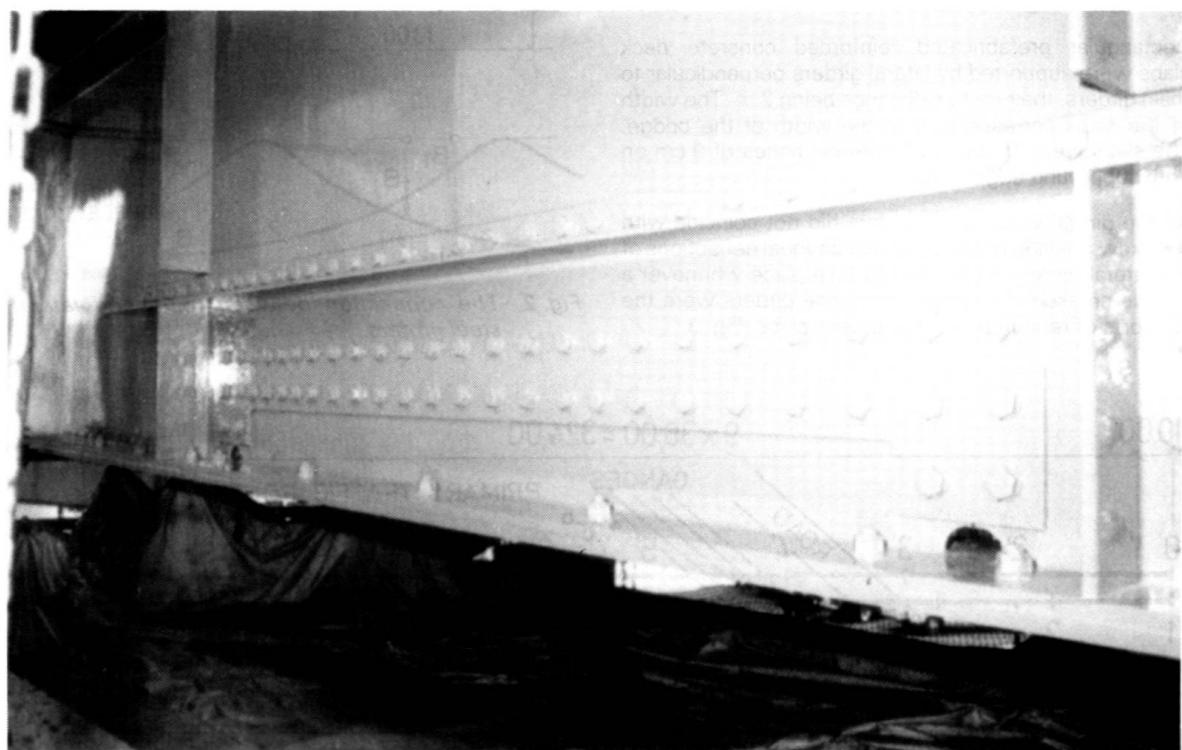
The repaired girder is shown in Fig. 3. The Technical Merit of Kansai Branch of JSCE was awarded for this work.

Fig. 3 Girder after remedy at site

- 1) To reduce the vibration as much as possible
- 2) To make the X type groove for welding and to remove the first layer by gouging
- 3) To keep the root gap from 1 mm to zero
- 4) To make a scallop in the part of web plate where the welding line crosses the web plate
- 5) To set end tabs
- 6) To adopt the relay welding process.
