# The bridge in the Radnika Street in Belgrade (Yugoslavia)

Heft C-46: **Repair and rehabilitation of bridges: case studies I**

## 9. The Bridge in the Radnička Street in Belgrade (Yugoslavia)

**Owner:** *The City of Belgrade*  
**Designer:** *Construction: Directorate for Bridges, Belgrade*  
*Rehabilitation: University of Belgrade, Department of Civil Engineering*  
**Contractor:** *Construction and rehabilitation: Mostogradnja, Belgrade*  
**Date of construction:** 1968  
**Date of rehabilitation:** 1984

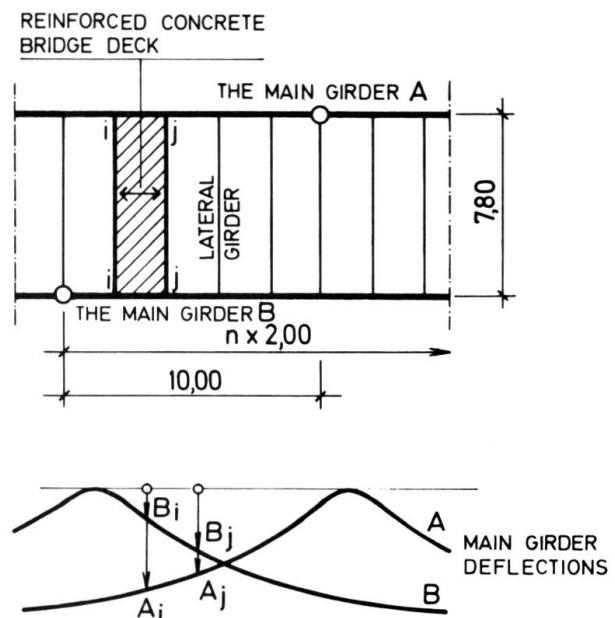
Fig. 2 The connection between main and lateral steel girders

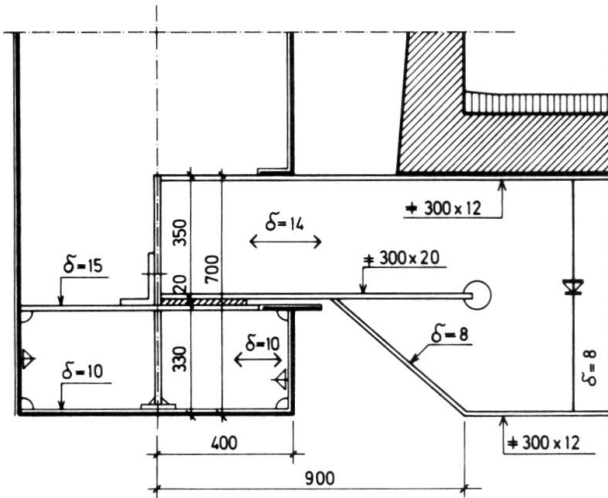
As the direction of lateral girders did not coincide with the skew position of the columns, unequal deflections of the lateral girders ends used to take place whenever a vehicle crossed the bridge and those girders were the supports of reinforced concrete deck slabs, Fig. 3.

The permitted movement of heavy vehicles by the right main girder only, still increased the unequal deflections of the lateral girders ends causing torsion and additional inconvenient stressing of reinforced concrete deck slabs.

Those slabs were connected to the upper chord of the lateral steel girders by tins anchored into the mass of concrete with four screws on both supporting edges. In the course of time, the connection was weakened and permanent damages of bridge decks above lateral girders took place. The lateral joints in asphaltic bridge deck, placed on each 2 m along the length of the bridge caused, beside uncomfortable drive, constant unforeseen dynamic impacts to the structure of the bridge. The repair of the bridge deck was practically impossible.

Fig. 3 Unequal deflections on lateral girders ends by which reinforced concrete deck slabs were supported

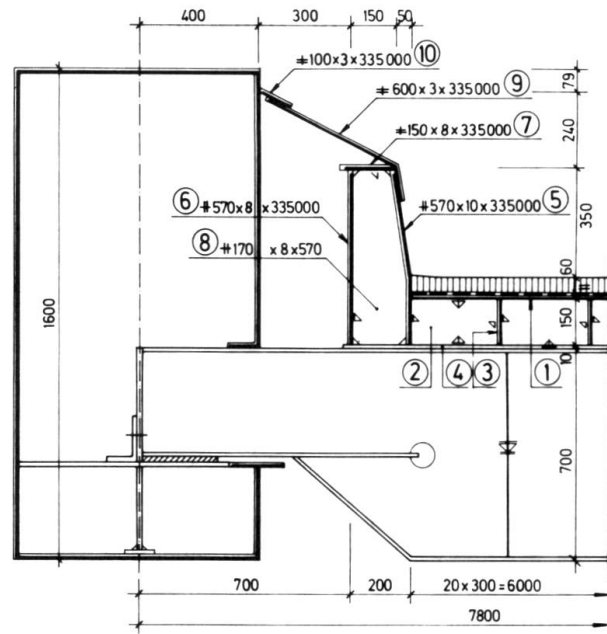
Fig. 4 The cross section of the bridge after rehabilitation

A relatively expensive but from the engineering point of view the most correct alternative solution was applied. The reinforced concrete bridge deck slabs were replaced by a orthotropic steel plate. However, due to the required minimum traffic brake and due to the existing connection between lateral and main girders, a modified orthotropic steel plate instead of the classical one was applied. Prefabricated, 10 m long assemblies of the orthotropic plate were delivered to the site and, in order to facilitate erection, their width was half the width

of the bridge so that the medium longitudinal seam was welded on the site. The connection of the orthotropic plate with the upper chord of the lateral girders was achieved by welding to the lower flange of the orthotropic plate, (Fig. 4).
