**Zeitschrift:** IABSE structures = Constructions AIPC = IVBH Bauwerke  
**Band:** 12 (1988)  
**Heft:** C-46: Repair and rehabilitation of bridges: case studies I

**Artikel:** Rehabilitation of Yamuna Bridge at Kairana (India)  
**Autor:** Manjure, P.Y. / Rohra, M.R.  
**DOI:** <https://doi.org/10.5169/seals-20929>

## 10. Rehabilitation of Yamuna Bridge at Kairana (India)

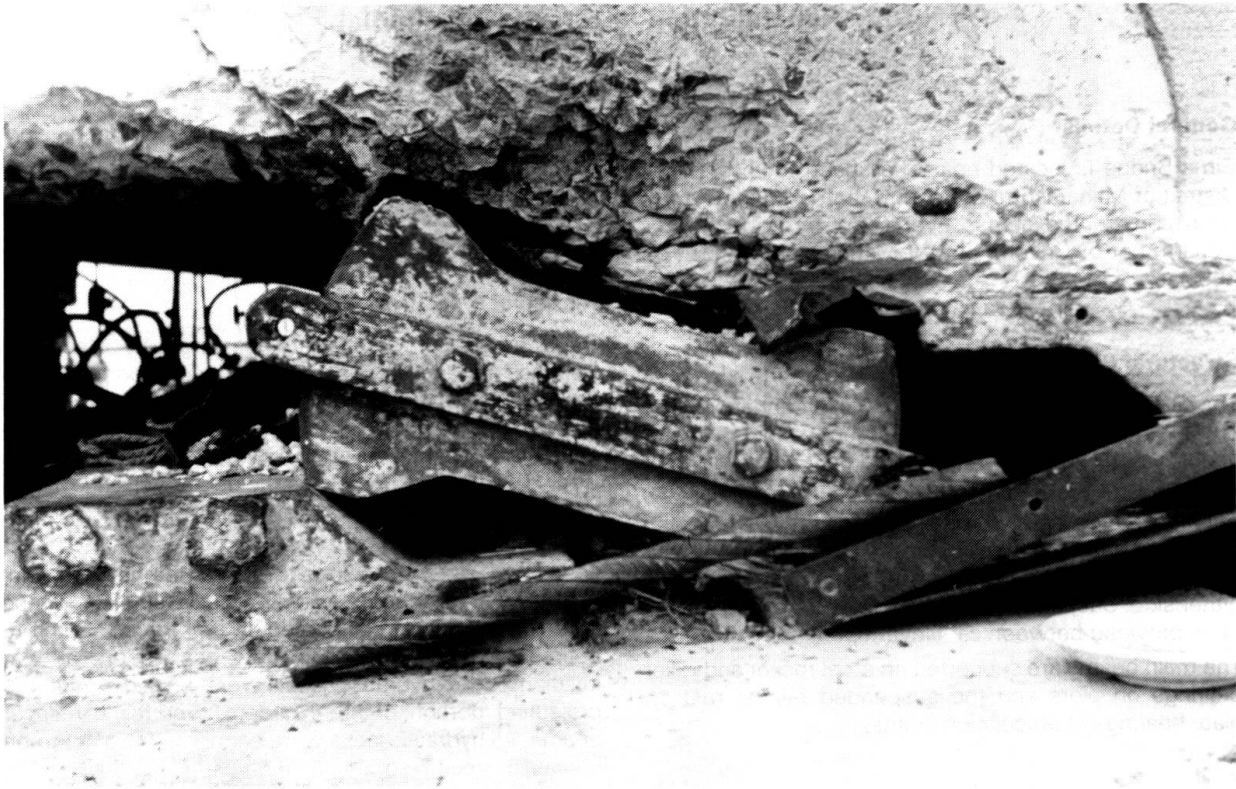
*Fig. 2 Position of segmental roller bearings*

Tapered steel shims were used to cater for change in inclination of span over supports, during lifting operation. After bringing the span to the level position, the suspended spans were shifted longitudinally to their original position by use of Freyssinet flat jacks at the expansion joint positions.

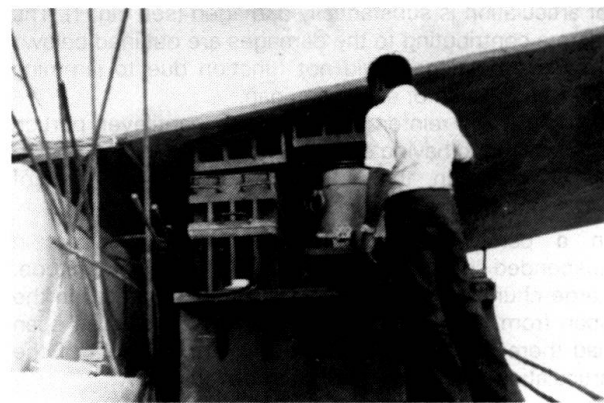
*Fig. 3 Lifting arrangement*

The well cap was also strengthened. Six numbers steel supports were erected from the well cap for lifting of the box girder. Each box girder was provided with two lifting points, one on either side of the pier. The large diameter Hydraulic Jacks of 200 tonnes capacity with safety nut arrangement were used for lifting the weight of 800 tonnes. In addition to the jacks stand-by support points were provided. Steel packing was provided over these support points continuously during lifting operation.

Before commencement of lifting operation, all the cracks were injected with epoxy resins. The sloping suspended spans were properly held with the cantilever tips to prevent any undesirable movement during lifting operation. To achieve uniform reaction at all the lifting points, all the jacks were connected to a common hydraulic circuit. The soffit of box girder was sloping. Therefore, wedge shaped steel boxes were fixed to the soffit for getting level surface at lifting points. Lifting arrangement is shown in Fig. 3. Packing boxes of different heights were planned so as to have a minimum number of them in position at any given time.
