Artikel: Repair of scoured substructure (Japan)
Autor: Morinaga, Norio
DOI: <https://doi.org/10.5169/seals-20932>

2. Repair of Scoured Substructure (Japan)

Case 1 Reinforcement with piles; Iwaide Bridge, Wakayama

Case 2 Repair by reinforced concrete lining; Natori Bridge, Miyagi

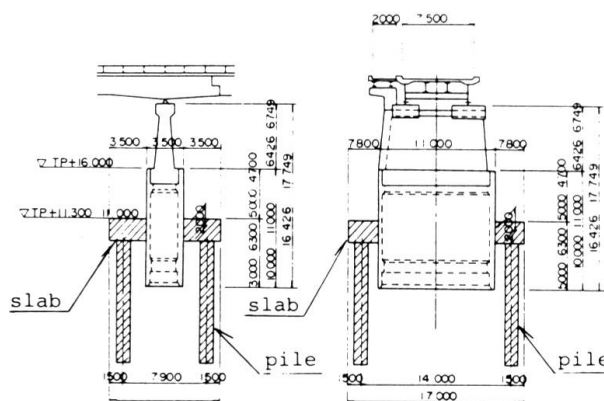
Fig. 2 Repair method (Iwaide Bridge)

The substructure has been scoured to a depth of 4 m average up to 6 m maximum from the effects of dredged riverbed and embankment located upstream. In the worst case, the depth of embedment was reduced to 5 m from the original 11 m. To prevent a further decrease, measures were taken in 1970 by temporarily placing protection blocks. Then in 1979 the caissons were checked again for its stability. To completely solve the problem, the substructure was reinforced by underpinning and constructing a new slab connected with the existing caisson. The repair job was performed on 7 heavily scoured substructures among a total number of 12.

For reinforcement of caisson with reduced depth of embedment, a cast in place pile method was chosen for underpinning, under consideration of geologic condition, clearance below girder during work an economy.

With the cast in place piles, four Benoto piles of 1.5 m diameter and 11.5 m length were placed at four sides of the caisson. The caisson and piles were connected by placing a 2 m thick slab on top to make a new footing (Fig. 2 and 3). To determine the dimension of slab and piles, the structure was analysed to resist working forces together with the existing bridge. The caisson and slab was connected by having the upper and lower steel reinforcements from the slab of 29 mm diameter and 3.5 m length embedded 30 cm deep with resin into the sides of the caisson.

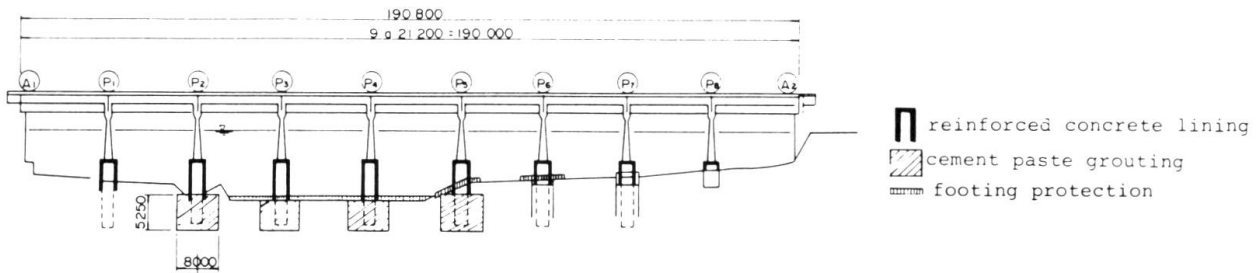
Fig. 4 Location of repair (Natori Bridge)

The Natori bridge, completed in 1932, has 190.8 m bridge length and 7.5 m road width (Fig. 4). The superstructure is a 9 span steel plate simple girder. The substructure consists of a rigid frame reinforced concrete pier and caisson.

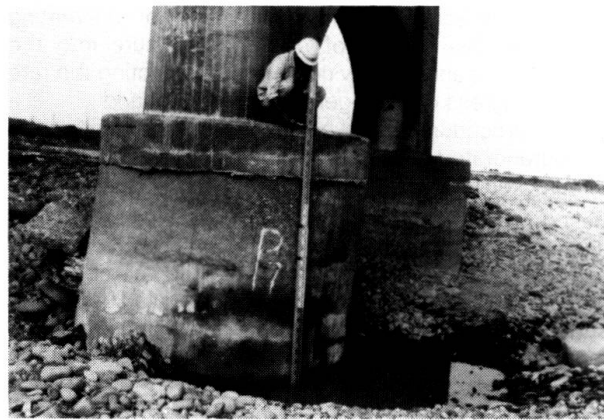
Fig. 6 Before repair (Natori Bridge)

The substructure on this bridge was repaired due to the following problems:

- 1) Exposed steel reinforcements at top of the caisson.
- 2) Bridge pier endangered of toppling due to scouring at the caisson causing differential settlement and loss of strength in the surrounding foundation.
- 3) The connection between caisson and pier has been deteriorated from shear force.
- 4) Furthermore, due to its old design, its ability to resist today's load has been questioned.
