# Rehabilitation of prestressed concrete bridge deteriorated by salt (Japan)

### 3. Rehabilitation of Prestressed Concrete Bridge Deteriorated by Salt (Japan)

#### Case 1 Nadachi Bridge, Niigata

## Case 2 Oyataroh Bridge, Miyazaki

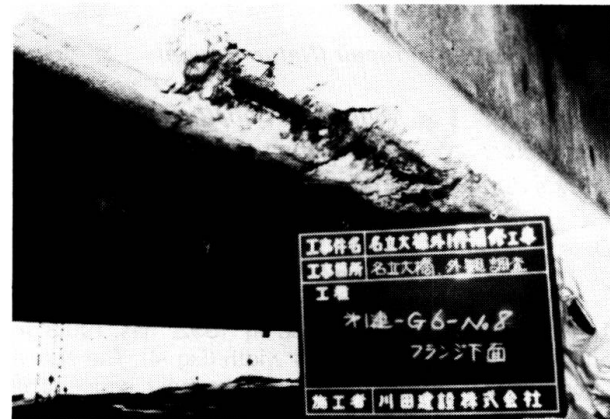
According to inspection test carried out in 1982, cracks and stripping were discovered mainly along the longitudinal reinforcements of the main girder lower flange. Corrosion seepage from these cracks and stripping were noticed at many places. These are the typical characteristics of damages on most concrete structures in the area affected by blown salt.

Fig. 1 Deterioration of flange (Nadachi Bridge)

In the actual rehabilitation procedure, the cracked concrete portions, portions with corrosion seepage and stripped portions (these areas have lost their strength and were acting only as loads on defected girders) were removed, then salt and debris stuck to the surface of steel members and concrete were removed by sand-blasting. In addition, a modified epoxy resin paint was applied to the surface of steel reinforcements and cables, then the concrete that was lost was restored.

Epoxy resins were used for rehabilitating the concrete. Porous concrete surfaces and uneven portions were corrected by epoxy resin mortar mixed with sand; to make a good surface for paints. Epoxy resin prepacked concrete method was adopted for continuous or large sections that had fallen off. In this case formwork was attached and filled with dry aggregate and then epoxy resin grout was applied.

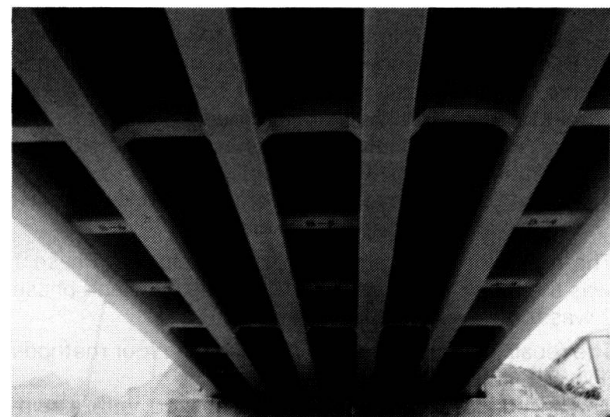
Fig. 2 After repair (Nadachi Bridge)

Upon completion of the rehabilitation of sections performed as stated above, an anti-corrosive paint was applied to prevent corrosive materials from penetrating.

In applying anti-corrosive paints to these concrete structures having the normal surfaces not treated with paint, there were many unknown points, and it was thought to be important to conduct a research on the suitable kinds of anti-corrosive paints. Thus, four kinds of paints shown in Table 1 were applied to the rehabilitated bridge. Generally, for a structure into which salt has already penetrated, the salinity will vary depending on the location of the portion to be painted, so that the effect of painted material varies by the location. Thus the effect at different places cannot be compared on the same basis. Therefore, concrete slabs painted with four different kinds of paints and unpainted concrete slabs were exposed below this bridge (Fig. 1 and 2).

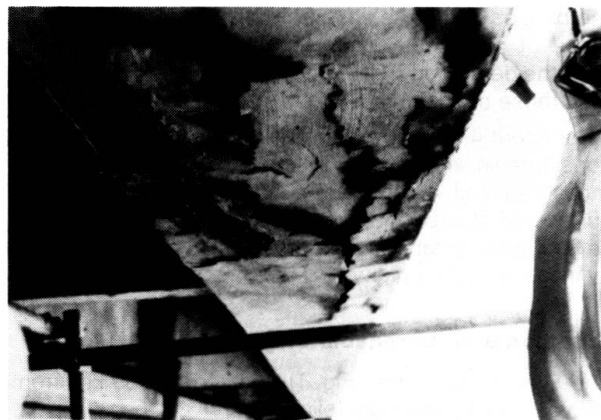
The inspection carried out in 1985 revealed damages typical of salt deterioration such as cracked concrete along the transverse reinforcement at the lower flange of main girders, concrete stripping and rust. Furthermore, inspection by breaking the concrete revealed that in some cases 2 cables were broken among the 12 cables that are used.

Fig. 3 Crack at lower flange (Oyataroh Bridge)

The same repair method was applied as for Nadachi bridge. Cracked or stripped concrete areas were removed, sandblasted, resin paint applied on steel and concrete restored to its original dimension with epoxy resin mortar by the prepacked concrete method. To repair broken cables, reinforcement methods by adding external cables were studied. Considering the present traffic and other conditions of this bridge, it was decided that the present strength is sufficient and that further reinforcement will not be needed.

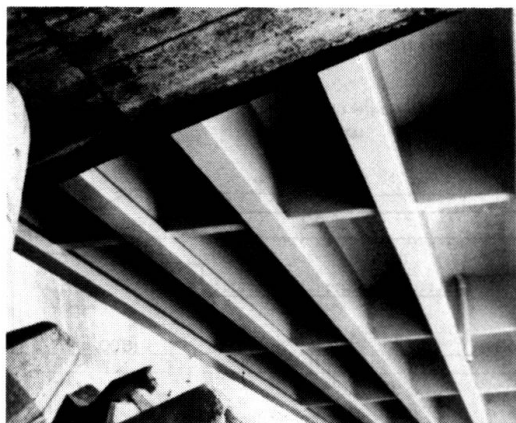
Fig. 4 After repair (Oyataroh Bridge)

The anti-corrosive paint applied is as follows: the first coat is epoxy resin primer; second, third and fourth coat is polybutadien resin paint; finish coat is polyurethane resin.
