Ohara Bridge fatigue crack repair (Japan)

6. Ohara Bridge Fatigue Crack Repair (Japan)

Owner: Toyama Prefecture
Engineer & Contractor: Kawada Industries
Work's duration: 6 months
Date of repair: 1984 – 1985

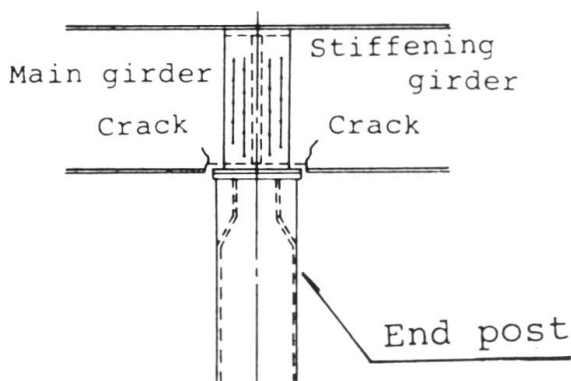
The fatigue cracks occurred at the connecting gusset plates to each panel of intermediate post, which connects the stiffening girder to arch rib (Fig. 2, 3), and also at the web of stiffening girder above end post, which is the joint between center span and side span (Fig. 4, 5). These cracks were found by visual inspection during patrol in 1982.

Fig. 4 Location of crack

With respect to the fatigue cracks in the web of stiffening girder above the end post, the stress concentration by secondary bending stress at the notches, which also resulted from out-of-plane displacement, was found to

Among these cracks, a temporary repair was made for the cracks in the web of stiffening girder immediately after finding them in order to prevent a rapid breakdown as explained below. That is, stop holes were drilled at the end of all cracks in the web. Moreover, steel brackets were installed on all end posts and were used as temporary supports for stiffening girders in side span and center span.

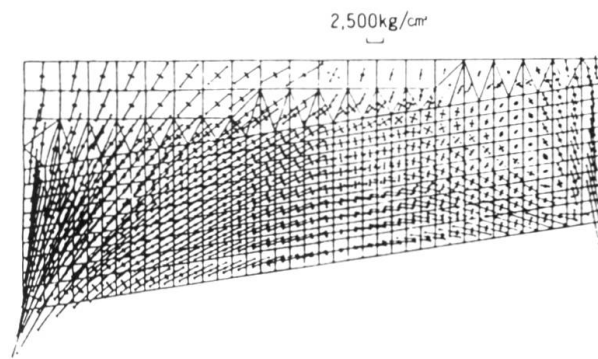
The fatigue cracks in the gusset plates of intermediate posts were mainly caused by excessive stress concentration at the corner section. This stress concentration was caused by a relatively large longitudinal displacement between stiffening girder and arch rib, which was created by the movability of both end supports. This was confirmed from displacement obtained in a loading test on the actual bridge, results from stress measurements, and the results of 3-dimensional finite element method analysis (Fig. 6). Therefore, as repairing method, new damper bearings were installed on the top of both abutments for reducing the relative longitudinal displacement (Fig. 7). This damper bearing comprised a rubber bearing, return spring and special hydraulic damping system. The supporting condition provides movability at both support bearings for static movement such as temperature effect and resists only to vertical movement caused by live load, giving elastic restraint toward longitudinal movements. Moreover, improvement schemes by making rigid joints or by providing hinges at the gusset plates of intermediate posts were reviewed, but the former indicated an adverse influence upon arch rib and the latter was found to be uneasy to work with. In addition, the compression stress was found to be primary, and the relief of residual stress by the outbreak of cracks was found to be expectable, so both improvement schemes were not adopted this time.

Fig. 6 F.E.M. analysis stress diagram
