# Fujigawa Bridge rehabilitation project (Japan)

## 7. Fujigawa Bridge Rehabilitation Project (Japan)

<b>Owner:</b>	<i>Shizuoka Prefecture</i>
<b>Contractor:</b>	
<i>Substructure:</i>	<i>Sumitomo Construction</i>
<i>Deck replacement:</i>	<i>Japan Bridge</i>
<i>Superstructure:</i>	<i>Yokogawa Bridge Works</i>
<b>Work's duration:</b>	<i>6 months</i>
<b>Date of repair:</b>	<i>1987 – 1988</i>

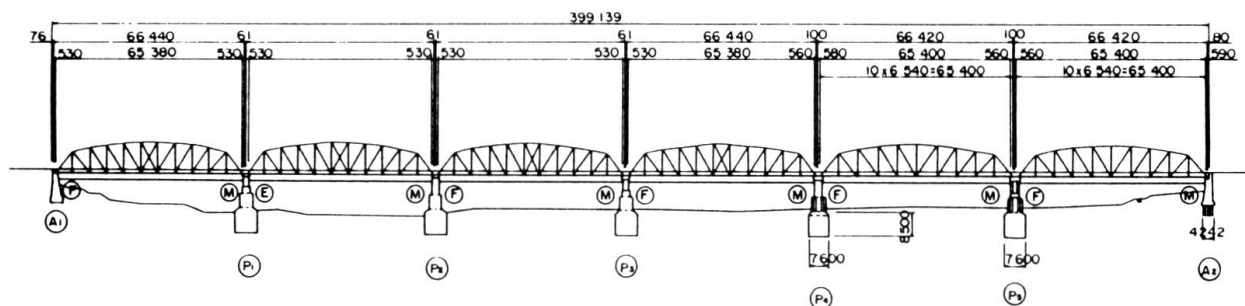
Fig. 1 Elevation

The Fujigawa Bridge, completed in 1924, over the Fuji River on Route 1 is a bridge with six-span curved chord pratt truss having a bridge length of 300.1 m, roadway width of 7.3 m and span of 65.4 m (Fig. 1). Route 1 is the most important road in Japan, and 60 years after completion of the bridge, the daily traffic flow was 21 000 vehicles, though bypass roads had been completed upstream and downstream of the bridge.

After many years of use, such problems as cracked concrete decks, corroded outer stringers, overstressed and deflected stringers, and scouring at the piers due to the lowered river bed of the Fuji River have occurred. Also, as a result of the increased traffic flow, traffic congestion caused by right turning cars holding the traffic had become a big problem.

To solve these problems, the substructure of the bridge was reinforced, and the stringers and deck on four spans to the left bank were replaced. Moreover, two spans to the right bank were replaced in order to install a right turning lane by the method that was chosen to complete the job with the least disturbance to traffic.
