Fujigawa Bridge rehabilitation project (Japan)

7. Fujigawa Bridge Rehabilitation Project (Japan)

Owner:	<i>Shizuoka Prefecture</i>
Contractor:	
<i>Substructure:</i>	<i>Sumitomo Construction</i>
<i>Deck replacement:</i>	<i>Japan Bridge</i>
<i>Superstructure:</i>	<i>Yokogawa Bridge Works</i>
Work's duration:	<i>6 months</i>
Date of repair:	<i>1987 – 1988</i>

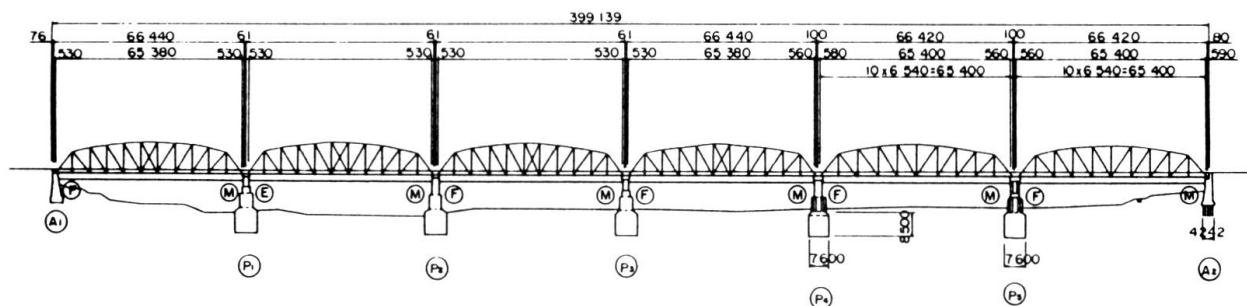
Fig. 1 Elevation

The Fujigawa Bridge, completed in 1924, over the Fuji River on Route 1 is a bridge with six-span curved chord Pratt truss having a bridge length of 300.1 m, roadway width of 7.3 m and span of 65.4 m (Fig. 1). Route 1 is the most important road in Japan, and 60 years after completion of the bridge, the daily traffic flow was 21 000 vehicles, though bypass roads had been completed upstream and downstream of the bridge.

After many years of use, such problems as cracked concrete decks, corroded outer stringers, overstressed and deflected stringers, and scouring at the piers due to the lowered river bed of the Fuji River have occurred. Also, as a result of the increased traffic flow, traffic congestion caused by right turning cars holding the traffic had become a big problem.

To solve these problems, the substructure of the bridge was reinforced, and the stringers and deck on four spans to the left bank were replaced. Moreover, two spans to the right bank were replaced in order to install a right turning lane by the method that was chosen to complete the job with the least disturbance to traffic.
